Erie, Pa

Bluff & Ravine Evaluation

February 26, 2020

Dahlkemper Landscape Architects & Contractors

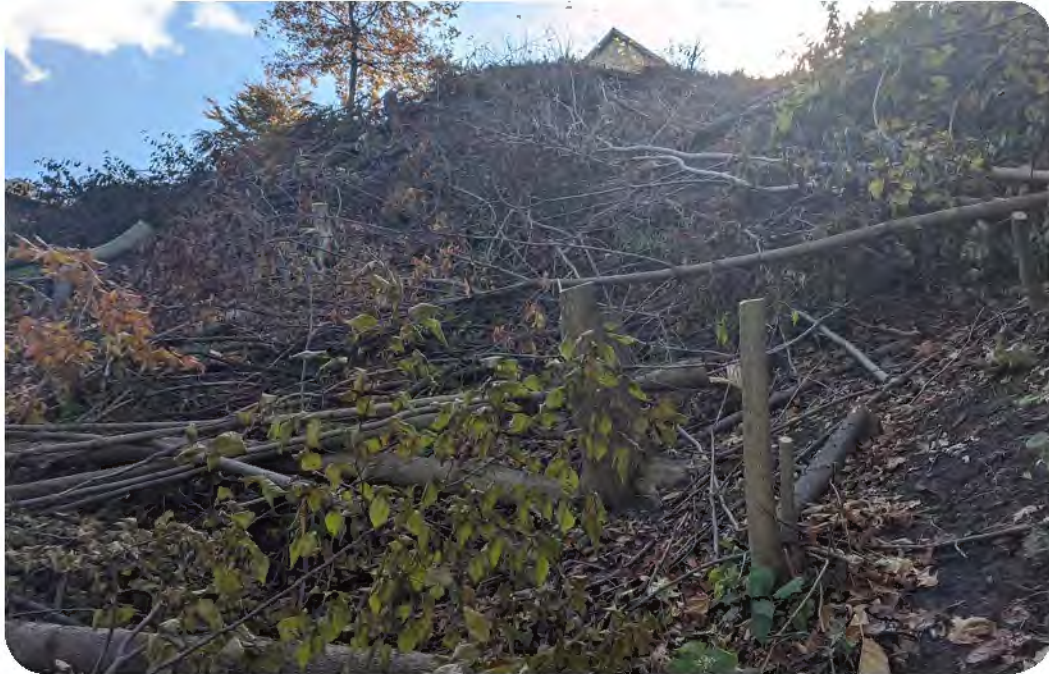
Bulk Vegetation Removal

The removal of vegetation from a slope leaves bare soil vulnerable to erosion. In addition, vegetation provides valuable roots for soil stabilization and soaking up of water from the soil - removing these threatens the health of the slope.

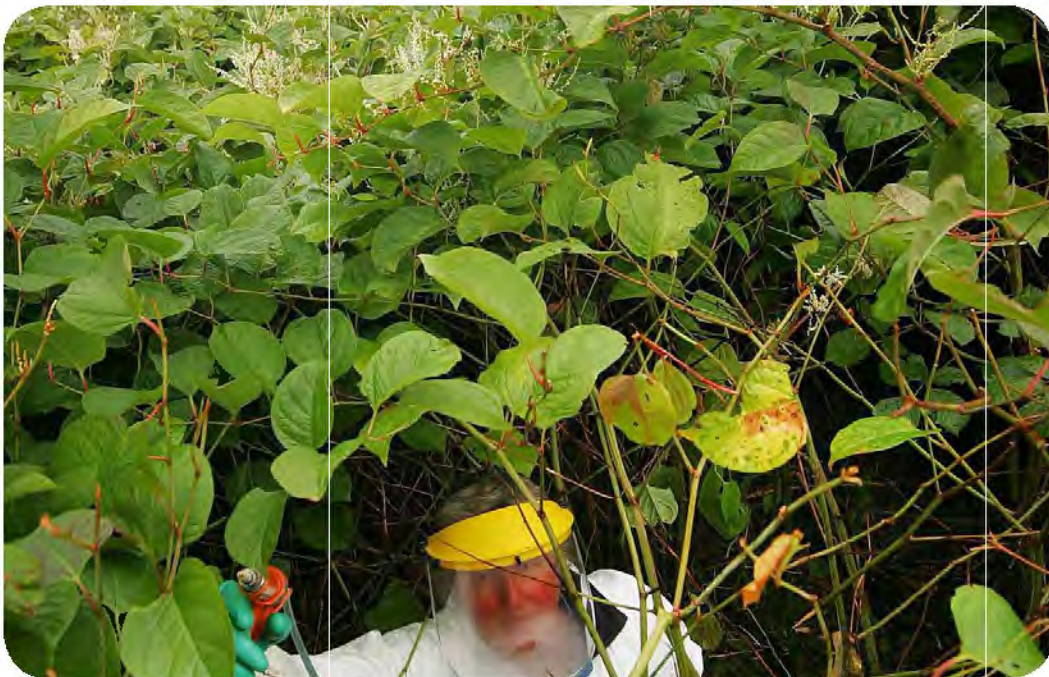
Invasive Vegetation

Invasive species threaten the native plant communities by out competing and taking over large areas choking out anything from growing. If not controlled they can kill out important slope stabilizing vegetation leaving them at risk of erosion.

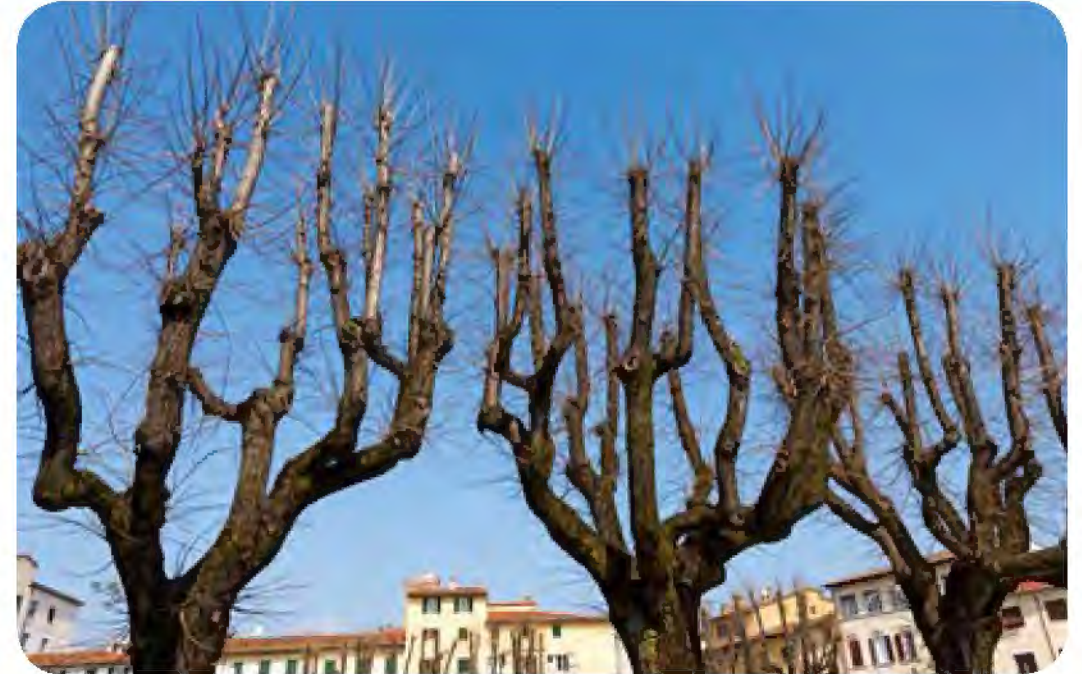
Improper Tree Trimming

Residents living near ravine and bluff properties want to enjoy their views leading to tree topping & poor trimming practices. This creates unhealthy diseased trees as well as dense canopies that will choke out any understory vegetation

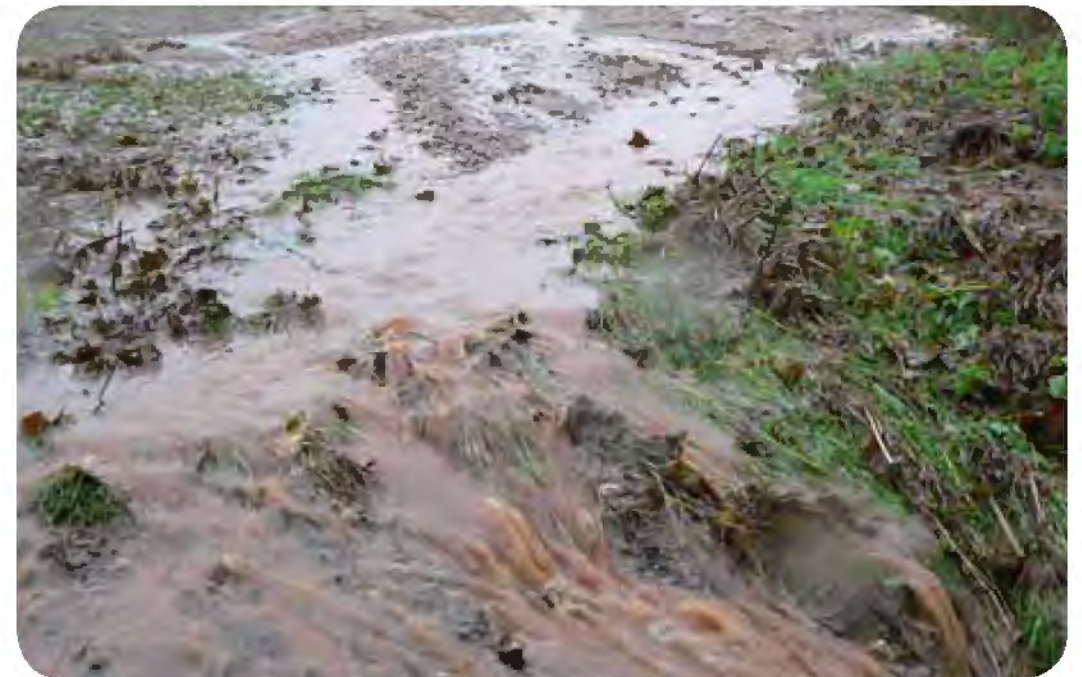
Poor Stormwater Control

Water is one of the biggest threats to ravine and bluff properties. Improper discharging or controlling of stormwater on the surface can lead to major erosion and slope failure.

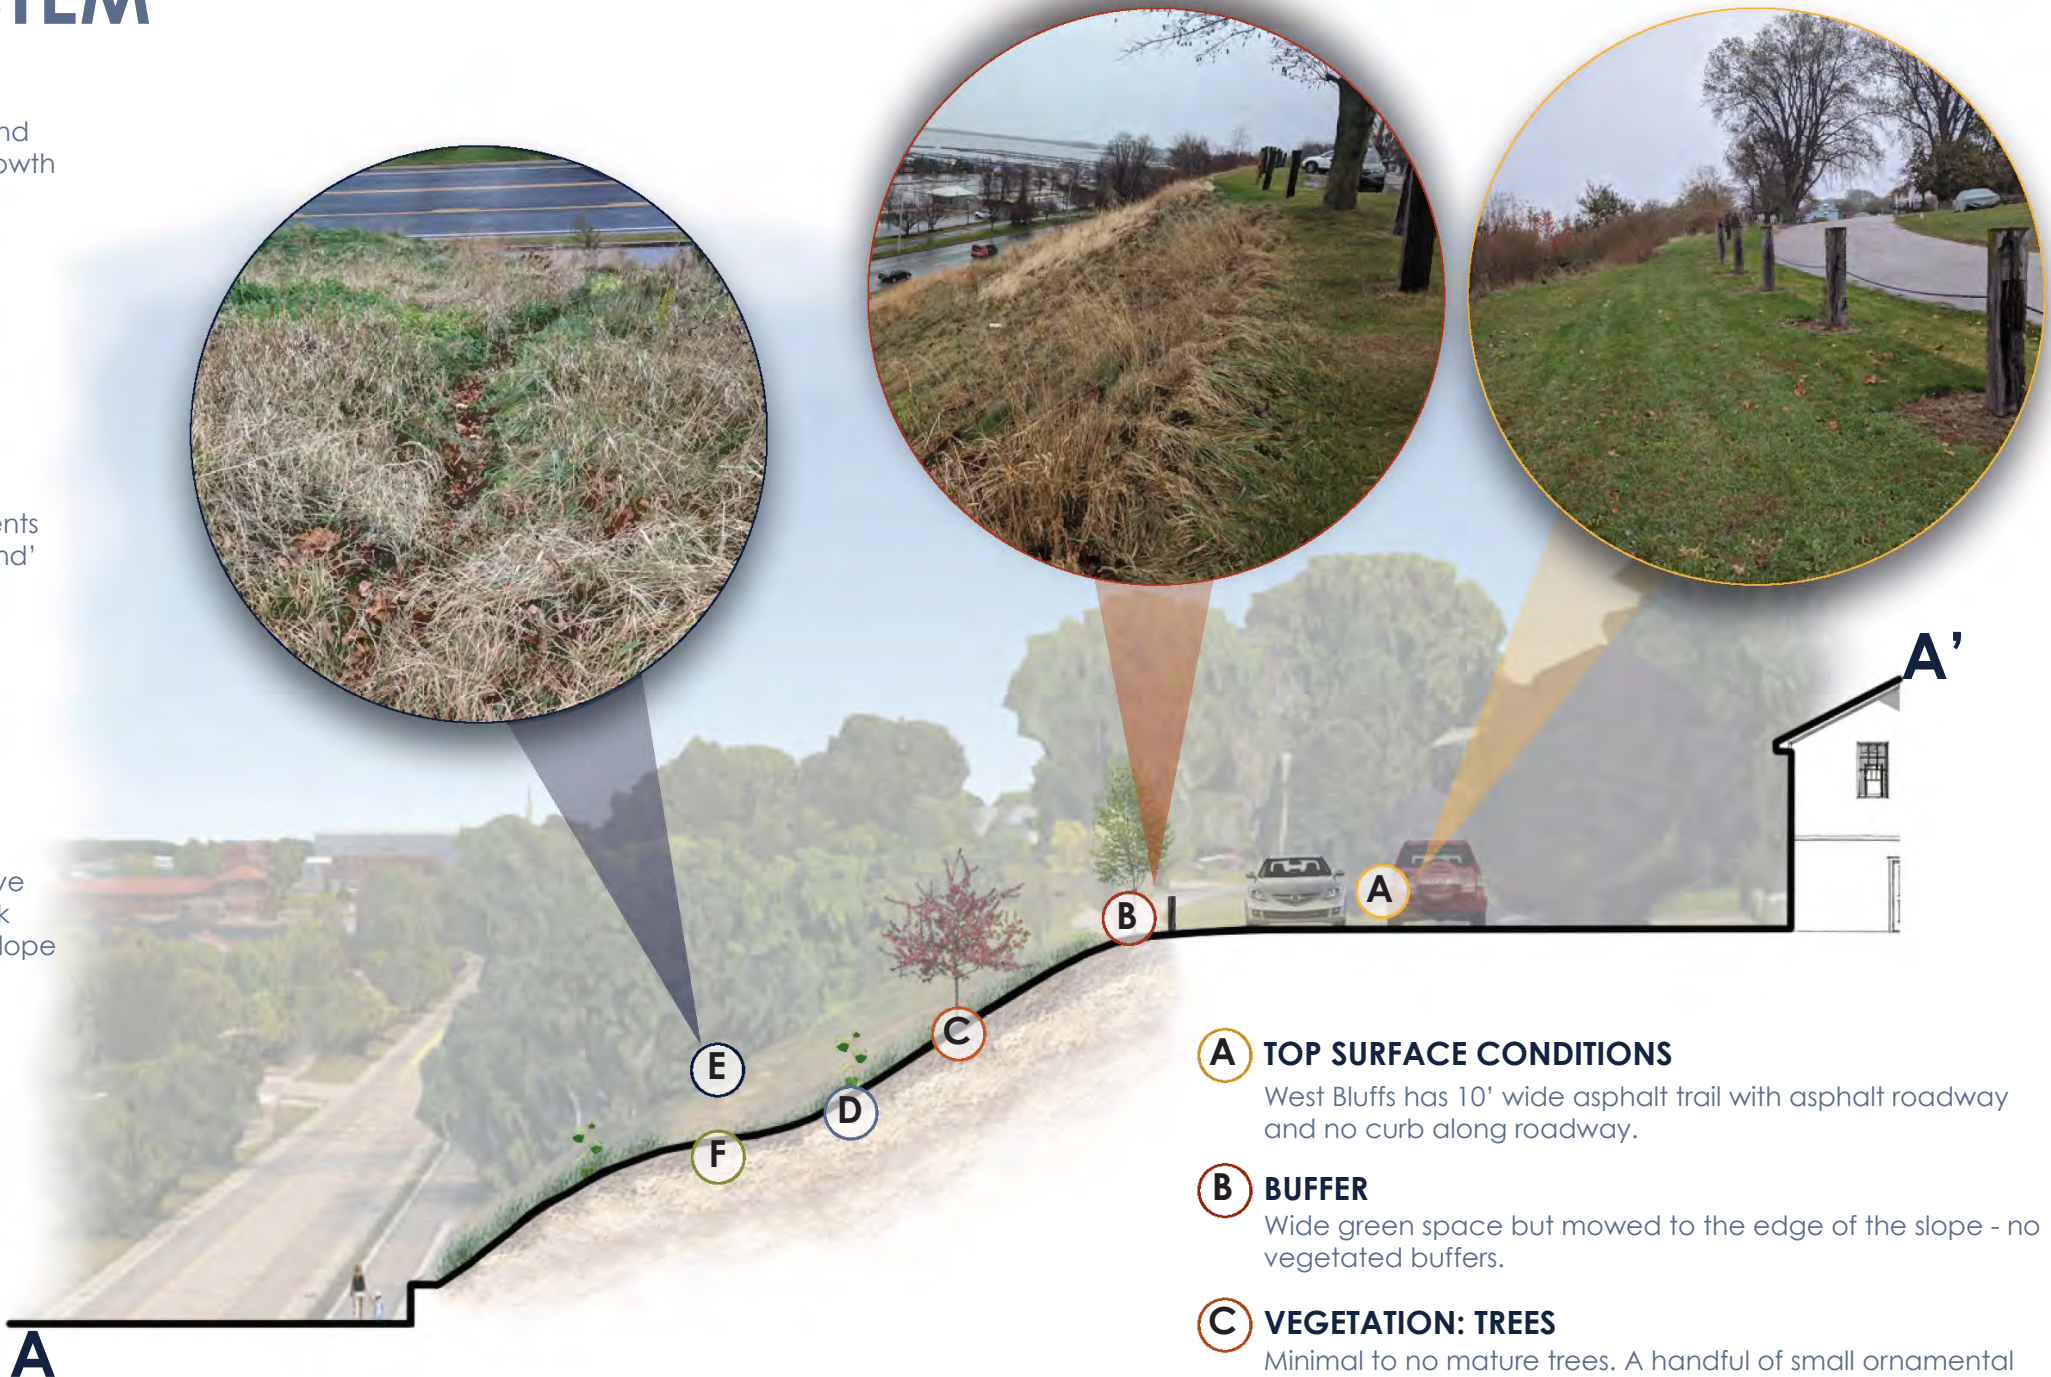
- A TOP SURFACE CONDITIONS**
West Bluffs has 10' wide asphalt trail with asphalt roadway and no curb along roadway.
- B BUFFER**
Wide green space but mowed to the edge of the slope - no vegetated buffers.
- C VEGETATION: TREES**
Minimal to no mature trees. A handful of small ornamental flowering trees scattered throughout bluff section.
- D VEGETATION: UNDERSTORY/GROUND**
Well establish low mow grass has stabilized the soil very well. Patches of invasive species throughout bluff section.
- E DRAINAGE/WATER**
Minimal rills created down hillside from channelized water flow.
- F WASTE/DEBRIS**
Trash & non-organic debris scattered throughout this section of the bluffs. Minimal yard waste discovered.

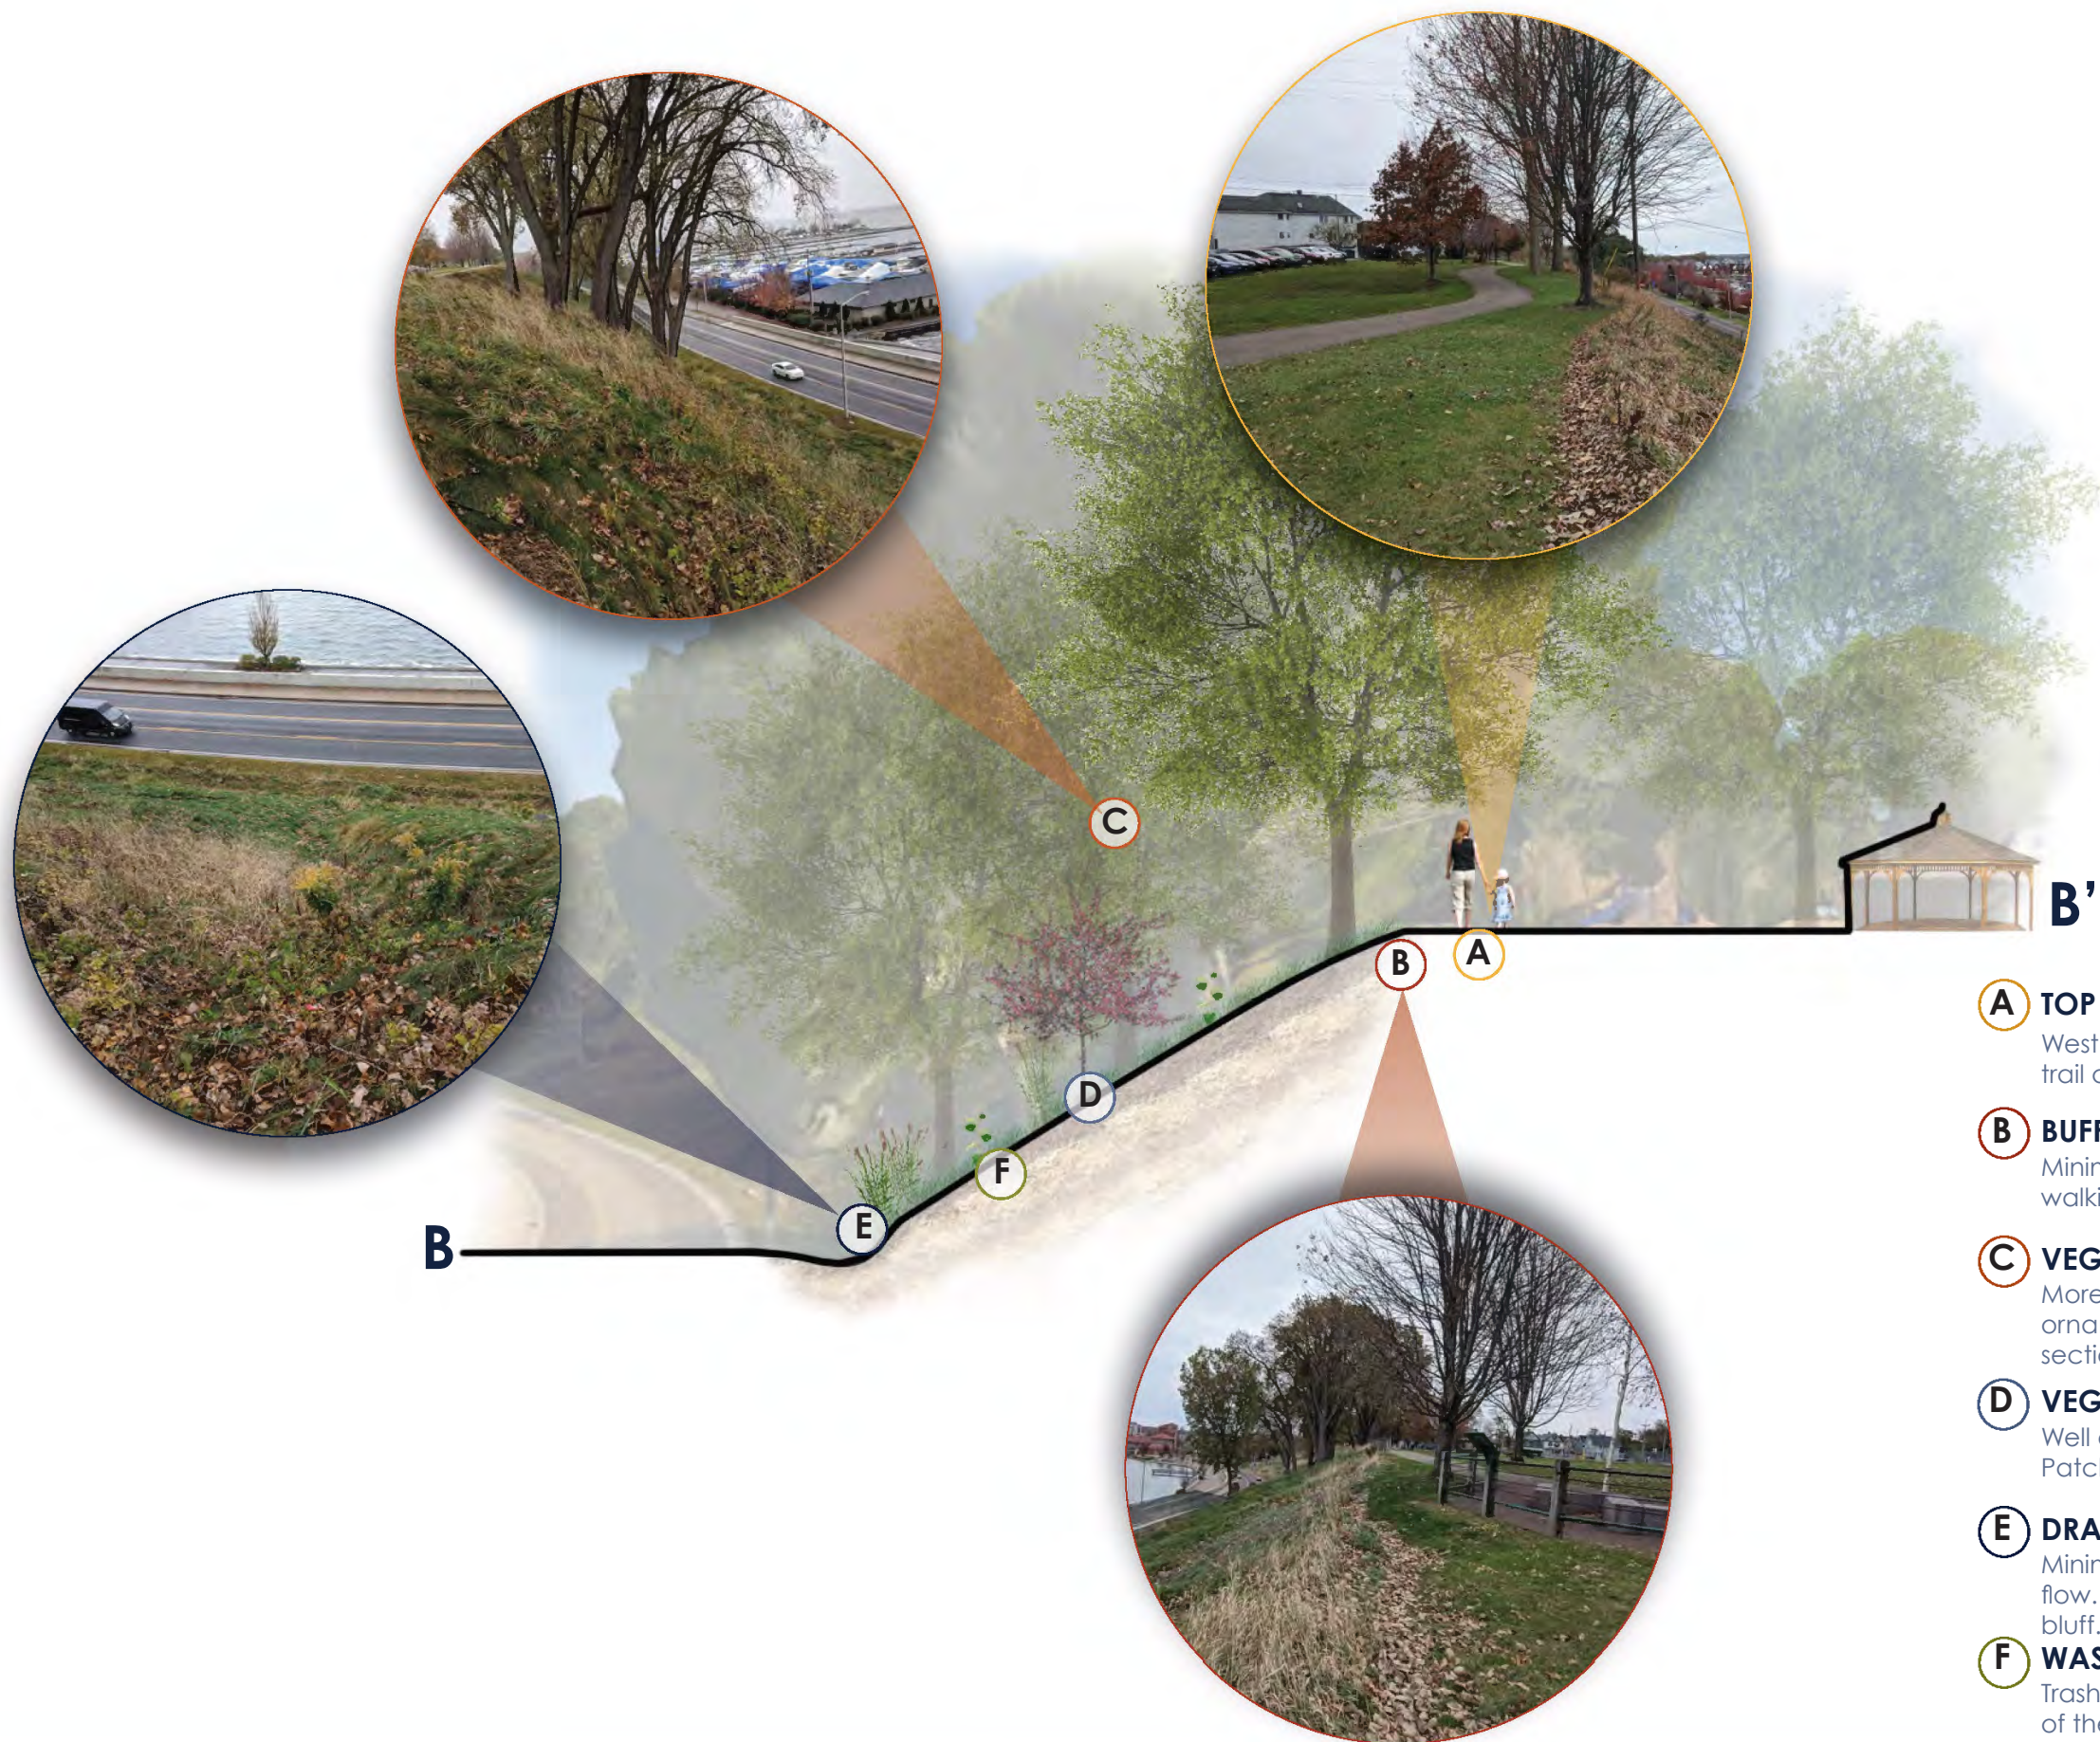
- A TOP SURFACE CONDITIONS**
West Bluffs between Cherry & Walnut has 10' wide asphalt trail at the top of the slope and green space on other side.
- B BUFFER**
Minimal green space as slope goes directly or close to walking trail leaving minimal space for a buffer.
- C VEGETATION: TREES**
More established mature trees and handful of small ornamental flowering trees scattered throughout bluff section.
- D VEGETATION: UNDERSTORY/GROUND**
Well establish low mow grass has stabilized the soil very well. Patches of invasive species throughout bluff section.
- E DRAINAGE/WATER**
Minimal rills created down hillside from channelized water flow. There is a swale with drainage along the toe of the bluff.
- F WASTE/DEBRIS**
Trash & non-organic debris scattered throughout this section of the bluffs. Minimal yard waste discovered.

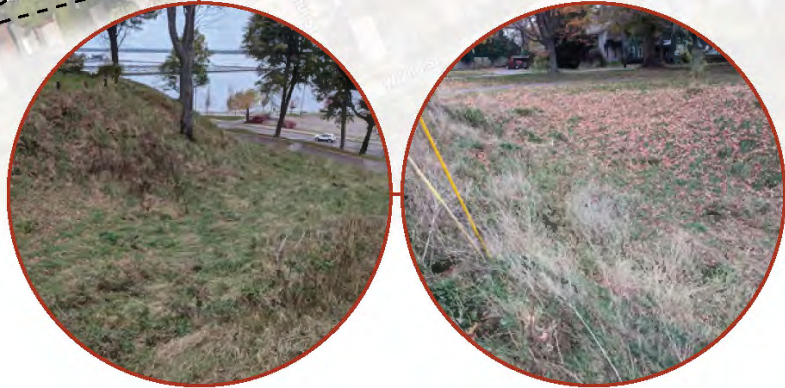
Stable ravine channel with established grass/ground cover. Could use canopy trees, understory trees and shrubs to maintain stabilization.

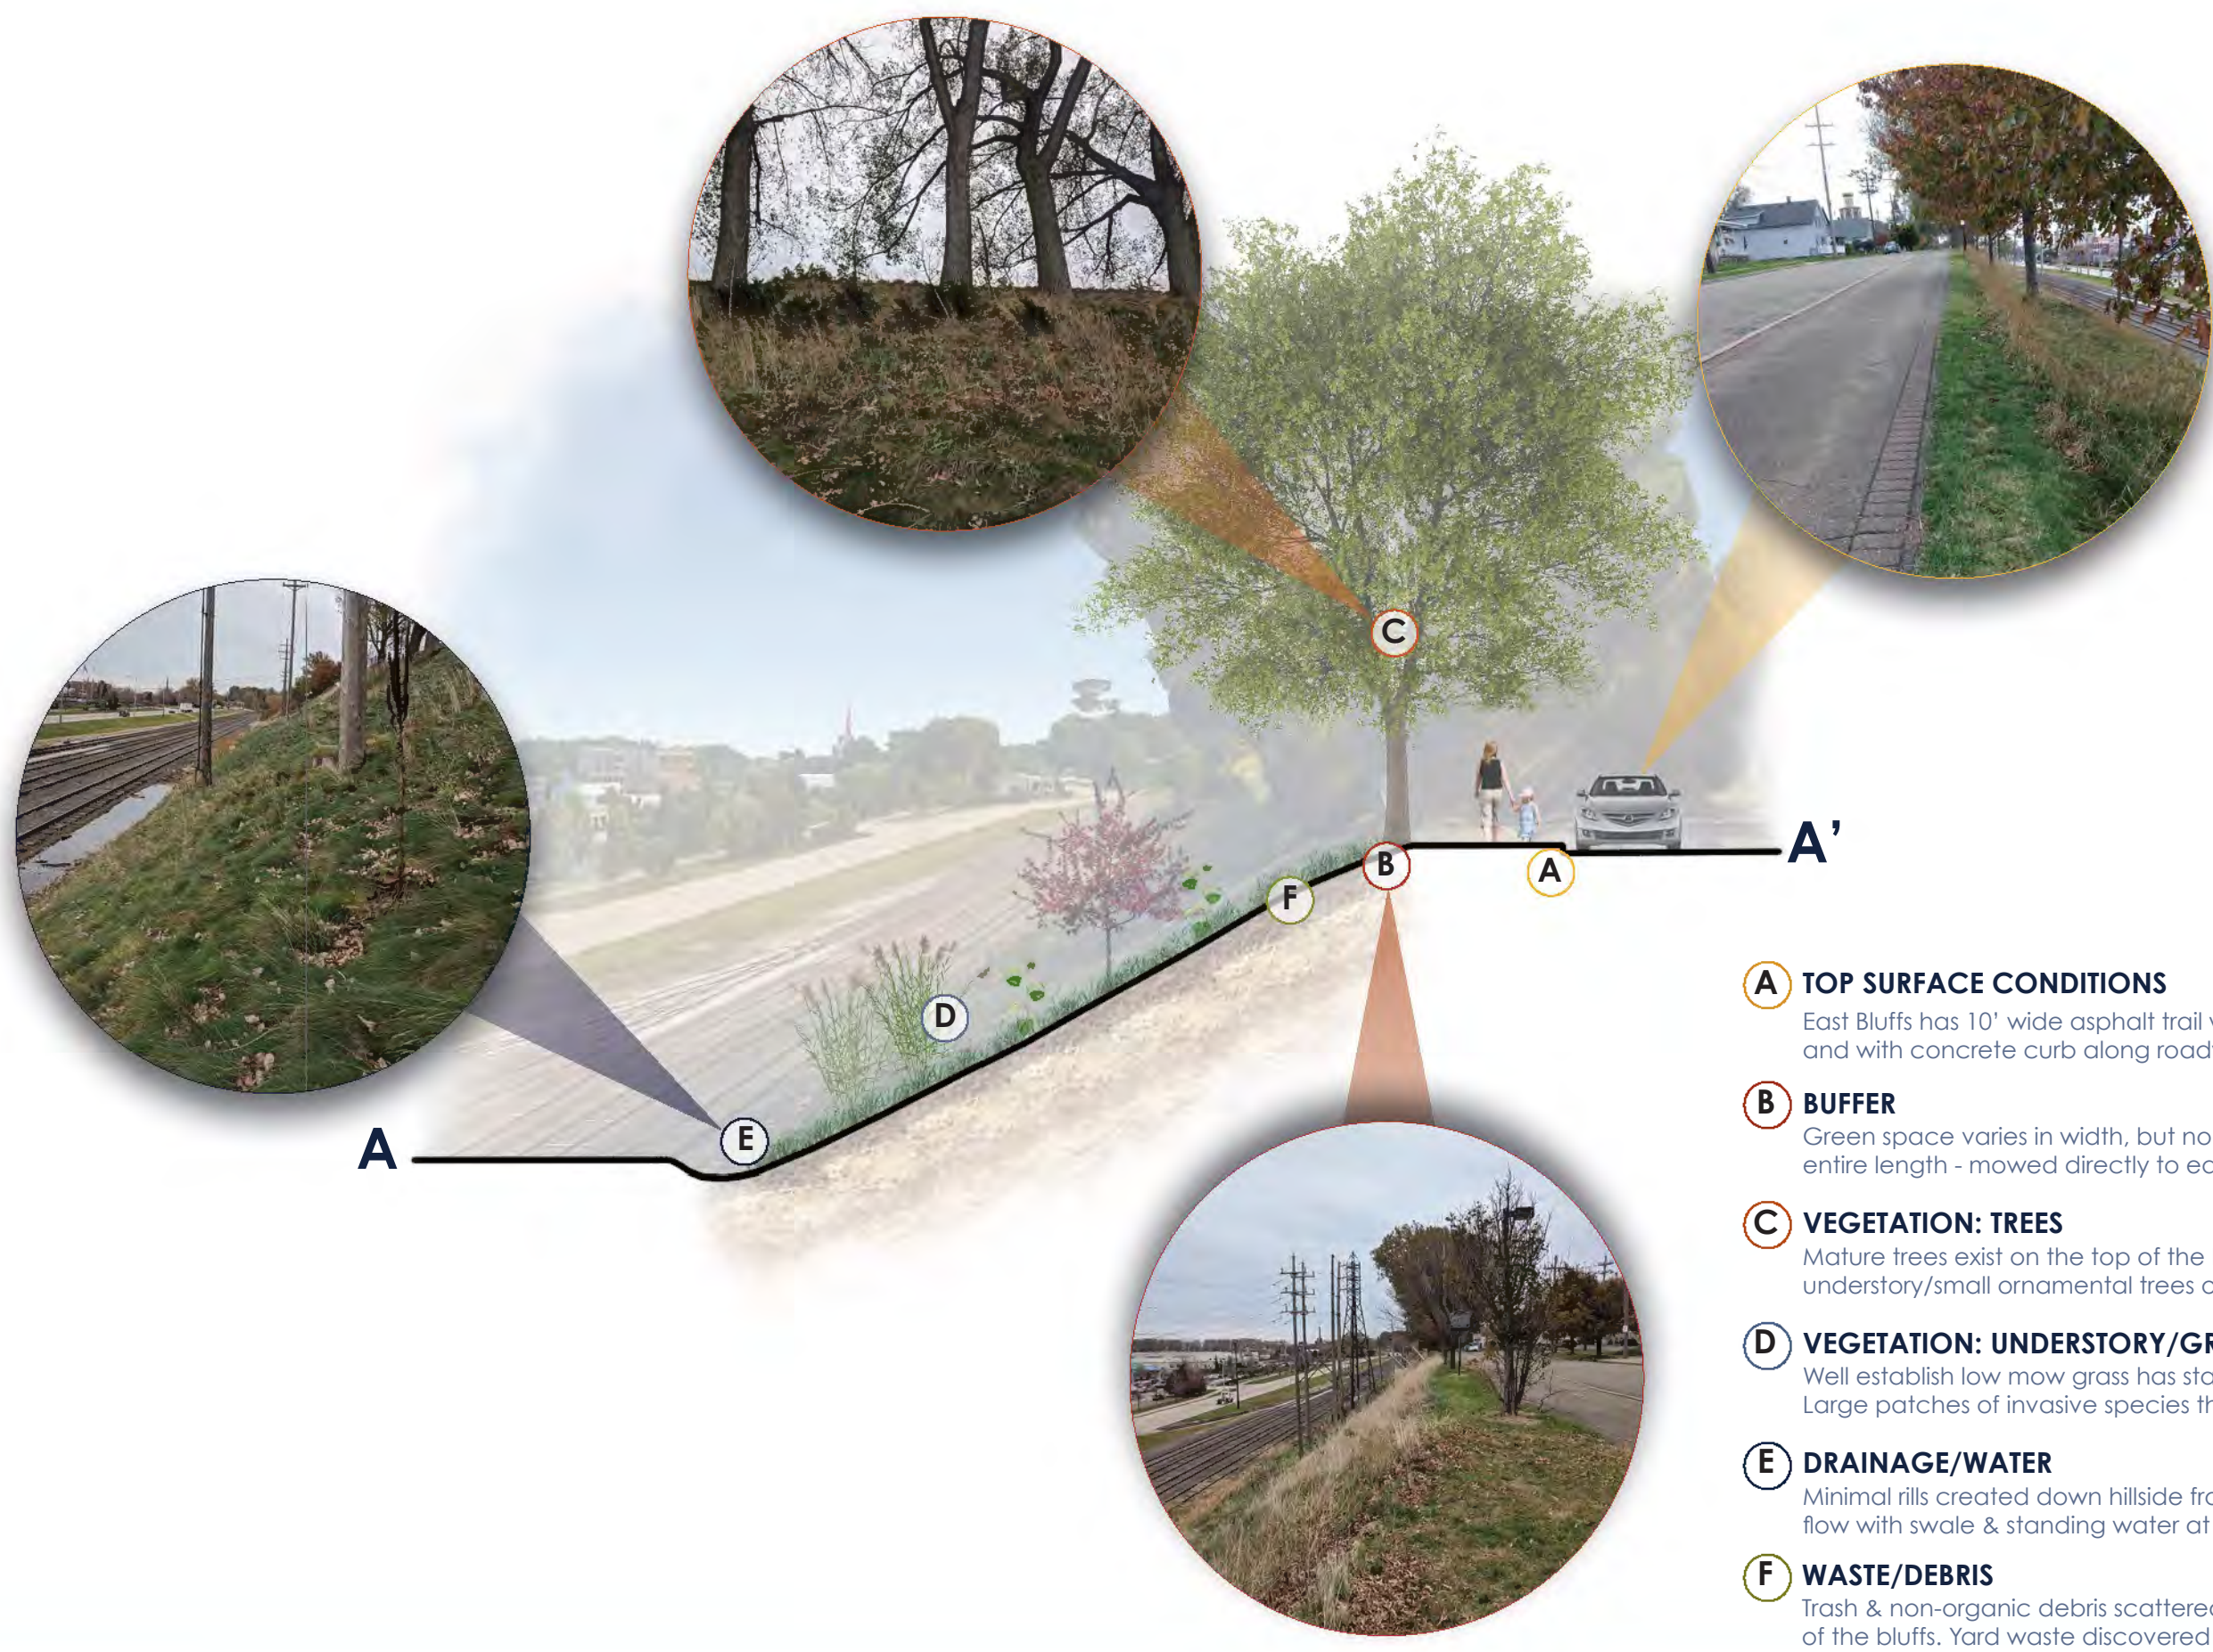
Inventory & Analysis: Bayfront East - Holland St. to Parade St.

- A TOP SURFACE CONDITIONS**
East Bluffs has 10' wide asphalt trail with asphalt roadway and with concrete curb along roadway.
- B BUFFER**
Green space varies in width, but no established buffer along entire length - mowed directly to edge.
- C VEGETATION: TREES**
Mature trees exist on the top of the bluff with a few understory/small ornamental trees on the slope.
- D VEGETATION: UNDERSTORY/GROUND**
Well establish low mow grass has stabilized the soil very well. Large patches of invasive species throughout bluff section.
- E DRAINAGE/WATER**
Minimal rills created down hillside from channelized water flow with swale & standing water at toe of slope.
- F WASTE/DEBRIS**
Trash & non-organic debris scattered throughout this section of the bluffs. Yard waste discovered near tops of bluffs.

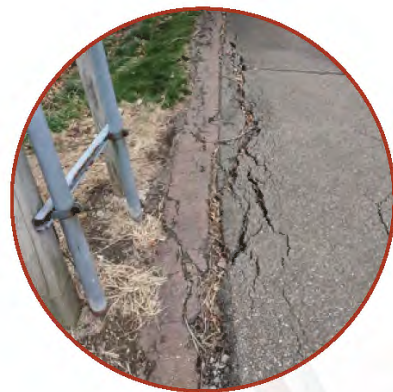
Steep bluff slope crests right at the edge of the walkway. Erosion is undermining the walk and causing it to tip down the slope. Wood retaining wall measures have been put in place at locations.

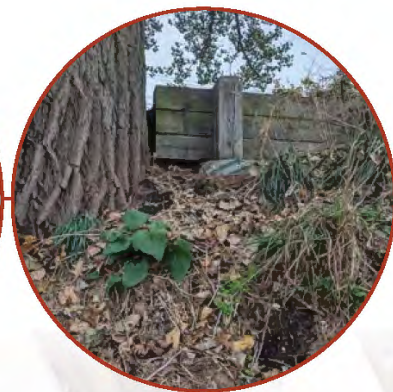
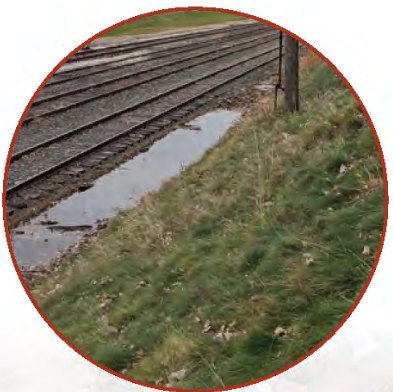
A swale holds water and debris along the majority of the bluff at the toe.

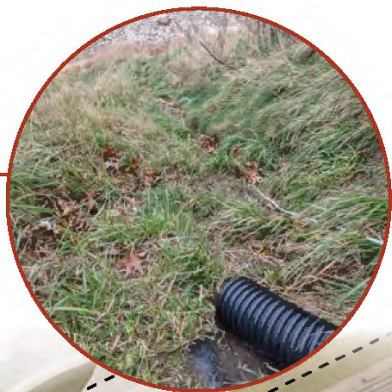
A rill is forming from the discharge of a drainage pipe at the top of the slope. Moving the pipe down the slope and discharging at the toe is preferred.

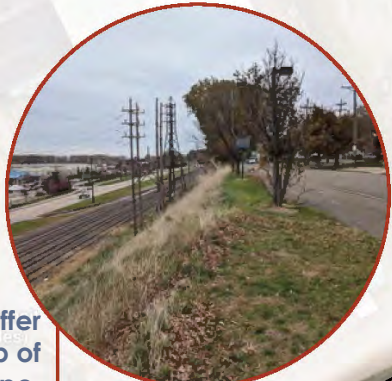
No buffer at top of slope. Mowed right to the edge.

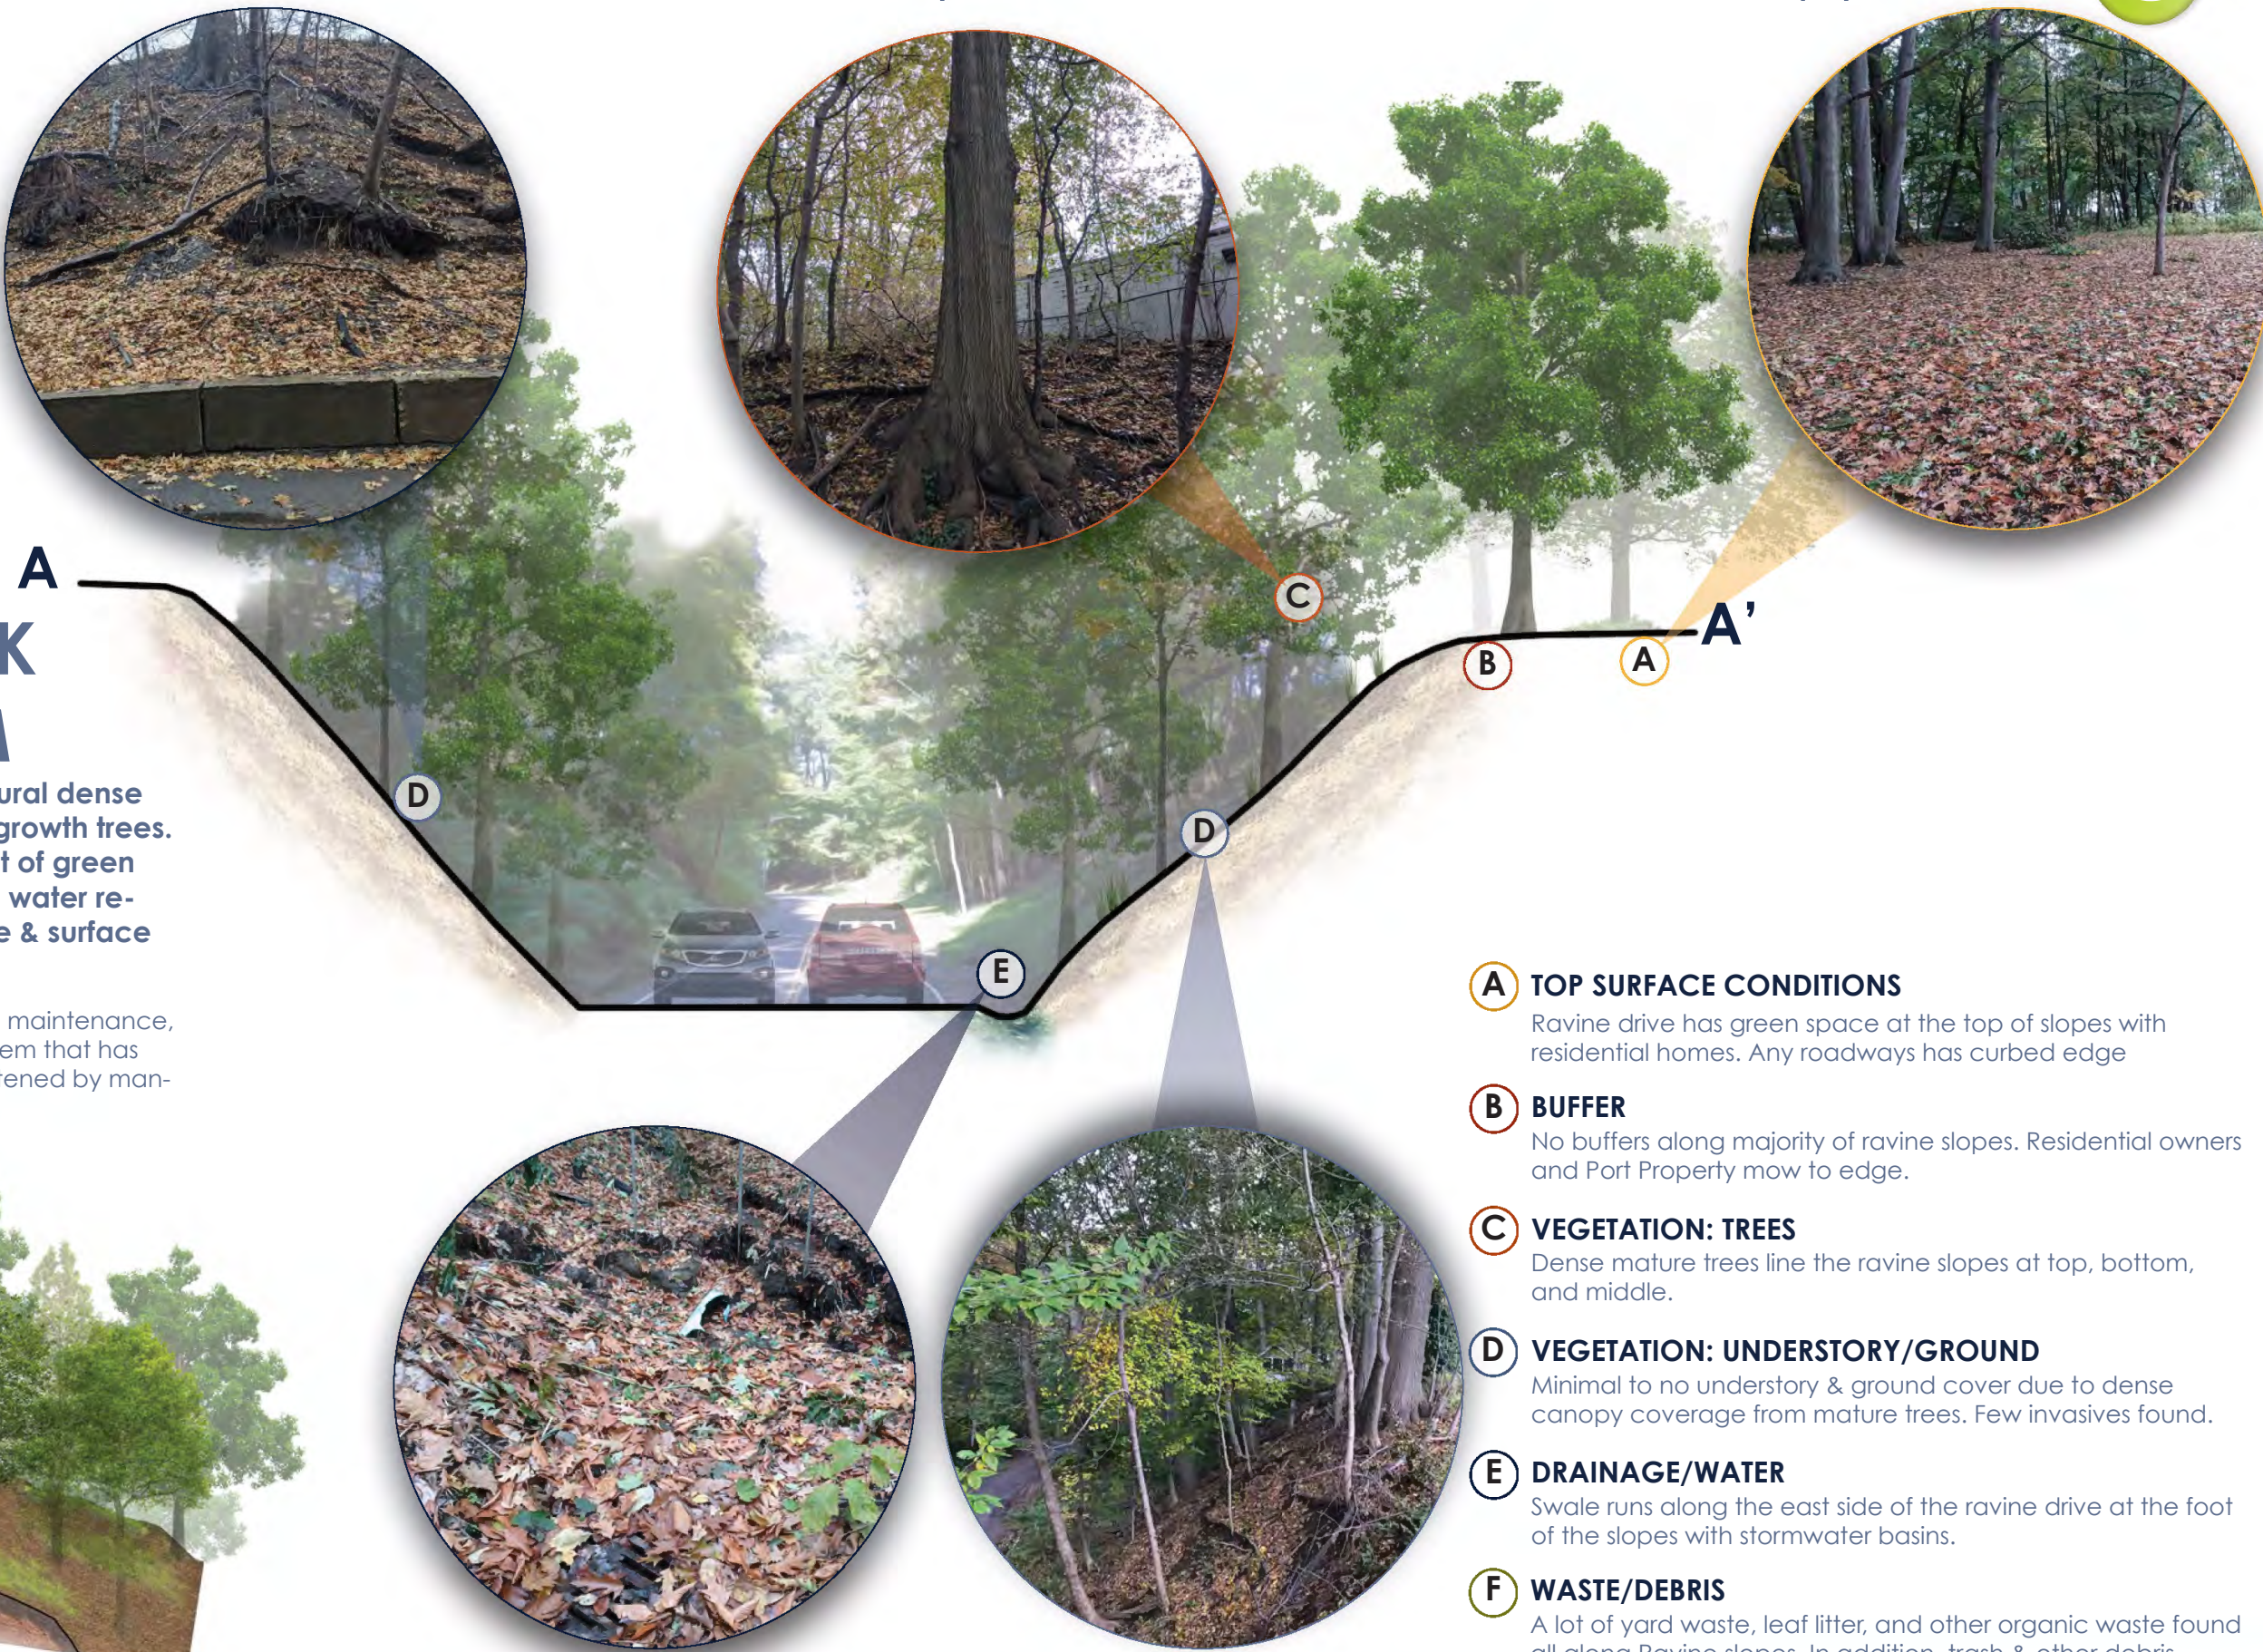
- A TOP SURFACE CONDITIONS**
Ravine drive has green space at the top of slopes with residential homes. Any roadways has curbed edge
- B BUFFER**
No buffers along majority of ravine slopes. Residential owners and Port Property mow to edge.
- C VEGETATION: TREES**
Dense mature trees line the ravine slopes at top, bottom, and middle.
- D VEGETATION: UNDERSTORY/GROUND**
Minimal to no understory & ground cover due to dense canopy coverage from mature trees. Few invasives found.
- E DRAINAGE/WATER**
Swale runs along the east side of the ravine drive at the foot of the slopes with stormwater basins.
- F WASTE/DEBRIS**
A lot of yard waste, leaf litter, and other organic waste found all along Ravine slopes. In addition, trash & other debris found.

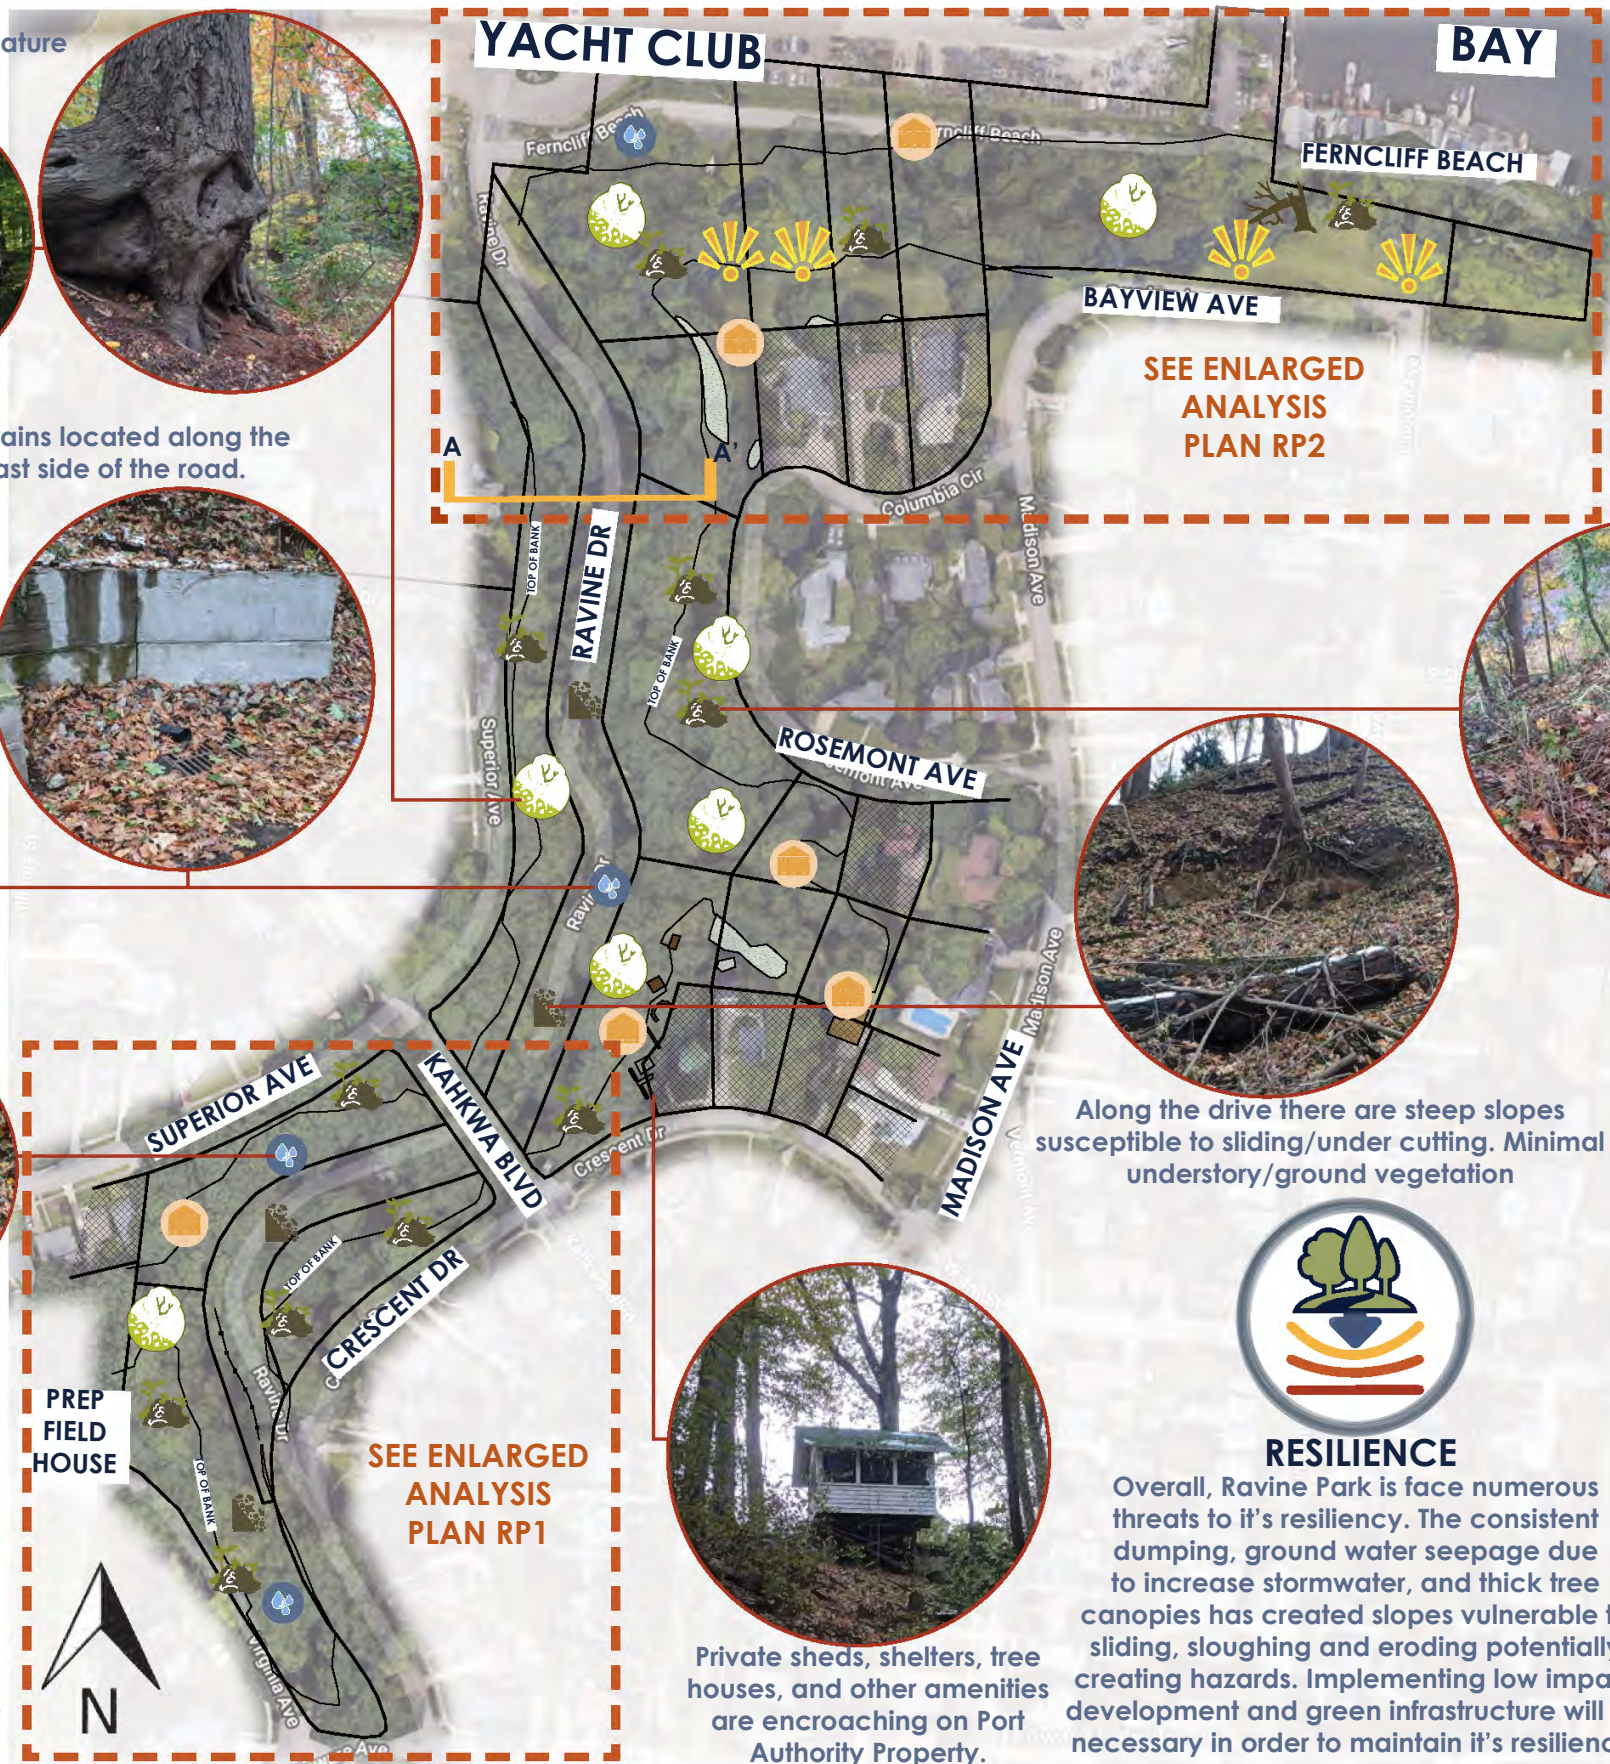
Organic yard waste including leaves, clippings, branches, and other material is being dumped at the top and on the ravine slopes.

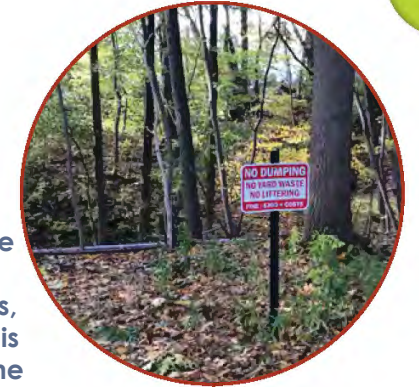
Along the drive there are steep slopes susceptible to sliding/under cutting. Minimal understory/ground vegetation

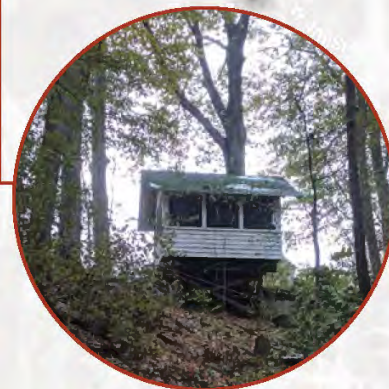
Private sheds, shelters, tree houses, and other amenities are encroaching on Port Authority Property.

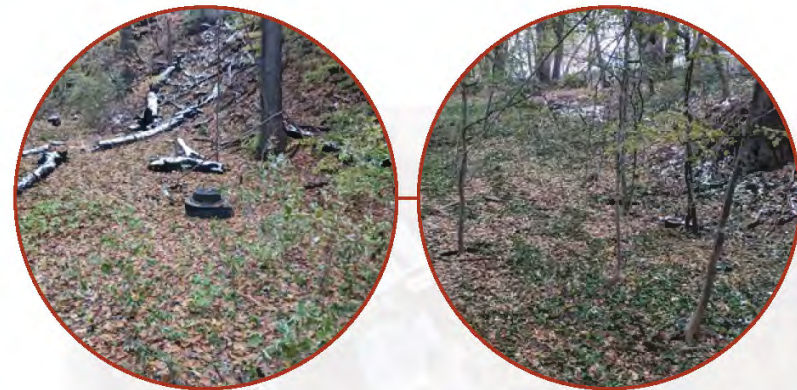
A shallow ravine funnels water towards a single storm drain and check dam.

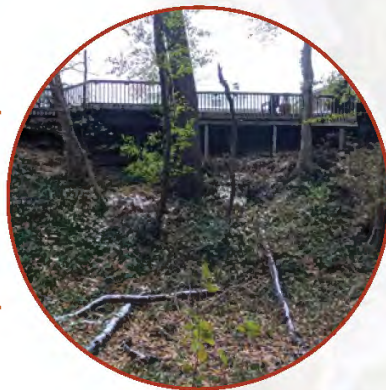
Home owners are encroaching on Port Authority property with various structures.
