Erie, Pa

Bluff & Ravine Evaluation

February 26, 2020

Dahlkemper Landscape Architects & Contractors

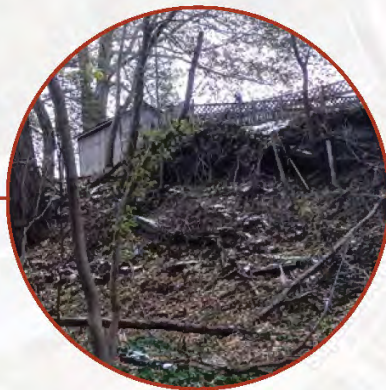
Slope crests at road and concrete wall at bottom has failed. Heavy erosion/sliding is susceptible in this area on both sides. Minimal erosion control in places makes the rich organic soil susceptible to moving.

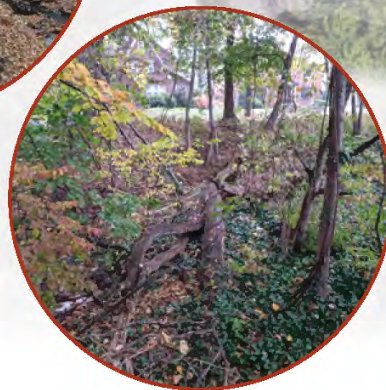
Shallow slopes filled with organic and trash debris, overgrown vines & understory.

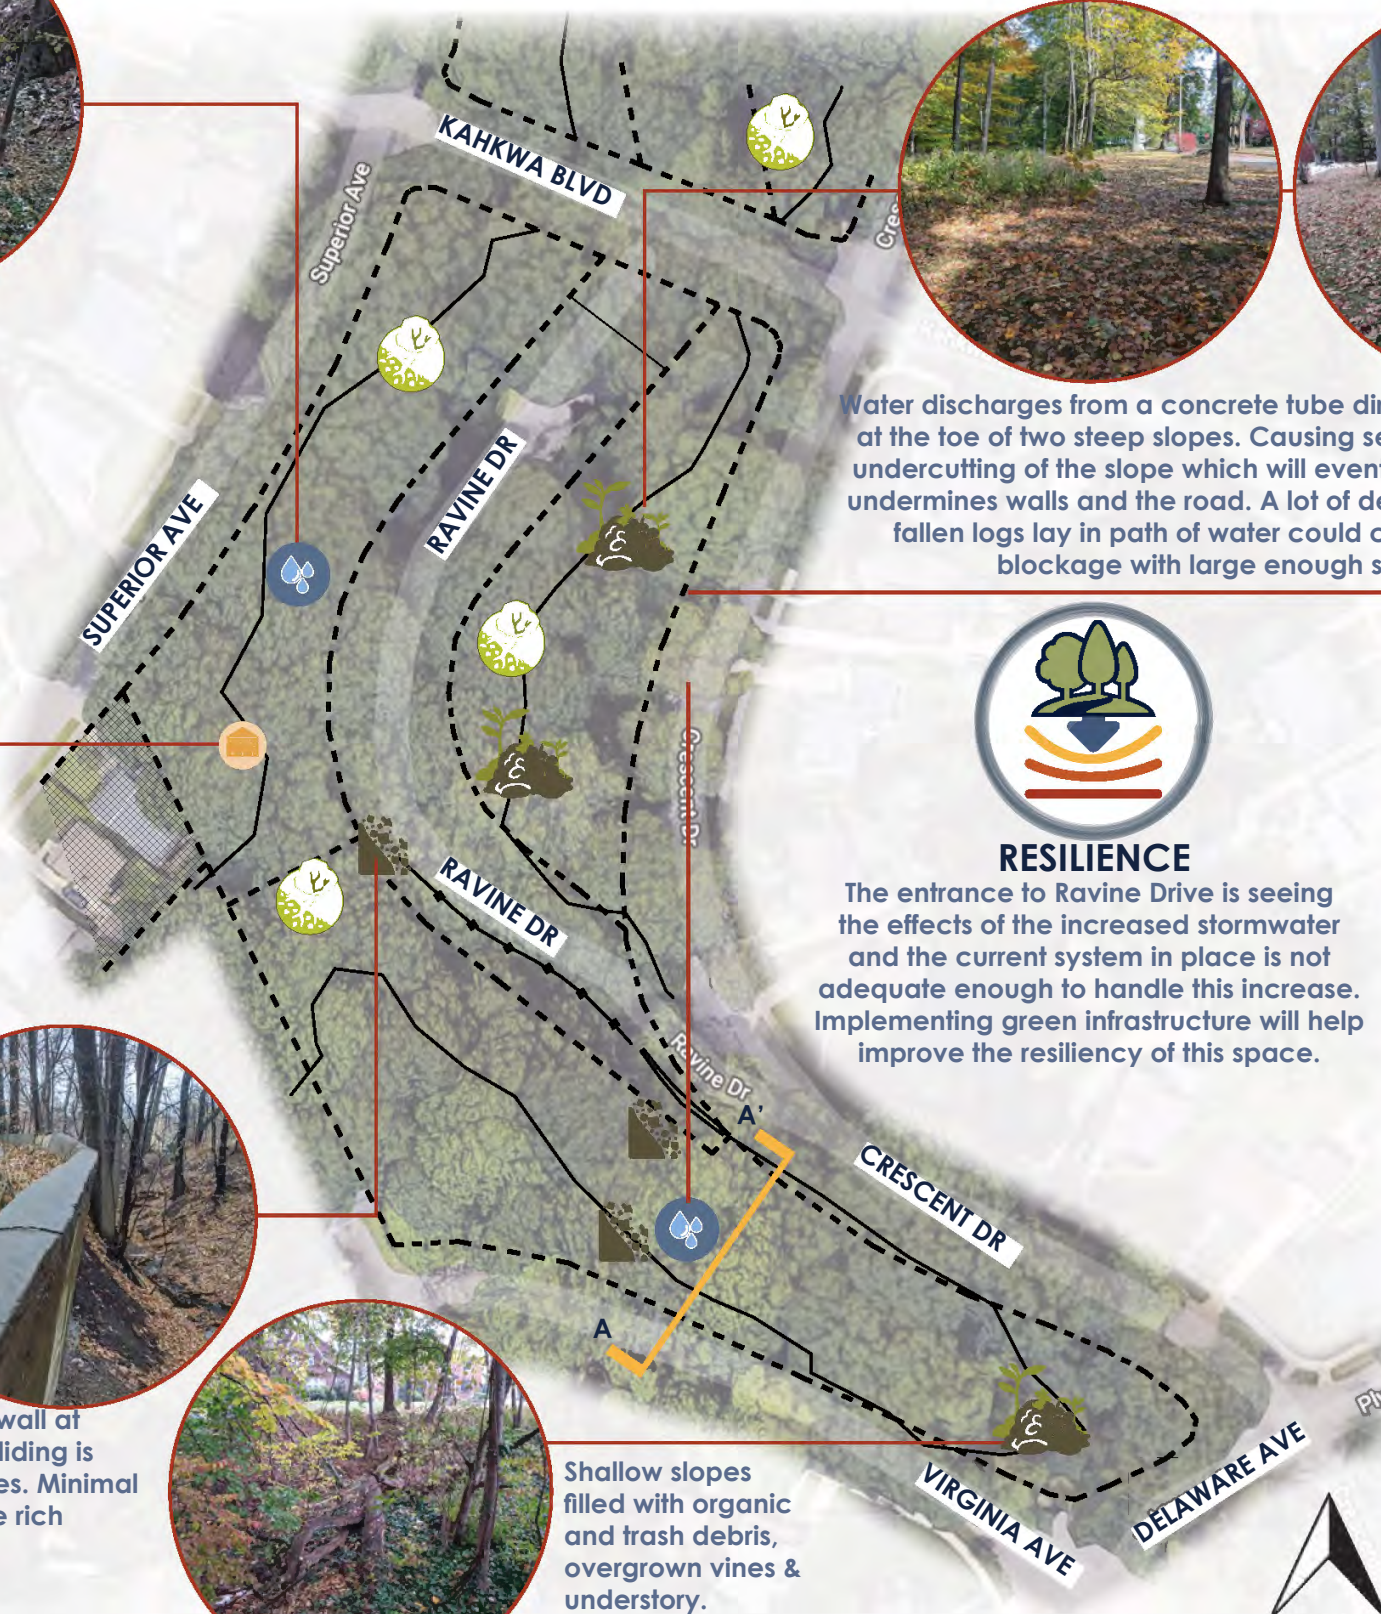
Flat areas at top of slopes have potential for pocket parks. Private residents need to stop dumping yard litter.

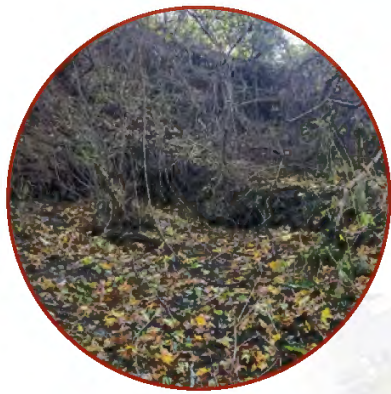
Erosion is occurring down the slop and at the top of the slope where the lawn is mowed directly to the edge of the slope. Slumping is evident in the lawn area as its starting to erode down the hill.

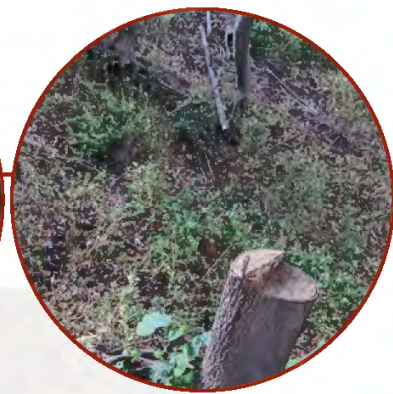
Bare steep slopes with a lot of added organic matter and clear cutting of trees is making slope susceptible to sliding.

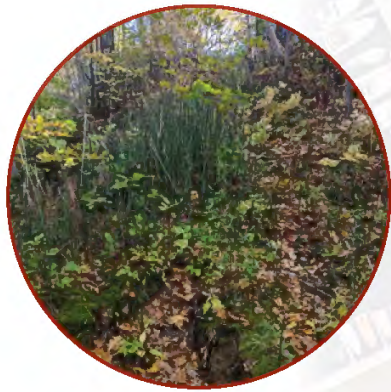
A snake grass/horsetail is spreading rapidly along the east side of the ravine. Most likely established through dumping.

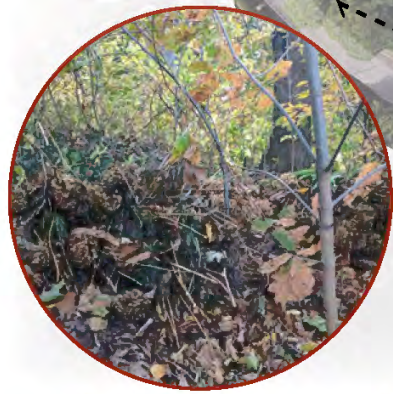
Plant, shrub, and grass clippings dumped in heavy piles.

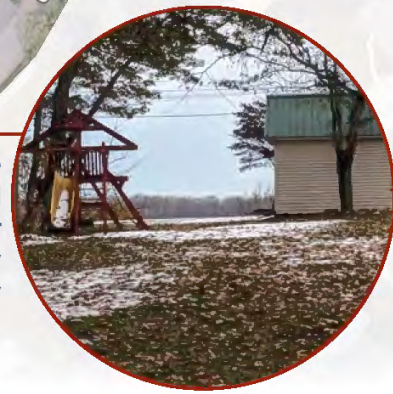
Structure encroached on the Port Authority Property

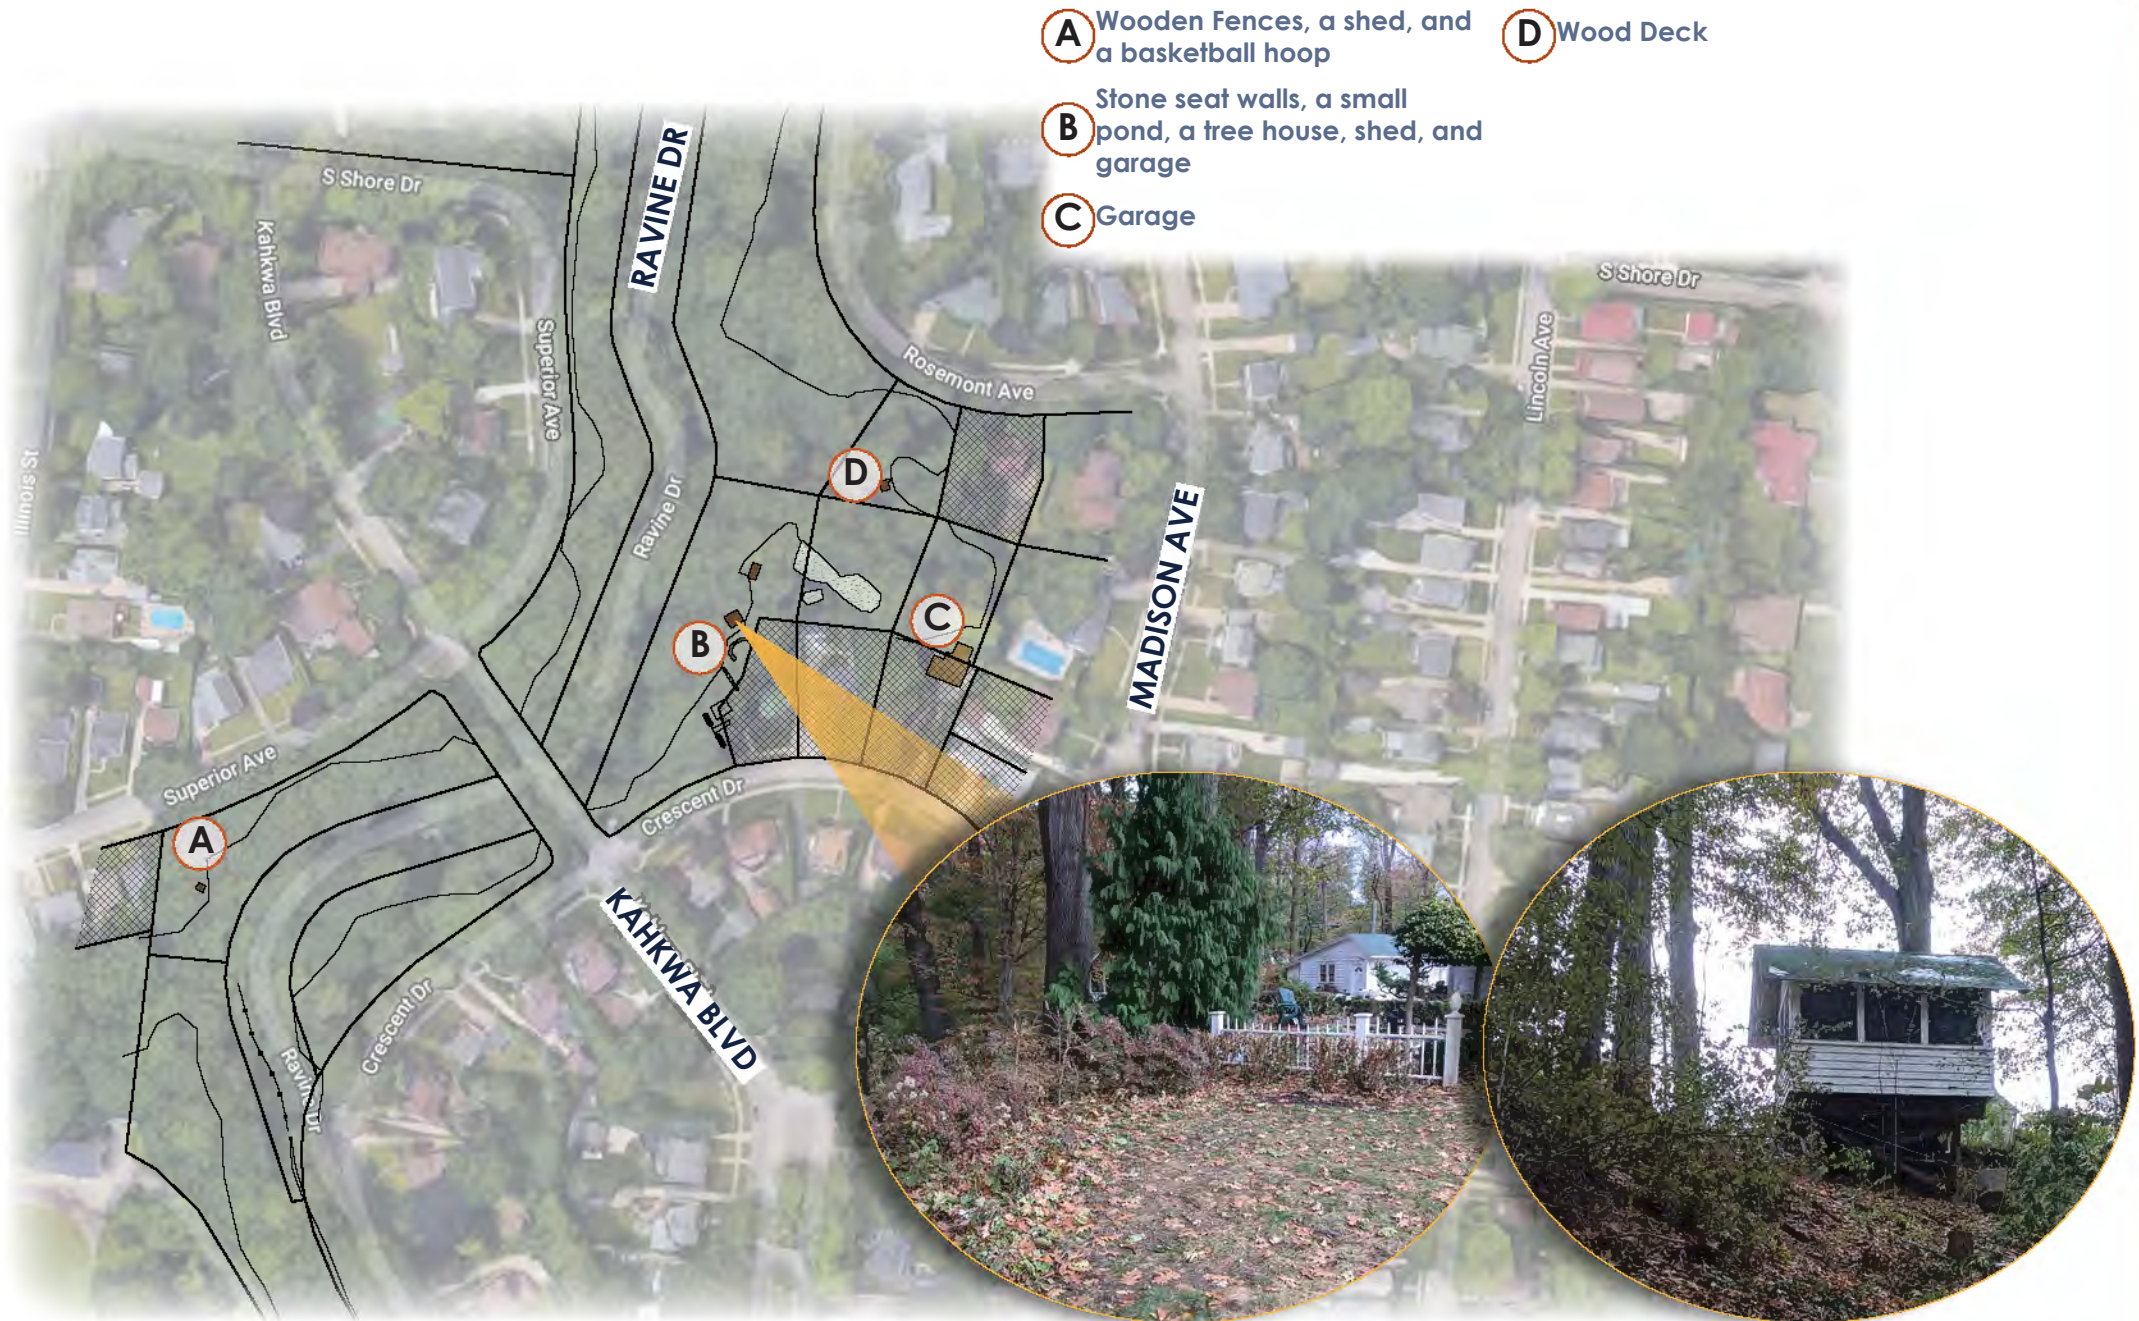
Encroachment Locations Discovered on Ravine Park - Entrance

Using Erie County Tax Maps and other survey plans obtained from the Port Authority, it has been determined there are various locations where adjacent property owners are encroaching onto the Port Authority owned property. All of the locations would need to be field verified with physical pins & a professional survey team.

Encroachment is an issue that will need to be monitored, verified, and discussed with adjacent property owners to determine to best course of action.

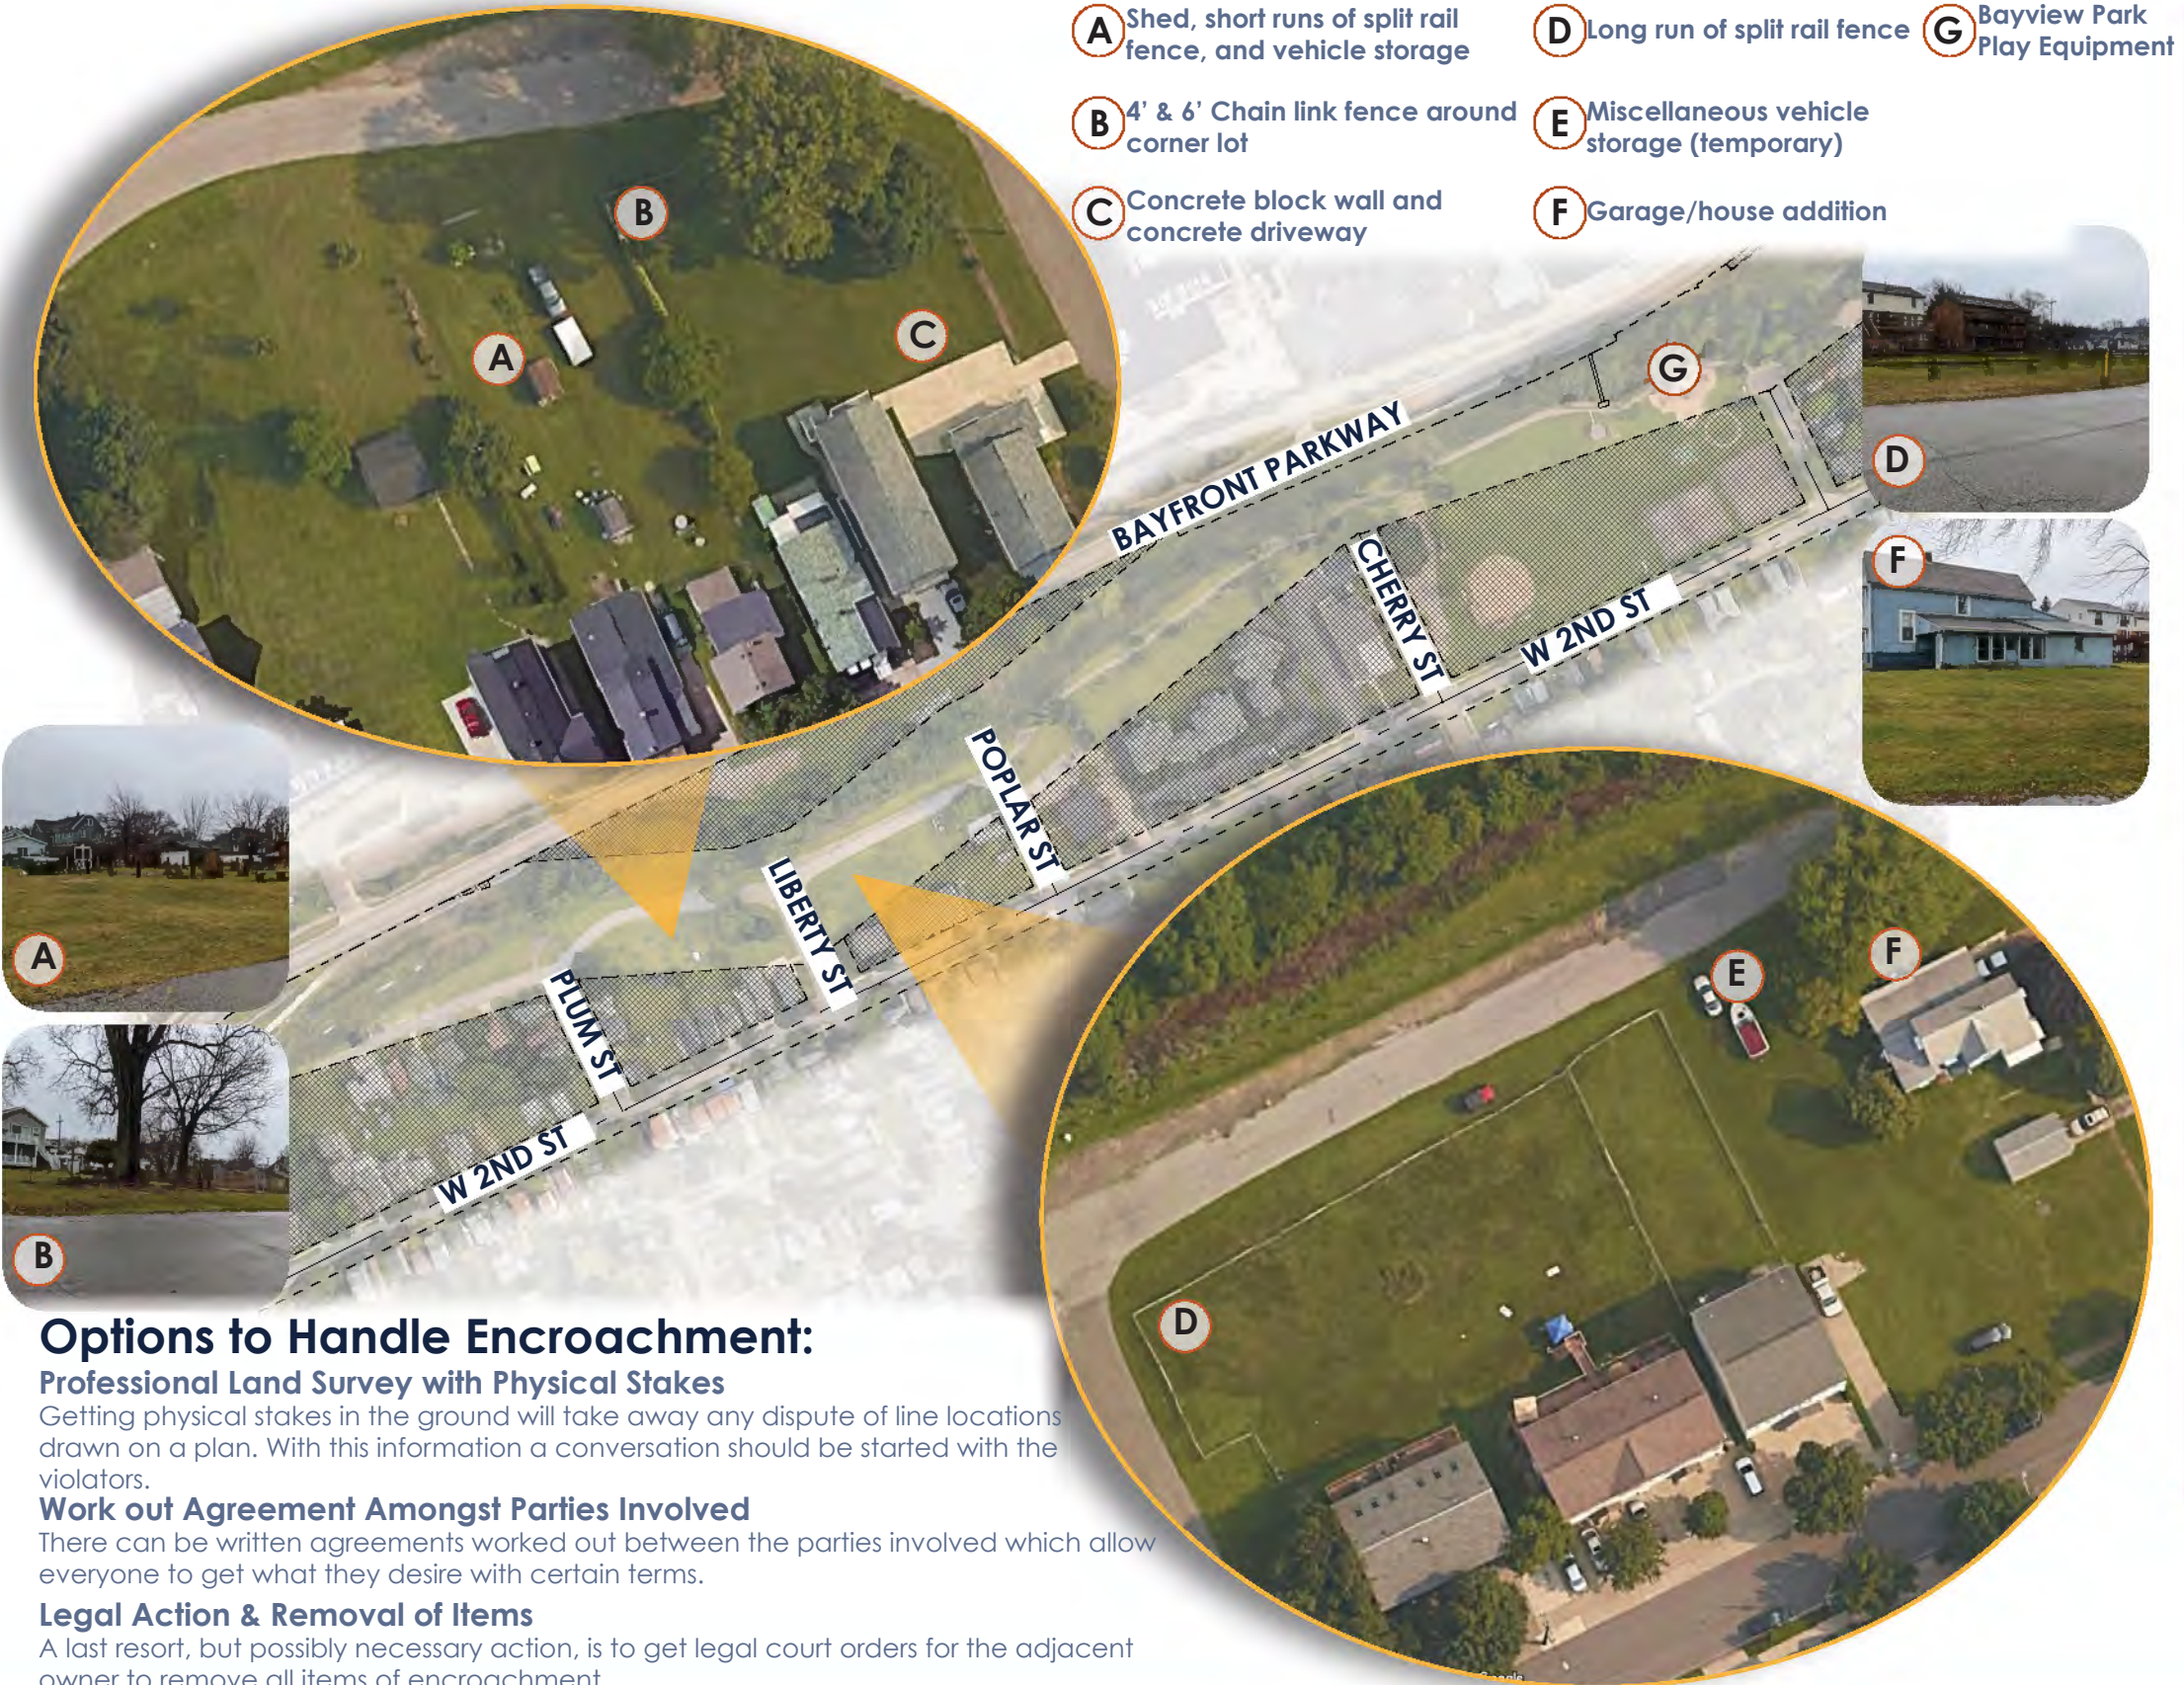
Encroachment Locations Discovered on Bayfront Bluffs - West

Using Erie County Tax Maps and other survey plans obtained from the Port Authority, it has been determined there are various locations where adjacent property owners are encroaching onto the Port Authority owned property. All of the locations would need to be field verified with physical pins & a professional survey team.

The encroachment locations found along the west Bayfront ranks as a **priority level 1-2** because although the majority of the locations are minor amenities that are not posing any threats, causing any damage or putting anyone in harms way, they become a legal matter and need to be addressed. There is, however, one item that is creating a health & safety risk - the play equipment at Bayview park. In addition, there is an entire garage sitting on Port Authority property that could become a financial and legal issue.

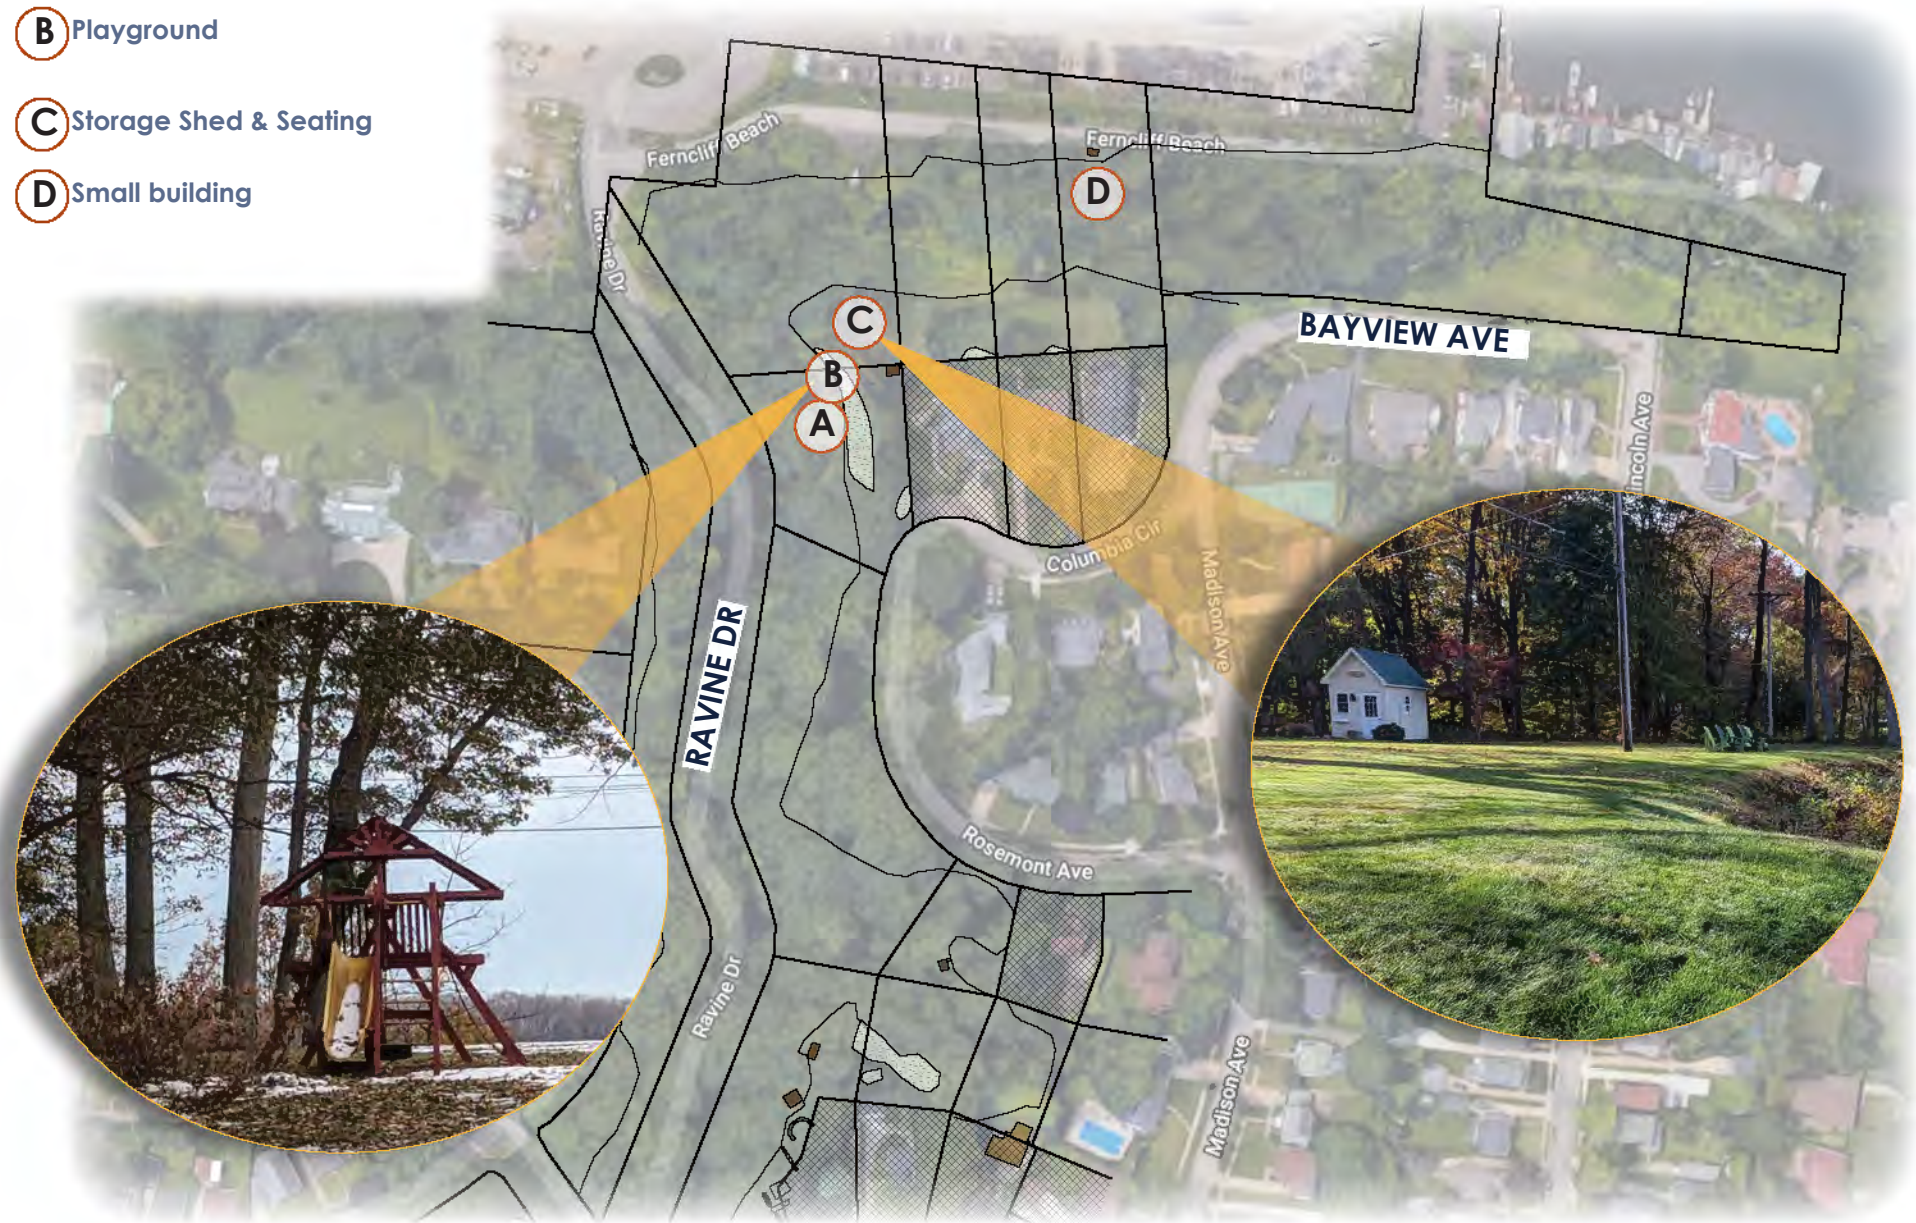
Encroachment Locations Discovered on Ravine Park - Bayview

- A** Planting Beds
- B** Playground
- C** Storage Shed & Seating
- D** Small building

The encroachment locations found along Ravine Park - Bayview ranks as a **priority level 2** because there are amenities such as sheds, planting beds, and playgrounds encroaching on Port Authority land creating a legal issue, but they are stable & not causing threats to the health and welfare of the public.

Options to Handle Encroachment:

Professional Land Survey with Physical Stakes

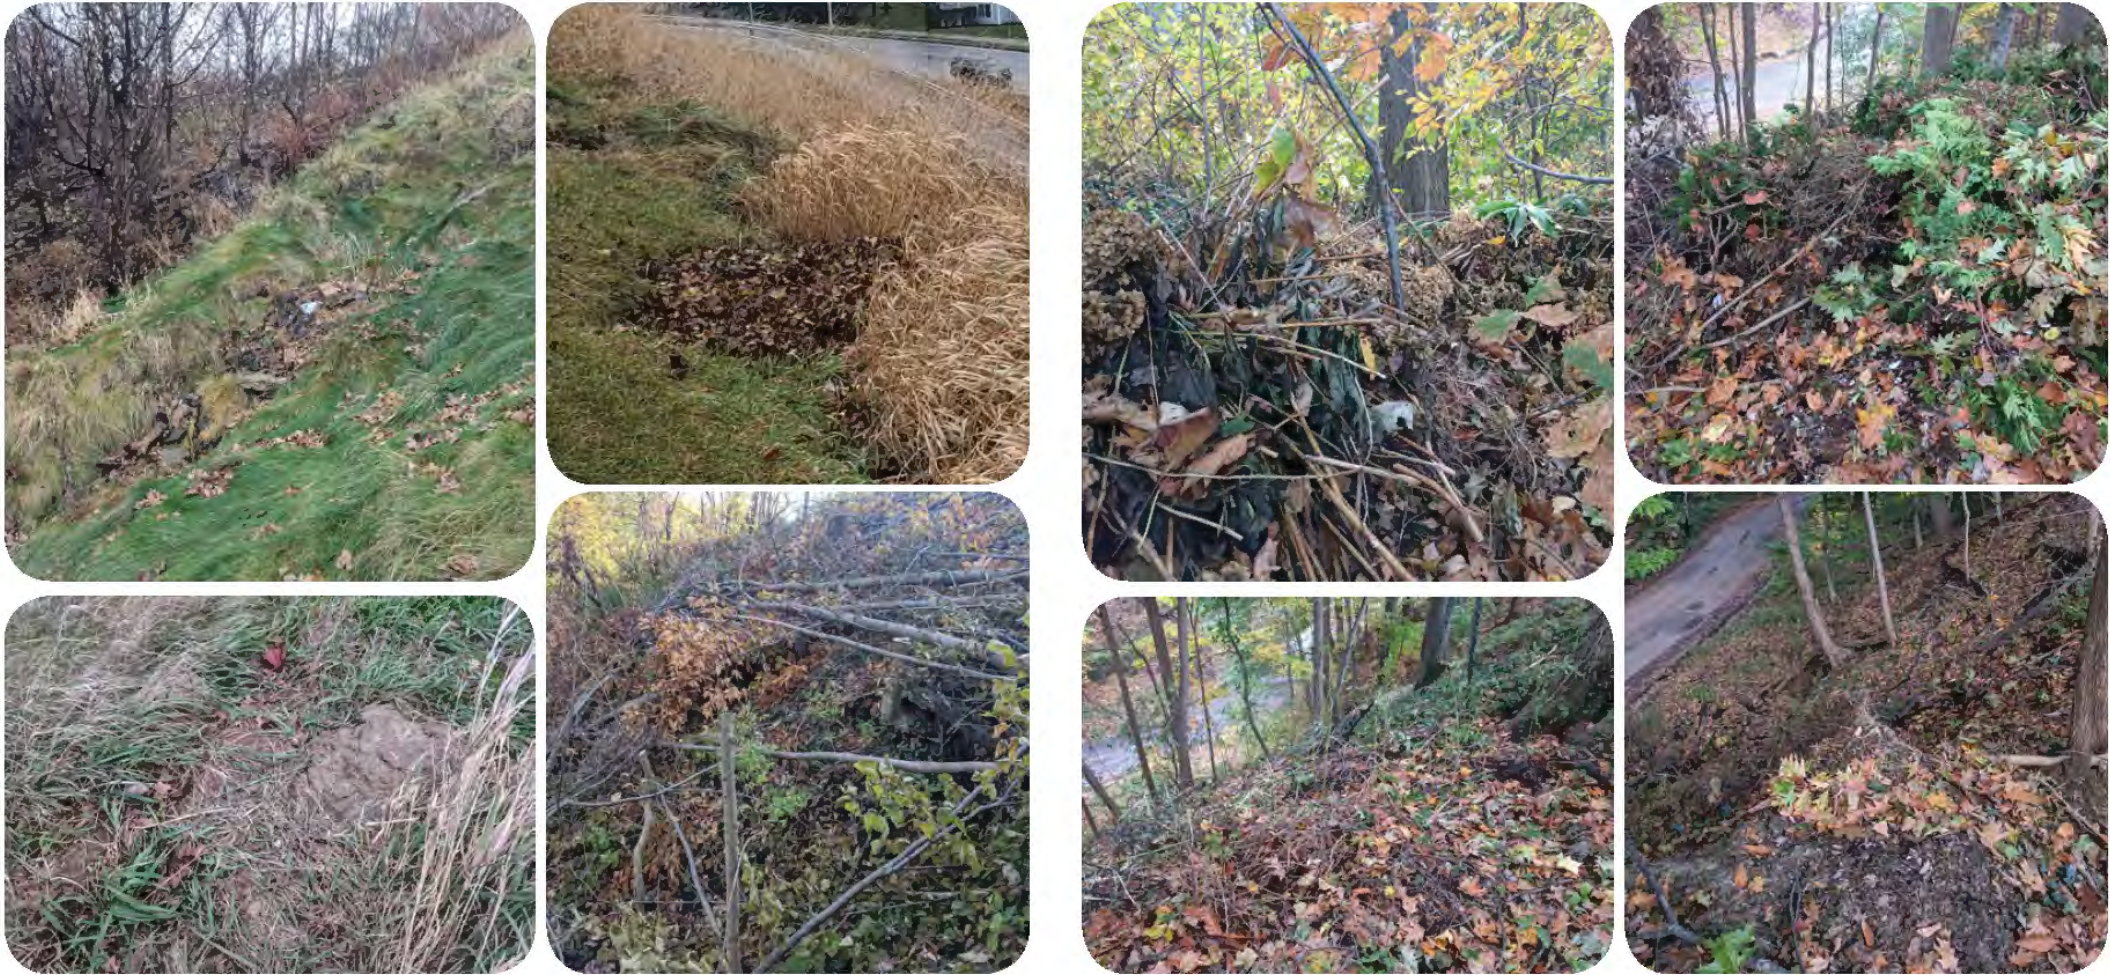
Examples of Waste Found in Areas of Concern

The dumping of yard waste and inorganic waste over the bluffs & ravines is a concern across all areas. Yard waste and trash, in addition to adding extra weight to the upper portion of the slope eventually causing failure, will smother any underlying vegetation. This does not allow any ground cover or understory vegetation to become established leaving unstabilized bare loose soil open to erosion, sliding, and sloughing. The organic waste eventually breaks down leaving behind unstable loose material susceptible to sliding. In addition, dumping waste spreads invasives and prevents rain water from soaking into the ground.

The dumping of waste threat across all areas on average ranks as a **priority level 2** because there is a large amount of waste discovered in certain areas, but all areas have signs of dumping. It doesn't create an immediate threat, but the continuation and build up of waste over time can cause major damage to the slope stability. It also reduces the aesthetic appeal of the natural areas.

Installing trail cameras to catch people dumping and follow up with fines. In addition, neighbors & community members need to be monitoring and reporting to protect their own community lands.

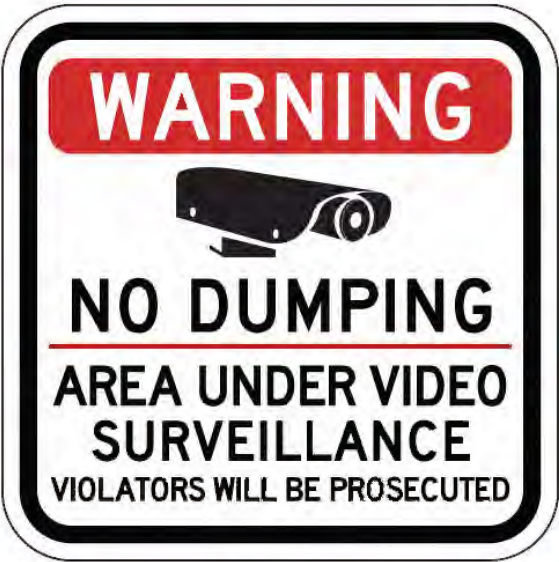
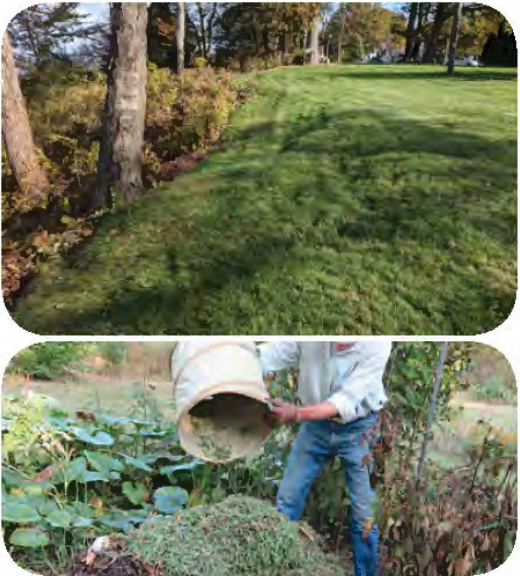
The edge of this slope will slide down & be gone over time. This is happening due to years and years of organic dumping creating loose unstable soil conditions at the top of the slope.

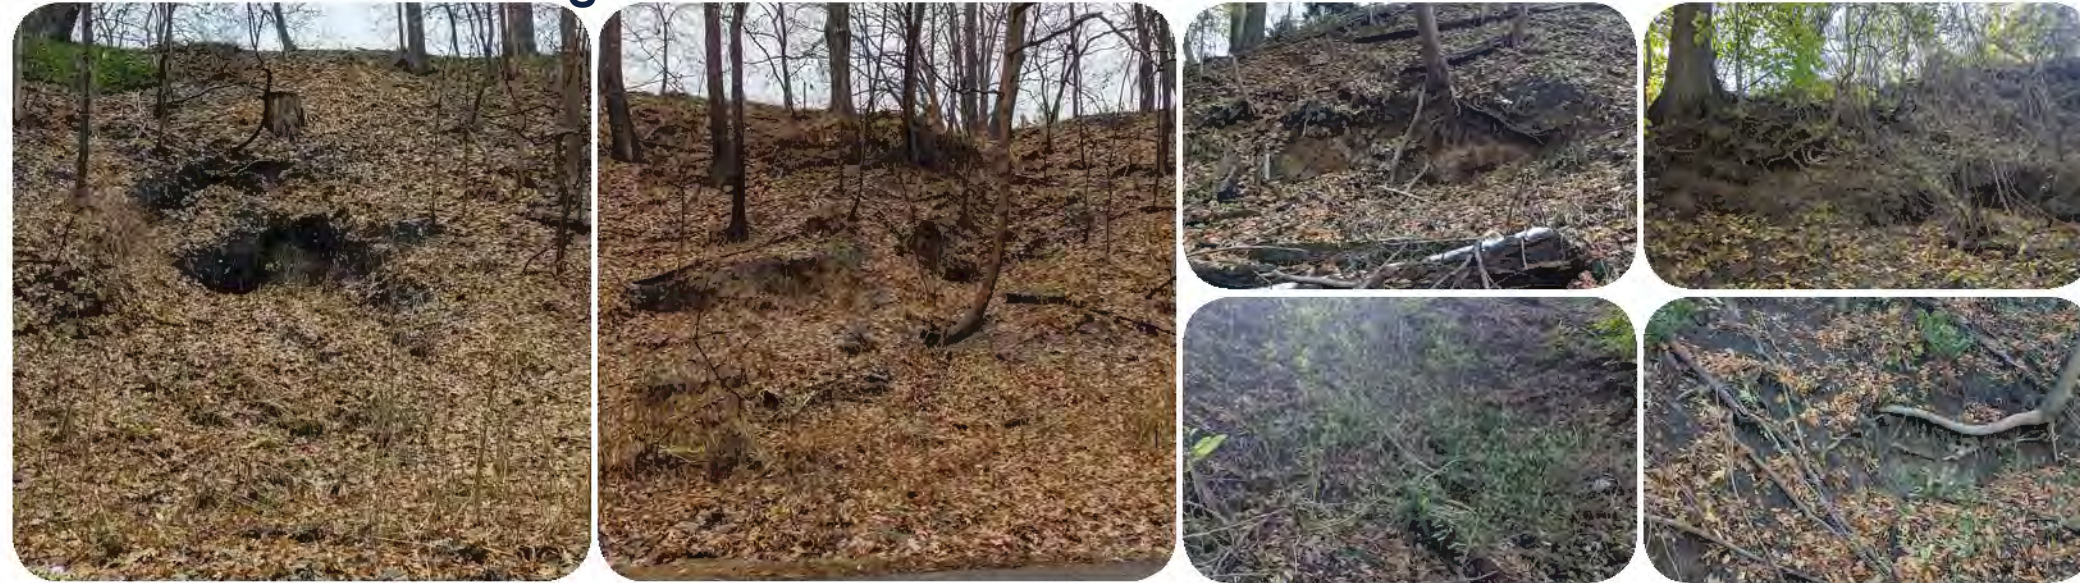
Current Conditions along Entire Ravine Park Area

Sloughing is when soil slides or moves down a slope due to loss in cohesion. Water and/or wet soil conditions are the number one factor for sloughing to occur on a slope face. Across all areas of Concern areas of various localized sloughing has been observed with larger sections occurring in years past. Due to the loose sandy soil and low shear strength, these slope faces are high susceptible to sloughing. In addition, due to the dense canopies bare soil is present and much more susceptible to sloughing. Ground & Surface water are the main causes.

Solutions to Sloughing:

- **Surface Drains:** The simplest method for reducing any erosion & sloughing caused by groundwater discharge is to capture the water where it discharges from the face of the slope.
- **Sub-surface Drains:** Taking the surface drain a step further and placing the drain into the slope face to capture water before it discharges from the slope face. The best method to drill the pipe into the slope will need to be investigated.
- **Improved Vegetation:** establishing healthy vegetation zones will help reduce erosion and stability across the entire slope.

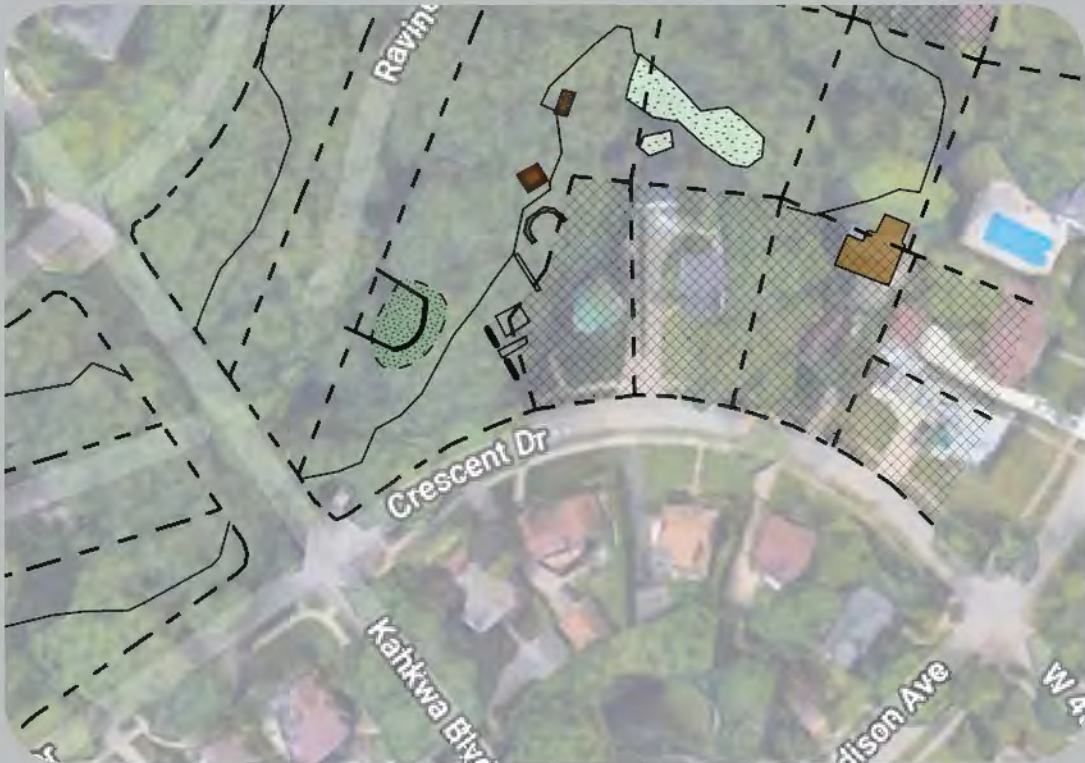
Surface Drains Location #1

Increased storm events has led to the increase in ground water, as well as surface water runoff, in this area. When the already vulnerable slopes become saturated the soil loses cohesion and slide causing significant damage.

This includes adding perforated pipes at the eight points of discharge on the slope face to intercept the water, transport it through a pipe down the slope, and discharge it at the bottom of the slope. The pipes should be wrapped in geotextile fabric and bedded in filter sand & gravel. In addition, the pipes should be anchored to the slope. Lastly, this includes backfilling the slough area using a crushed stone as well as planting the slope with appropriate vegetation to further stabilize the slope & establish vegetative cover.

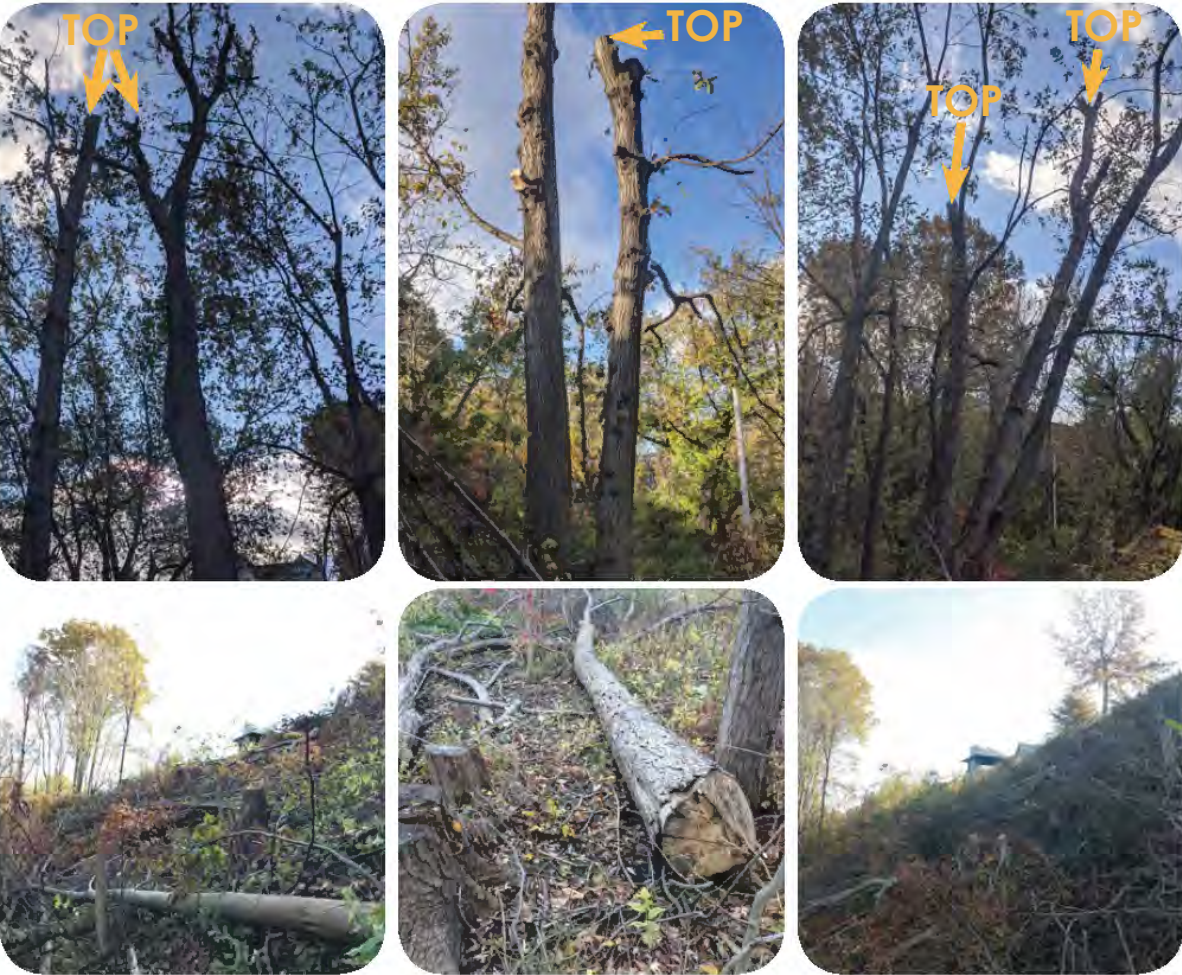
Tree Topping & Clearing Found at Cascade Creek

Why Tree Topping Hurts Trees: Stresses Trees

Cuts across a limb at multiple points leaves open stubs vulnerable to decay. Too many and the tree won't be able to close them off which allows the decay to move down the tree.

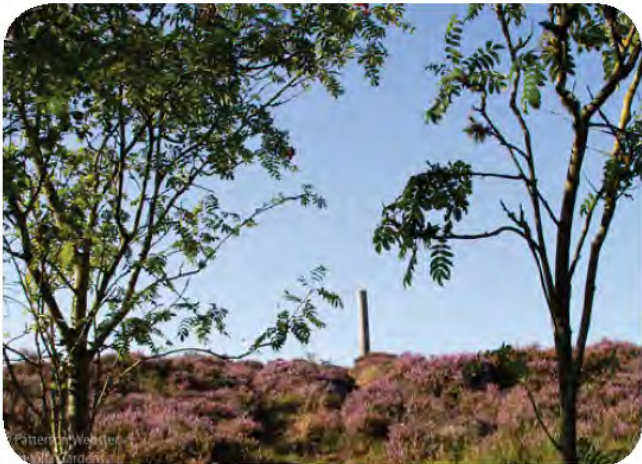
FRAMING A VIEW

An alternative to bulk clearing would be selective clearing beginning with any invasive or low grade trees to begin framing views. Framing a view accomplishes the desired view while allow select larger trees to remain and create a framed view.

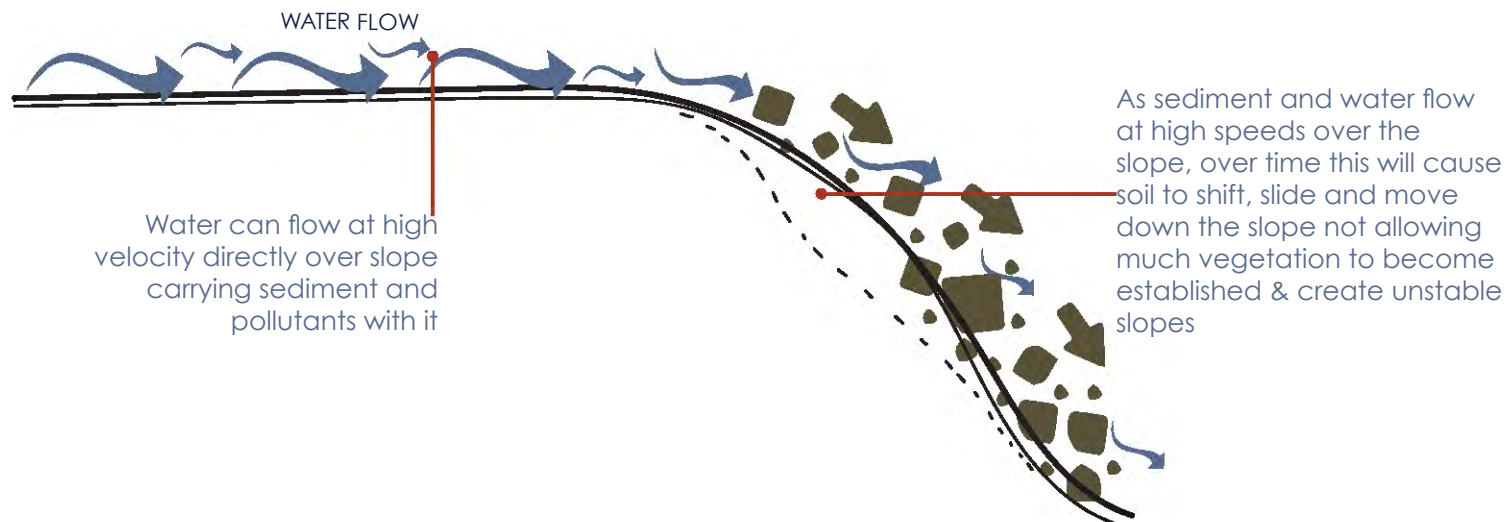
Current Conditions without Vegetated Buffers

Issue Summarized:
Having not buffer will allow water & sediment to flow freely over the slope causing erosion and soil displacement. In addition, necessary roots from the vegetated buffer that help further stabilize the soil are missing further putting the slope at risk for sliding, sloughing, and erosion.

General Recommendations for Vegetated Buffers:

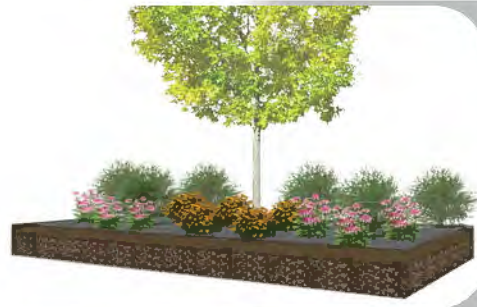
**COMPLEX NATIVE
VEGETATED BUFFER**

This provides estimated costs for a no mow zone through three different sized native vegetated buffers. A complex buffer including all three layers of vegetation (tree, shrub & herbaceous). A mid-range buffer including two layers of vegetation (shrubs & herbaceous). A simple buffer including just herbaceous plants.

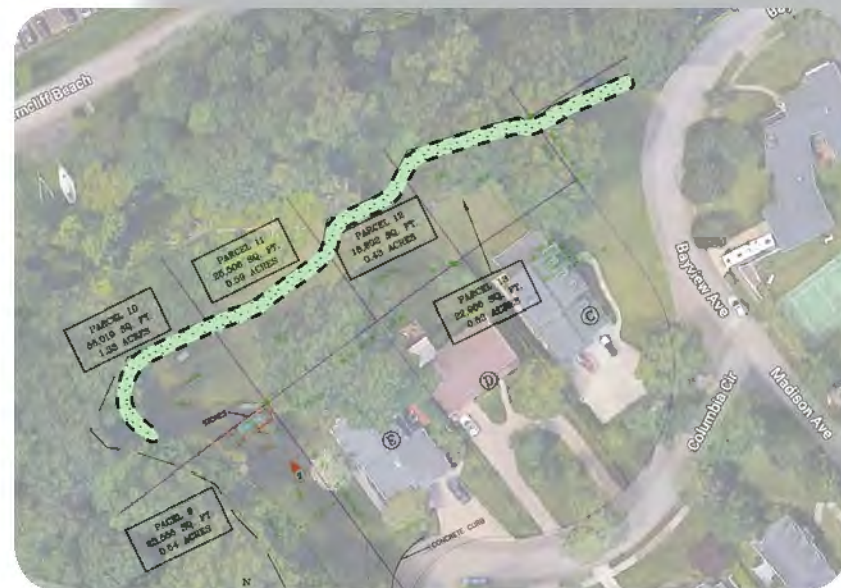
Ravine Park Buffer #1: 5,000 SF

This includes a range to install a linear 10'-0" buffer strip as shown on the conceptual plan. The low end of the budget would be a basic herbaceous planted buffer and the high end would be a fully planted buffer strip with all of the recommended layers of vegetation. This cost includes design and installation.

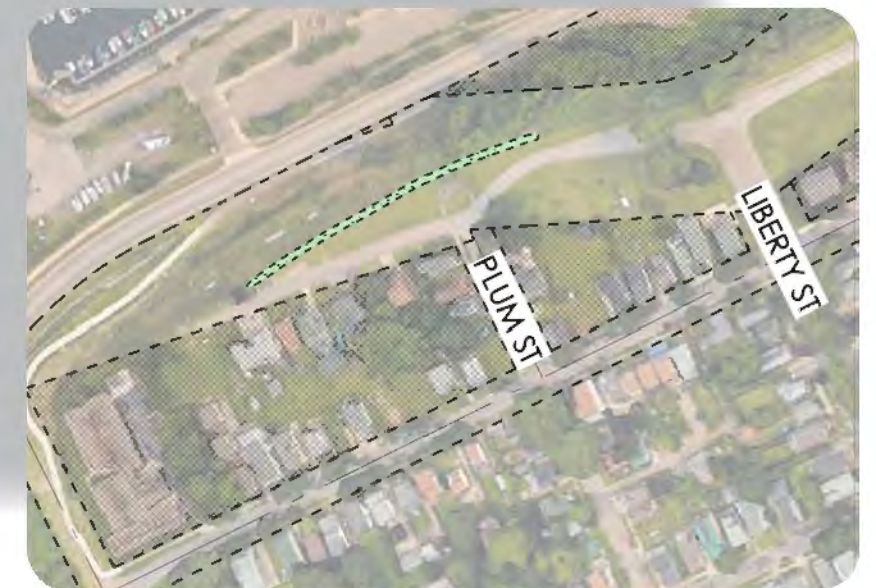
Bayfront Bluff Buffer: 5,000 SF

This includes a range to install a linear 10'-0" buffer strip as shown on the conceptual plan. The low end of the budget would be a basic herbaceous planted buffer and the high end would be a fully planted buffer strip with all of the recommended layers of vegetation. This cost includes design and installation.

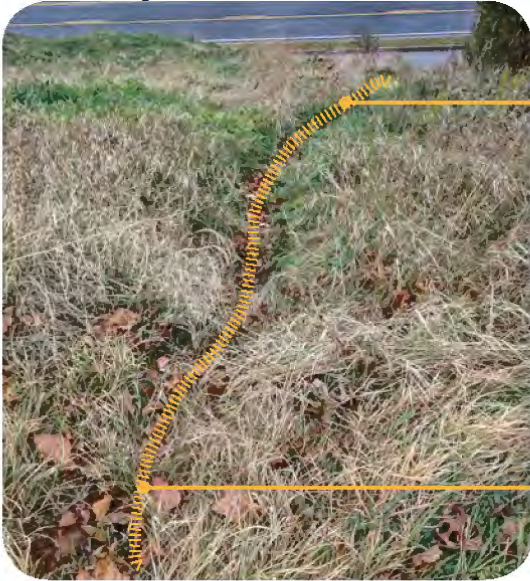
Near the bottom of the slope the rill has gotten much wider with areas of bare soil showing signs of undercutting. A large amount of debris & trash is collected in this area which is added weight to the soil making it more unstable.

Near the top of the slope the rill is narrow and shallow. The dense grass ground cover is helping to stabilize the soil, but some areas of bare soil are showing when pushed down grass is pulled back. This particular rill leads directly to a catch basin at the bottom of the slope.
