Erie, Pa

Bluff & Ravine Evaluation

February 26, 2020

Dahlkemper Landscape Architects & Contractors

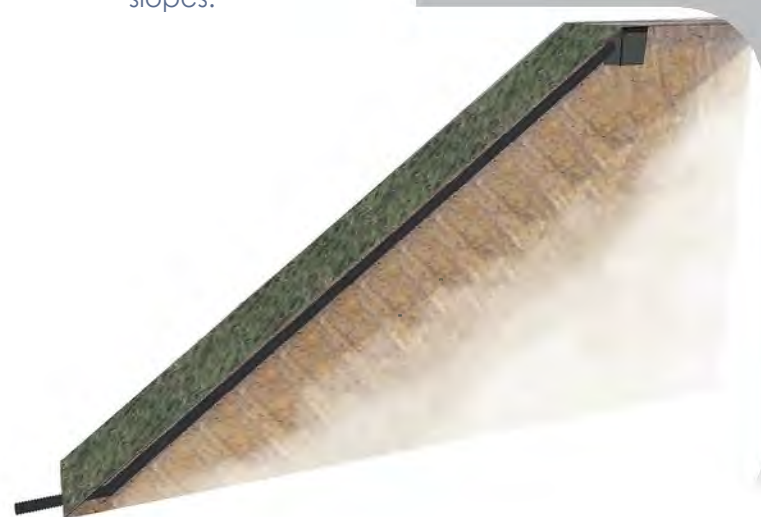
CATCH BASIN WITH DRAIN PIPE DOWN SLOPE

Capturing surface water at the top of the slope and transporting it down the slope via a pipe and discharging it is good practice to reduce sheet and rill erosion caused by water freely flowing over the slopes edge.

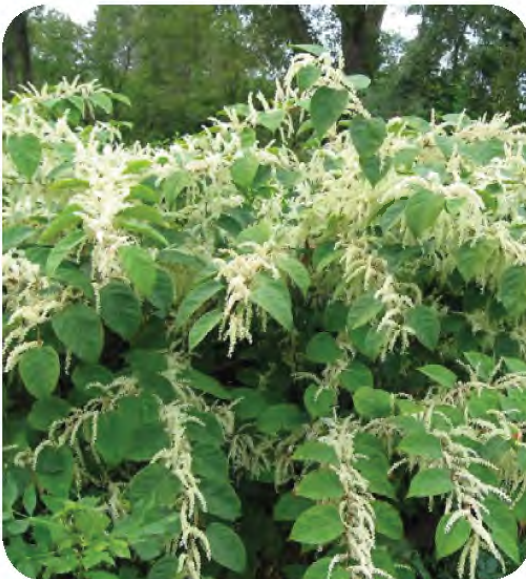
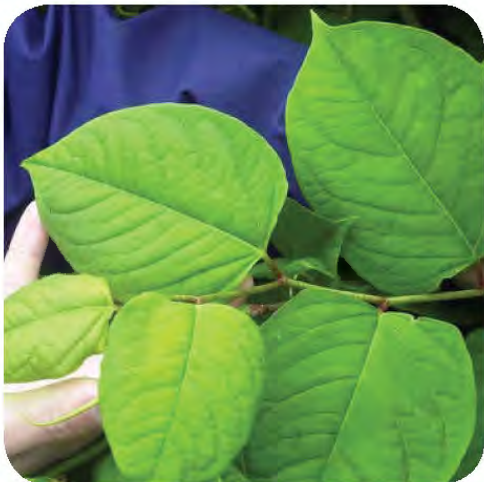
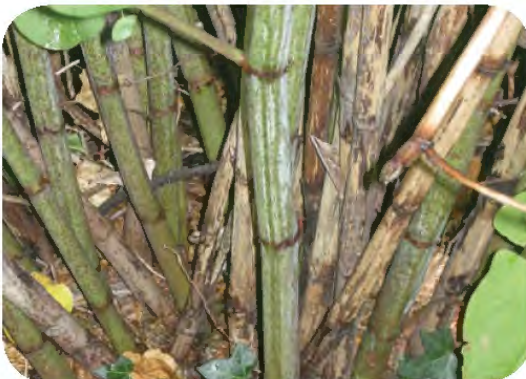
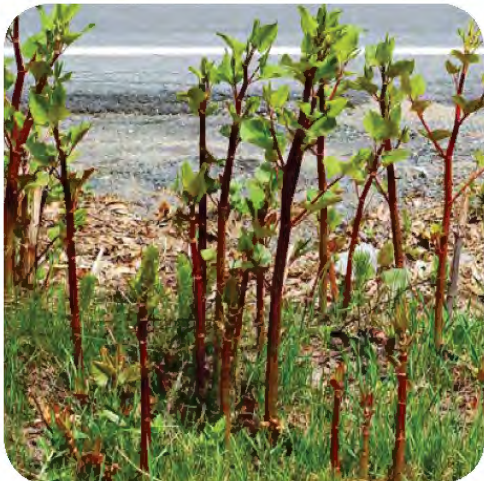
Japanese Knotweed
Polygonum cuspidatum

Invasive Plant Species are defined as non-native (or alien) to the ecosystem or particular area and whose introduction causes harm to the environment, local species, or human interests. These species can be introduced on purpose or by accident. Once a new species is introduced, it can be difficult to control and even more difficult to eradicate. Local plants and even local animals species can get displaced by being choked out by the invasive species. Invasive species control takes years and must occur annually to begin eradicating them from our local environments.

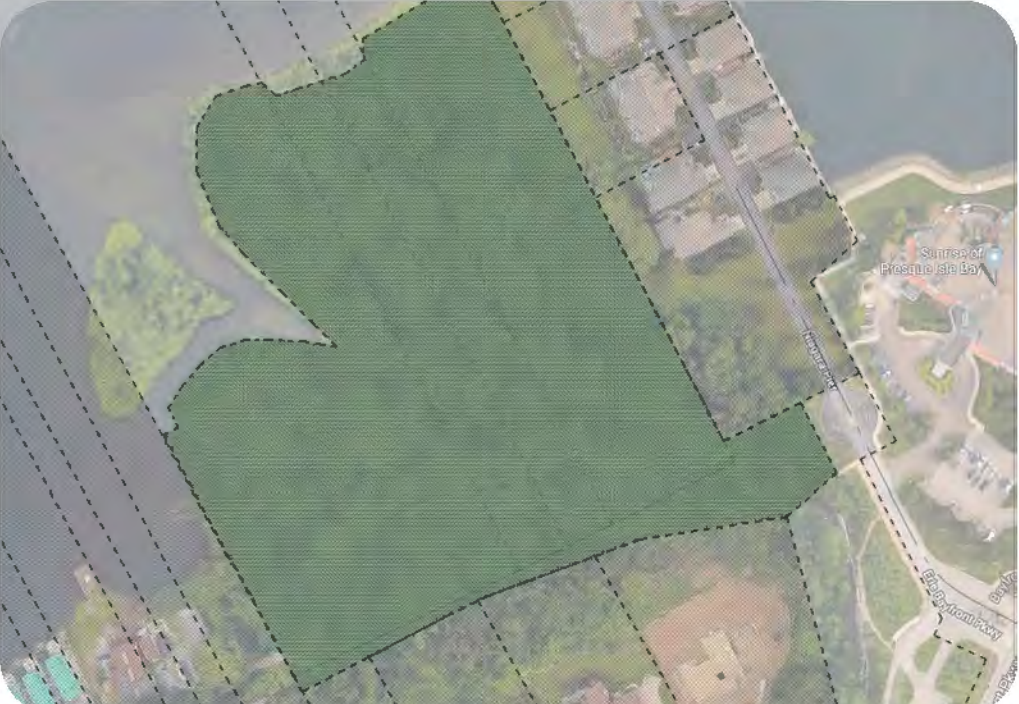
Cascade Creek Wetland: Whole Area

This includes treating the various invasive species found throughout the Cascade Creek Wetland Area. The invasive species have never been controlled here and the first year would take a major effort This is for one year worth of treatments. Invasive species control needs to be maintained annually to be most effective.

This provides estimated costs for invasive species control at three distinct areas. The control would include cutting the invasive species, treating the cuts with chemical treatments and repeating this process.

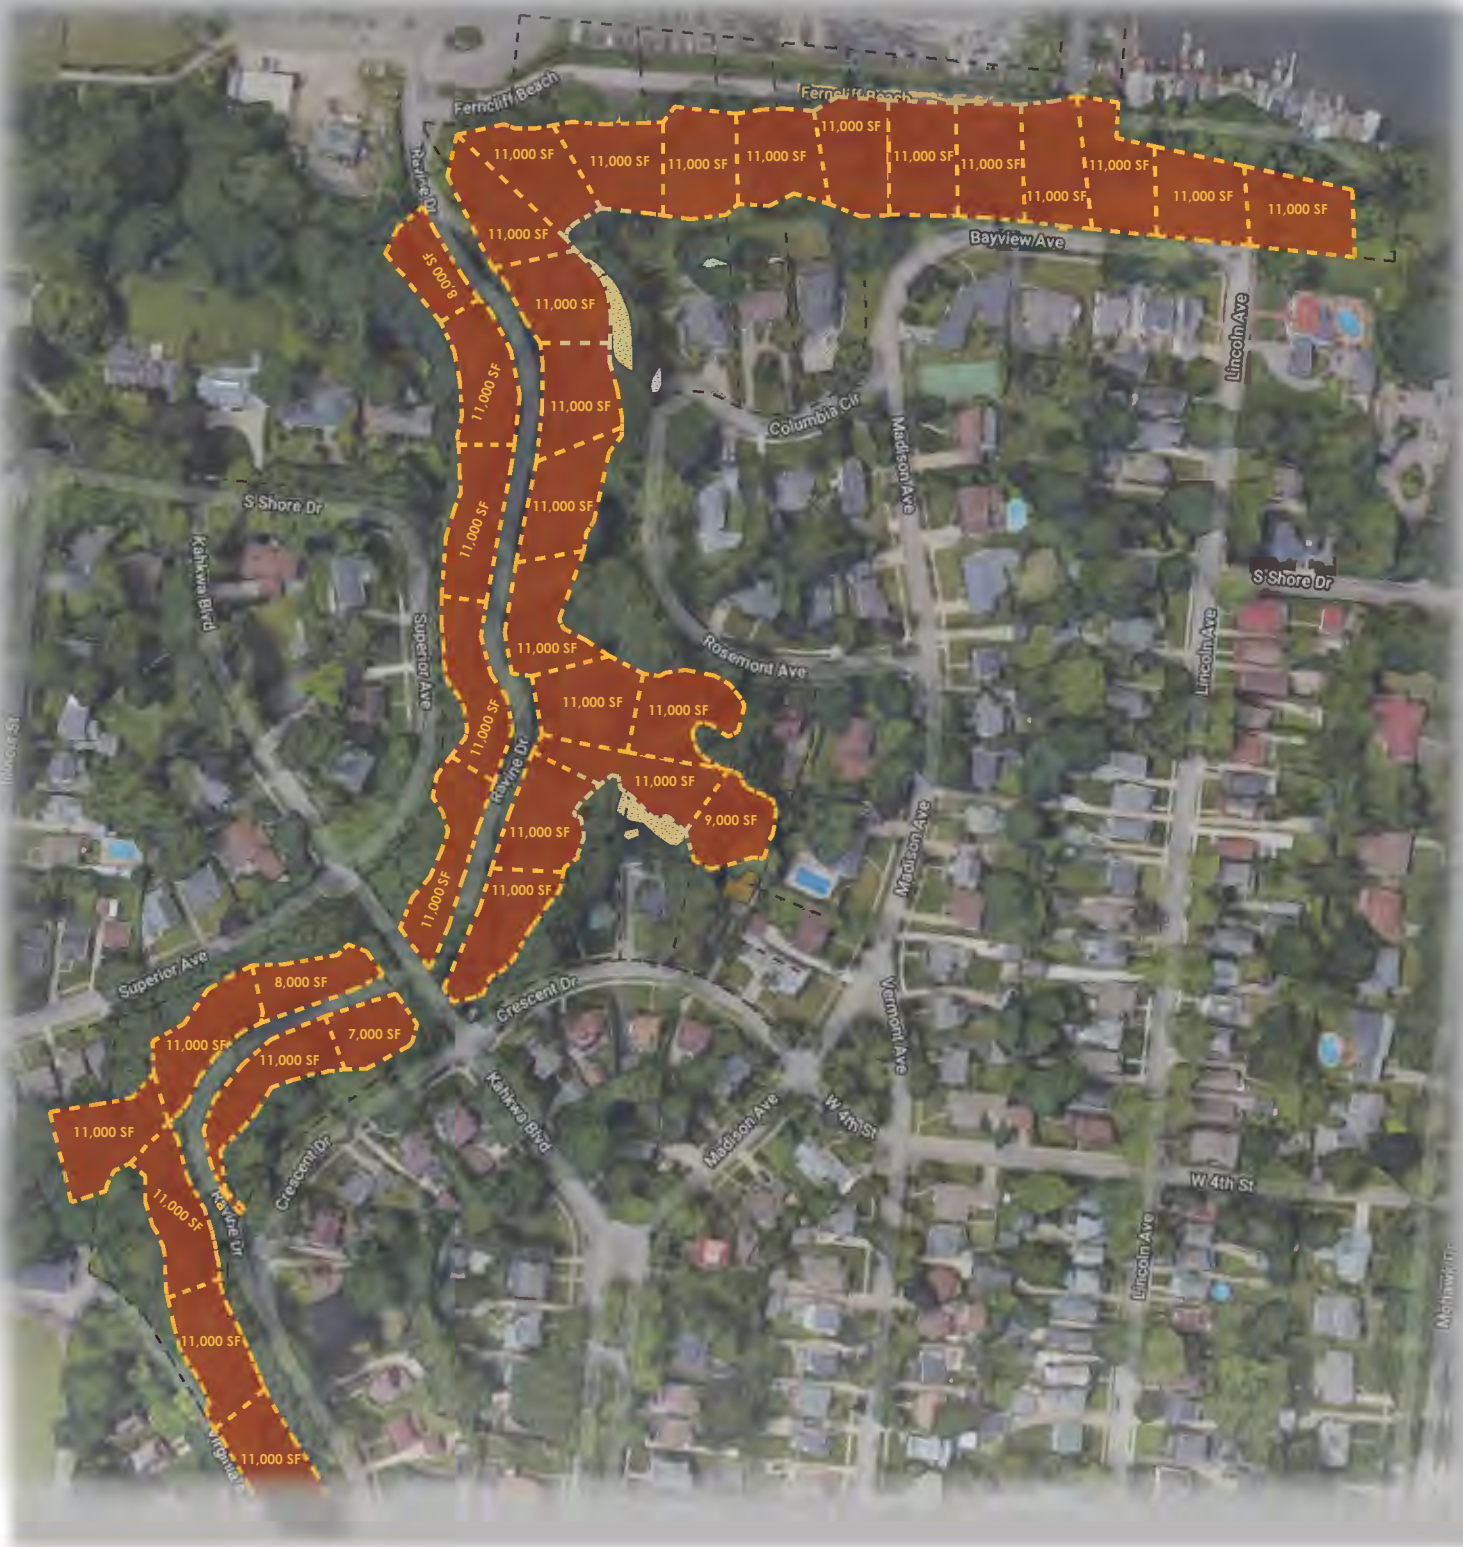
Tree Canopy Coverage Overall - Cascade Creek

Cascade Creek Area has a lot of mature trees that populate the area. This is a plan noting the various densities found in the area and which areas should be thinned/managed first.

Ideally a 40-60% canopy coverage is preferred. Canopy coverage is most important on slopes that are susceptible to erosion or have erosion issues currently. Dense canopy coverage on flat lands is not a big priority. Generally any canopies above 80% should be thinned, maintained, and monitored every year until ideal conditions are meant then reviewed every year.

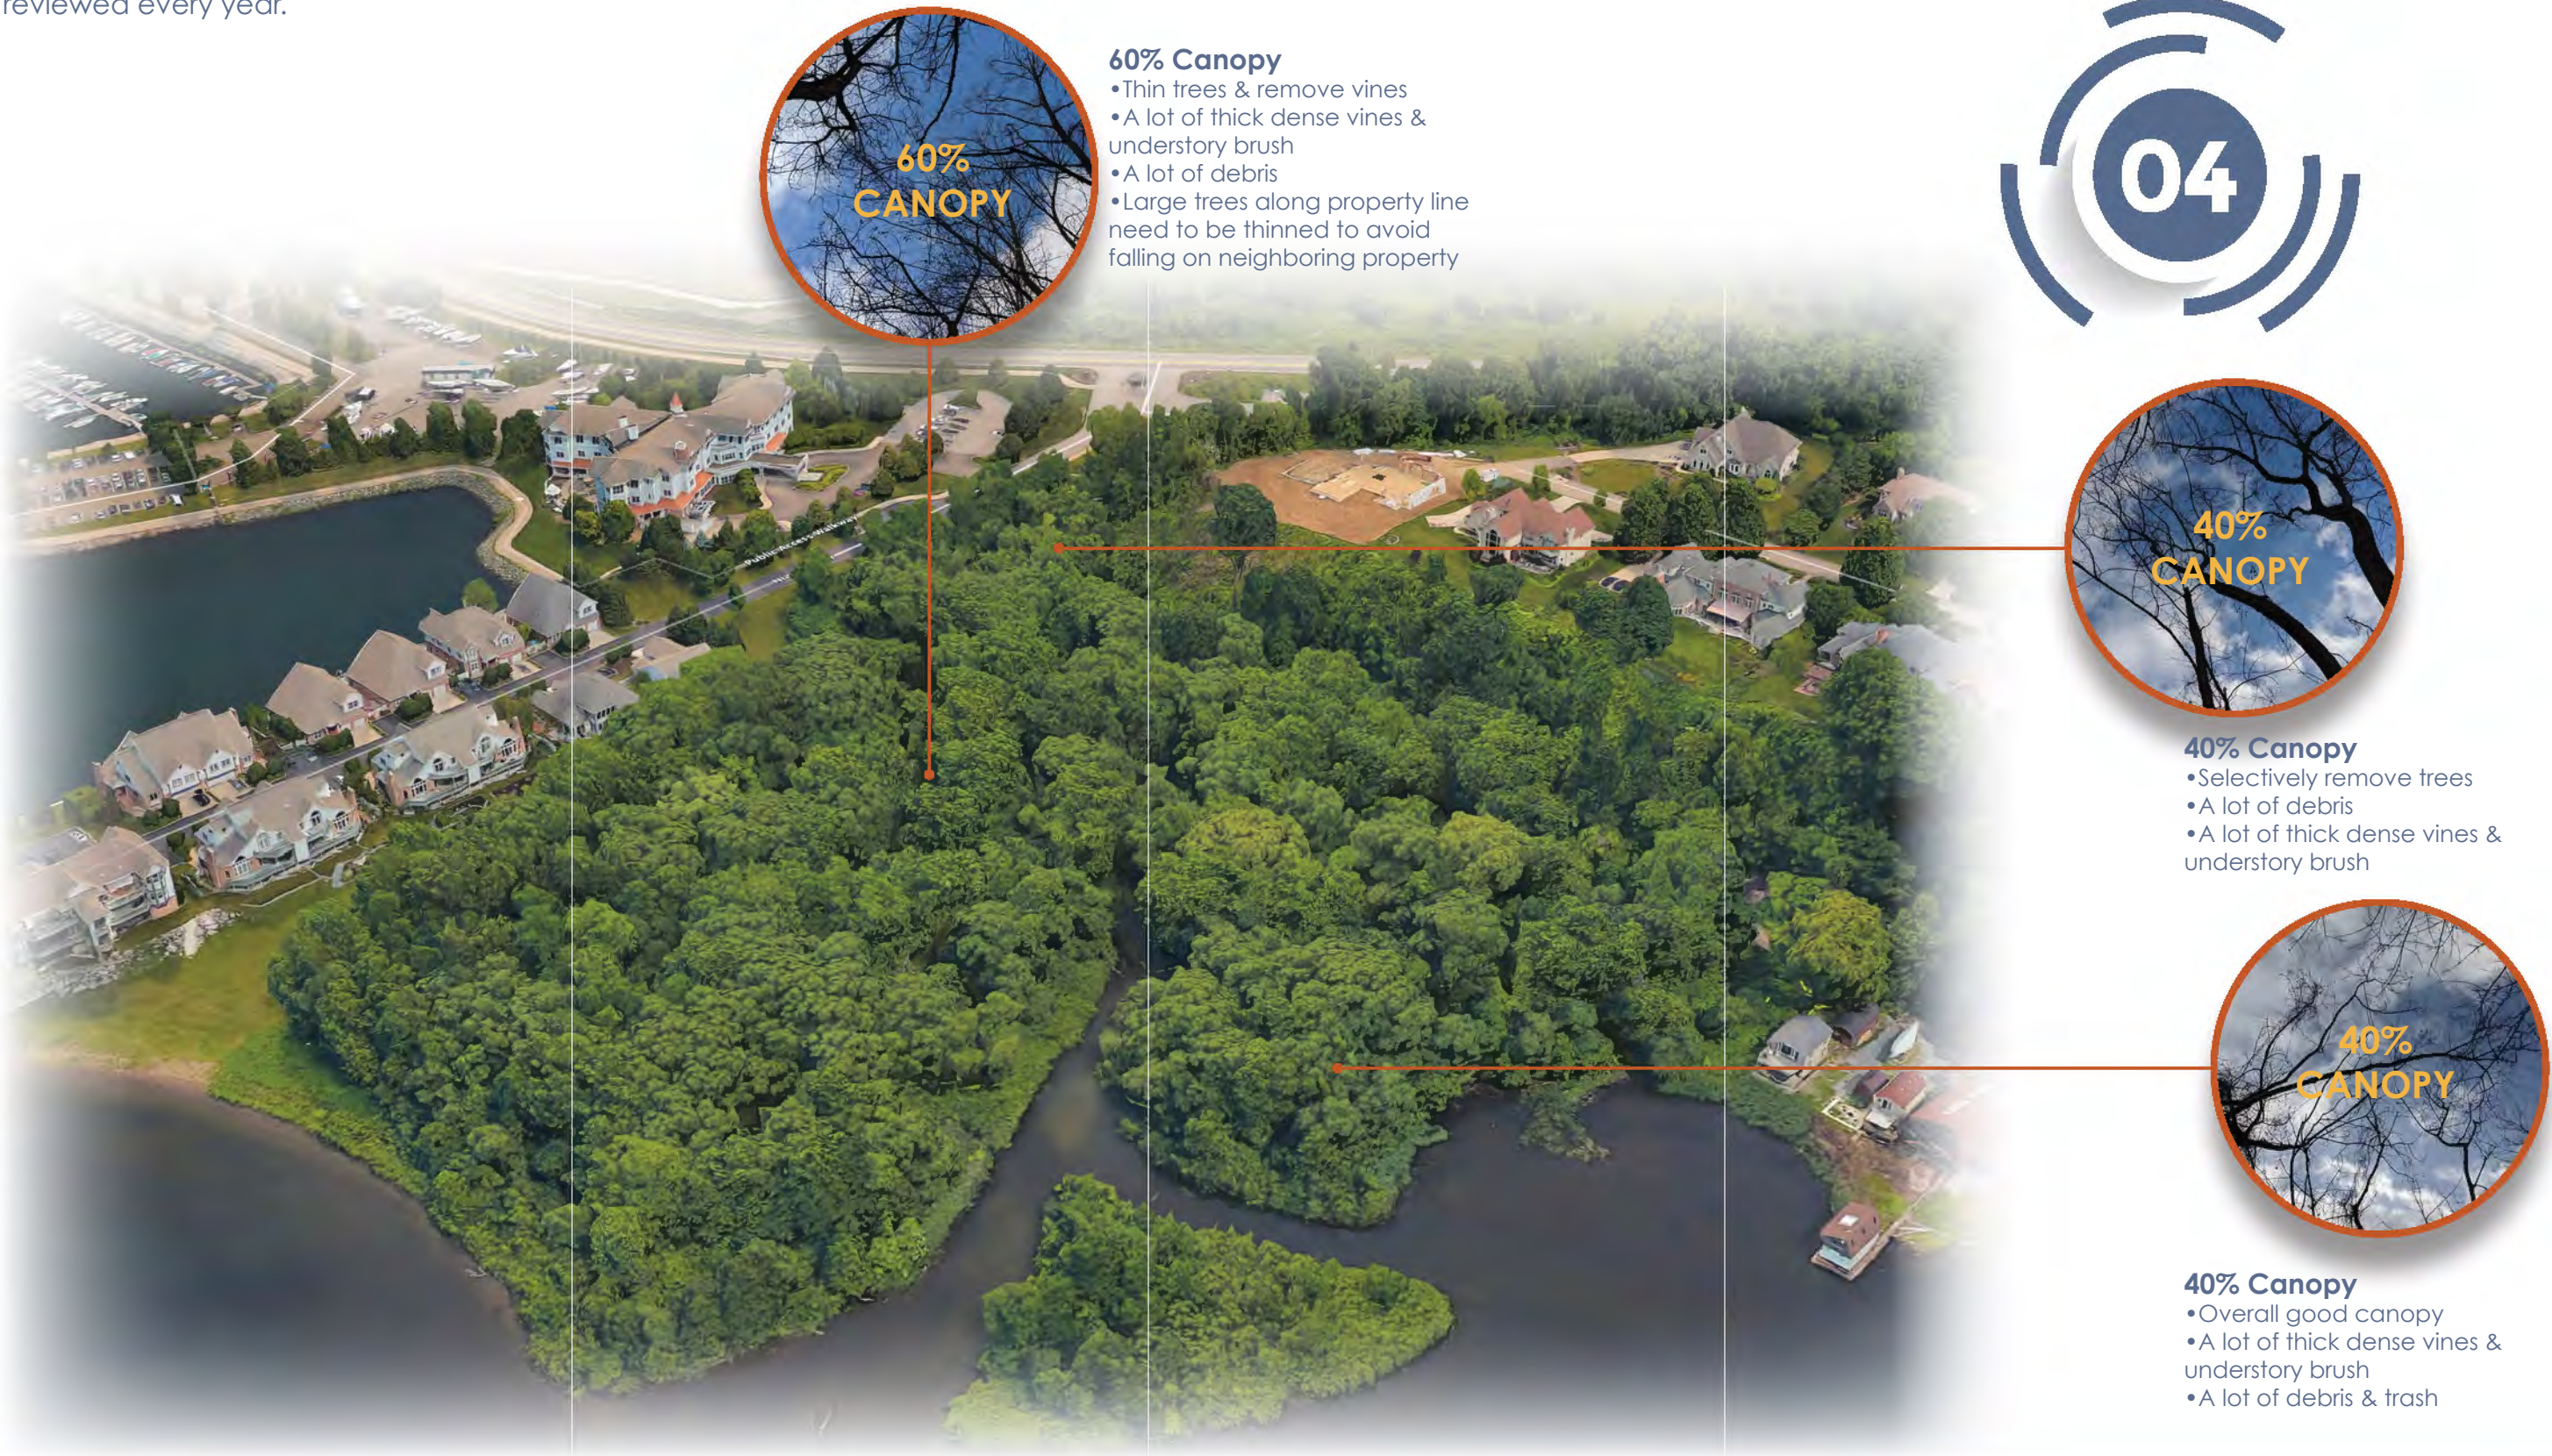
The three-man tree crew can trim/thin approximately 11,000 SF per day. Factors such as density, access and other conditions would effect this but the map to the right gives an idea of square footage covered per day. According to this plan to completely trim this area would take approximately 35 days.

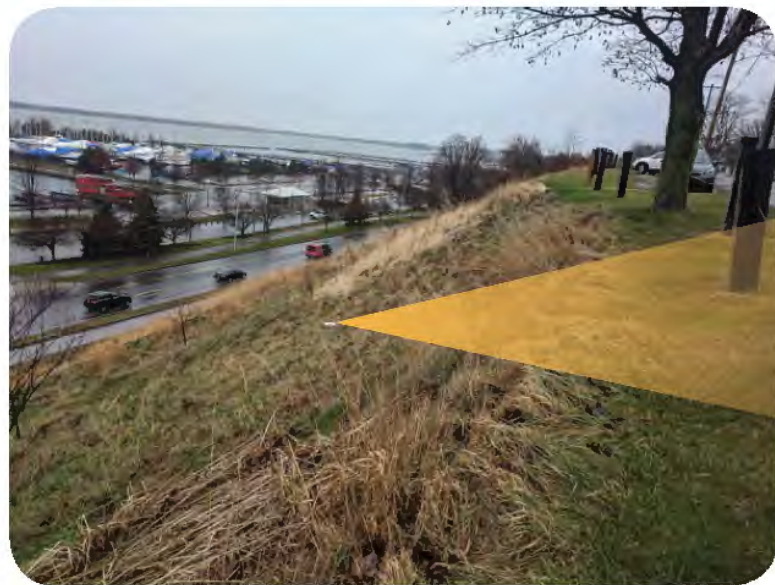
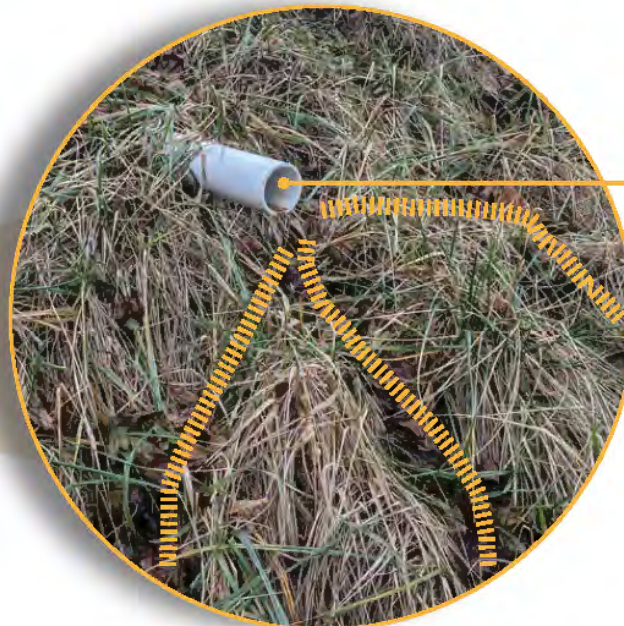
Current Conditions found at Bayfront Bluffs - West

A 4" PVC pipe is discharging water in the middle of the slope just below Cascade Street. It is unknown where this pipe comes from or what amount of water it's discharging. Small rills are forming at the discharge location and will continue to grow over time.

Solutions to Prevent Further Erosion & Rill Creation:

The first step will be to locate the pipe and find out where it's connected, how much water it's moving, and if it's a permitted pipe to be discharging onto Port Authority property.

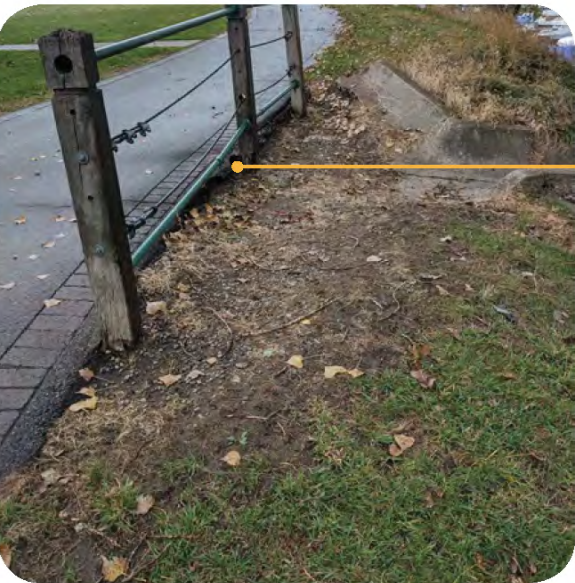
Current Conditions Found in Areas of Concern

We can see the asphalt path beginning to be undercut as the material is continually carried away with every rain storm. This will eventually lead to the failure of this walkway.

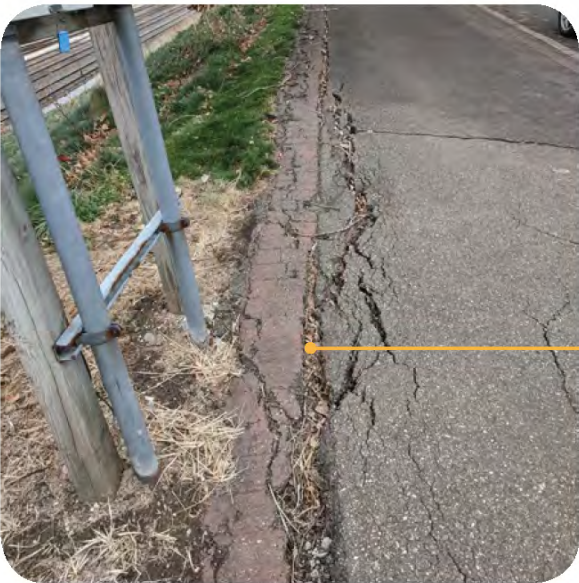
We can see the asphalt path beginning to tip & crack towards the slope. This could be an early indication that the soil is beginning to erode away causing the base to move.

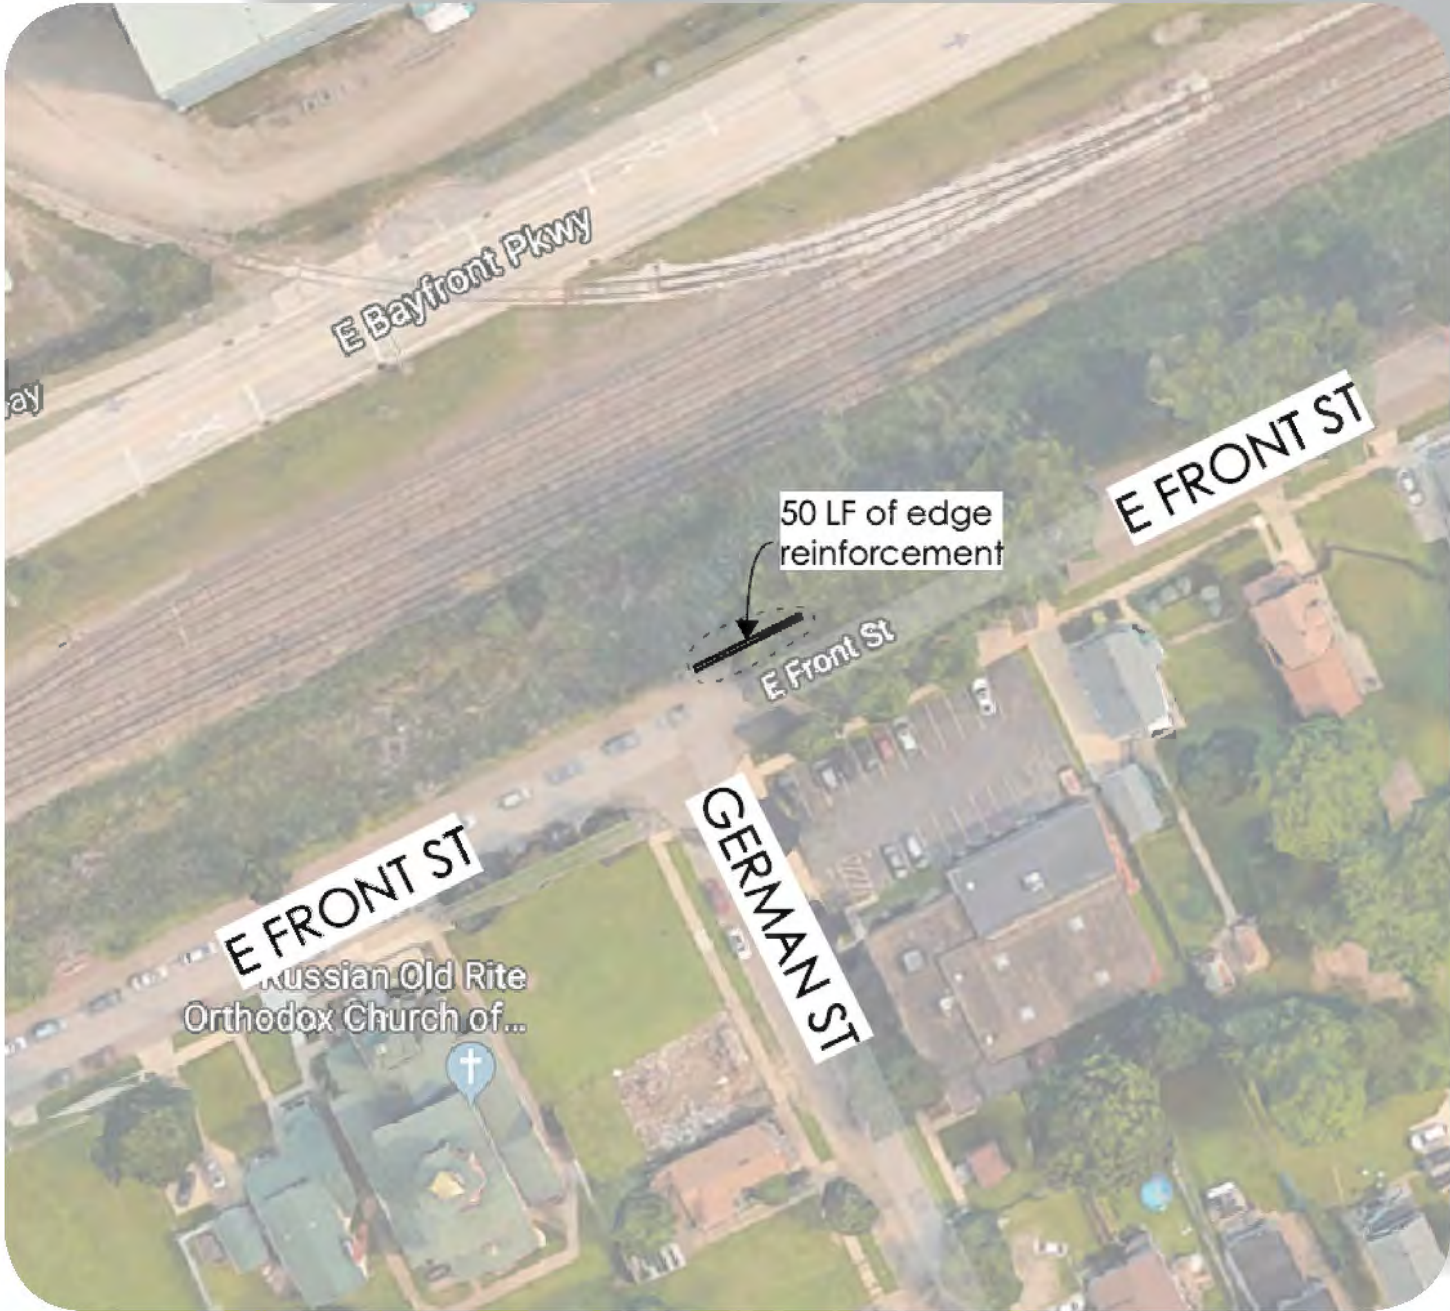
Reinforced Edge Protection

This provides four options for the edge reinforcement at the top of slopes where there is a hard surface close to the edge of the slope that is being undercut at the foot of German Street.

I
oversized
gravel
reinforcement

This includes installing a 18" wide oversized gravel strip along the edge of the hardscape surface for edge reinforcement. The oversized stone should be between 3-6" angular stone with fines in between to allow the stone to lock together further strengthening the edge.

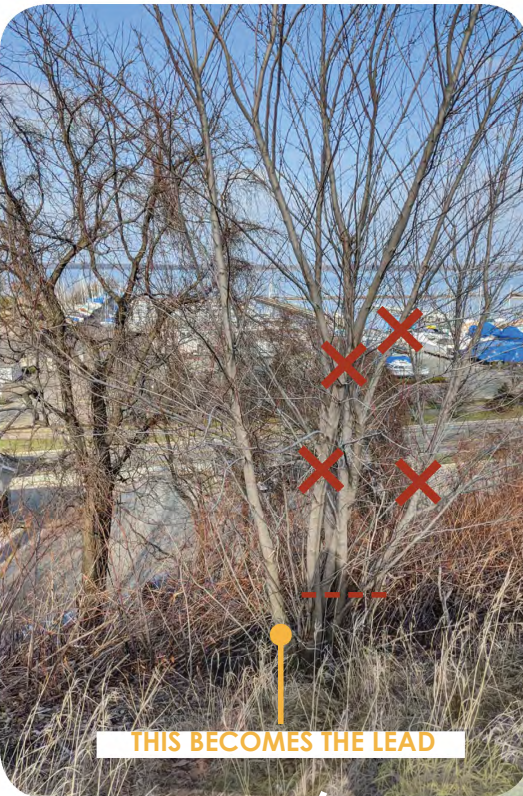
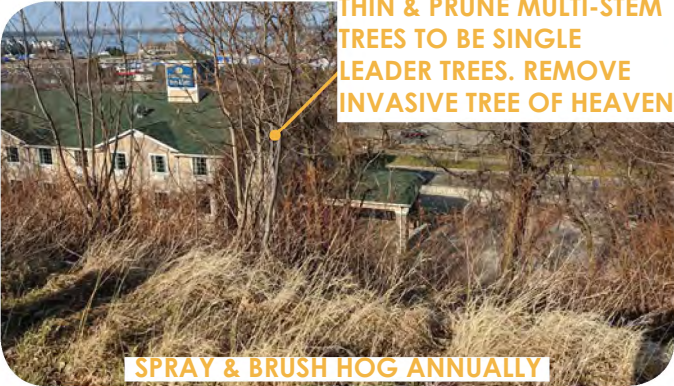
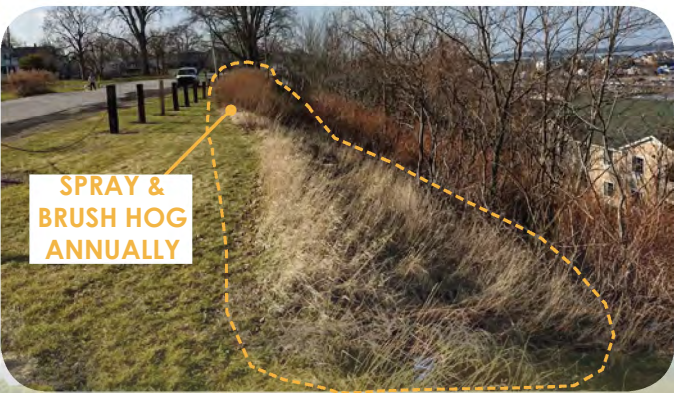
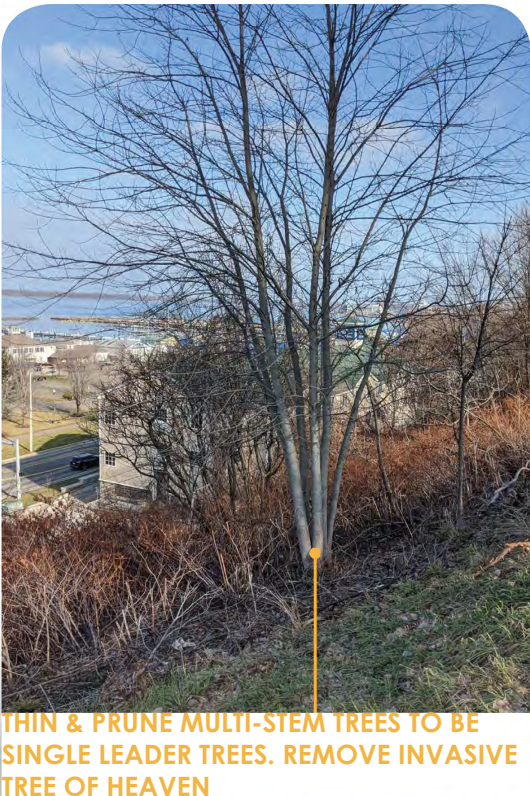
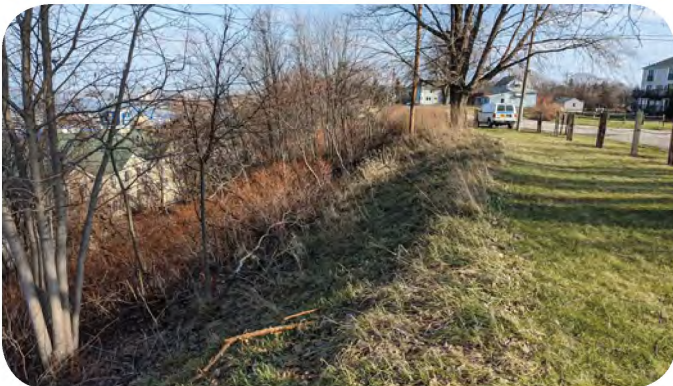
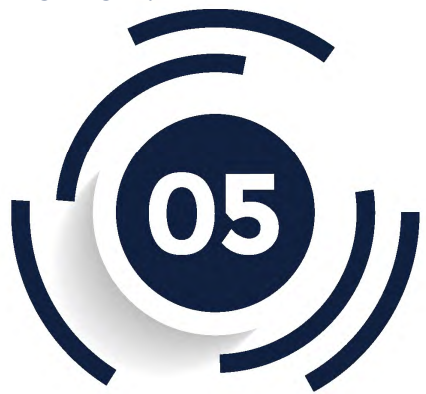
Tree/Vegetation Maintenance - Bayfront: Poplar to Plum

Along Front Street between Poplar and Plum there are numerous multi-stem trees on the Port Authority property that are not healthy trees and could grow to become hazardous. Multi-stemmed trees can break and create issues. Selecting one lead and removing the rest will help the health of the tree and views out. In addition, tall herbaceous plant material has been let go for years and has created an additional screen. These herbaceous materials can be selectively sprayed and brush hogged annually to maintain.

The issue along this stretch is aesthetic views to the bay. One major obstacle is the majority of the land is privately owned. The top of the bluffs can be maintained through selective trimming, invasive species removal, selective herbicide spraying, and brush hogging annually.

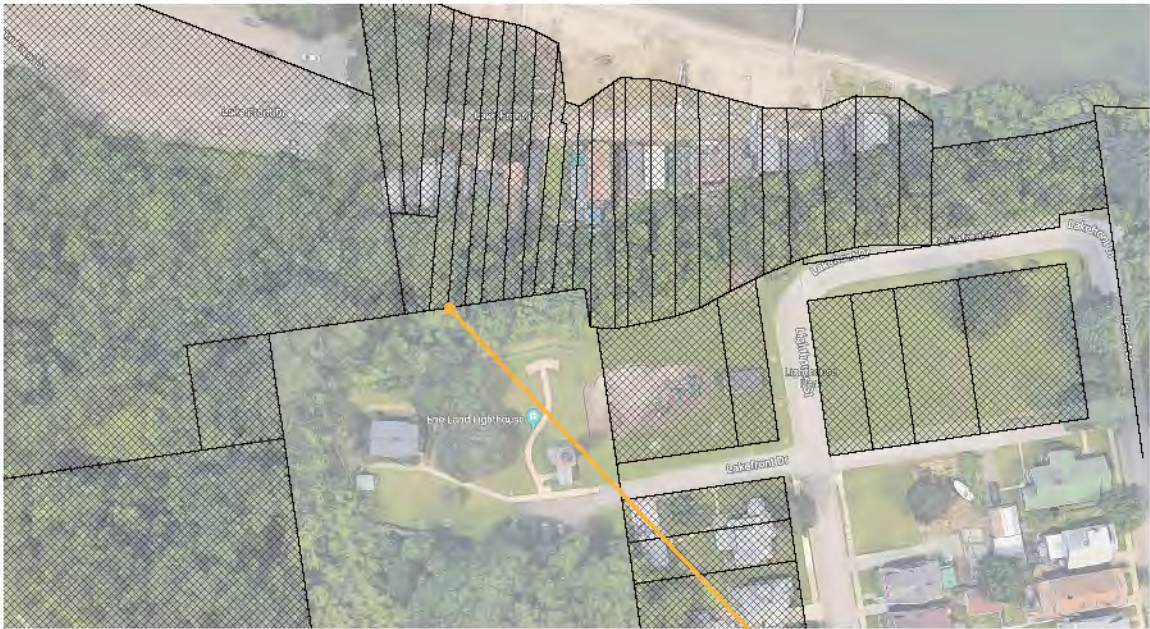
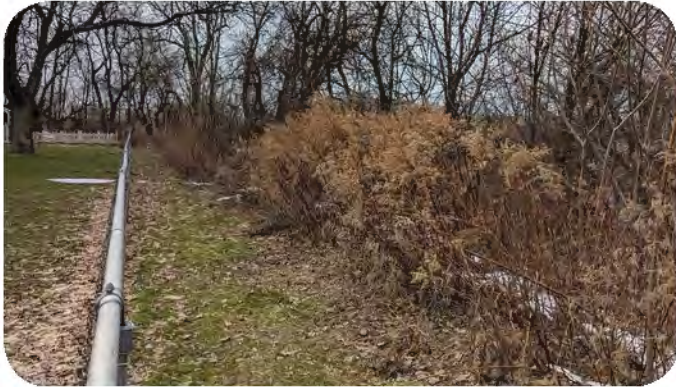
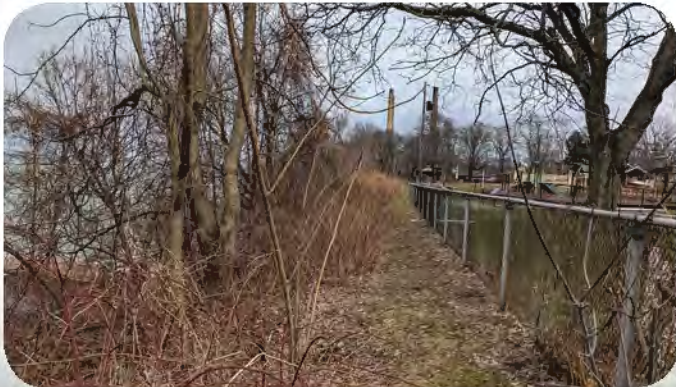
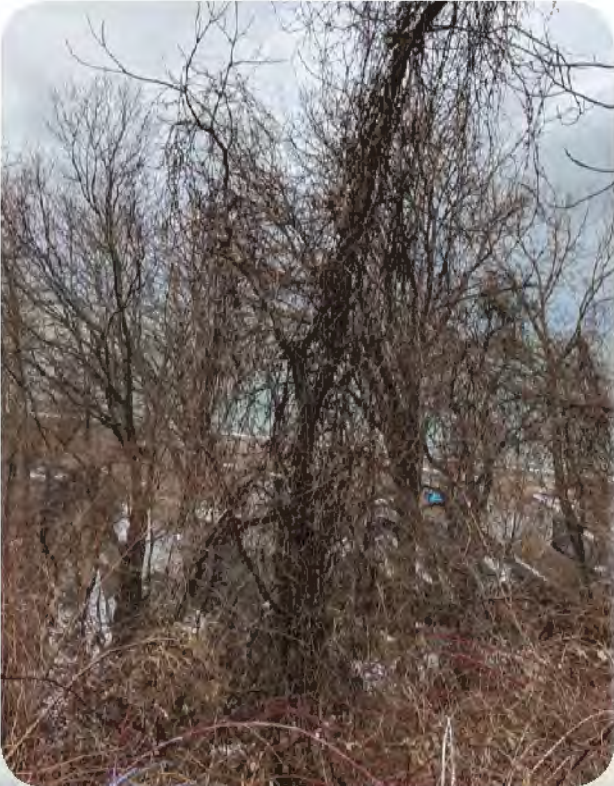
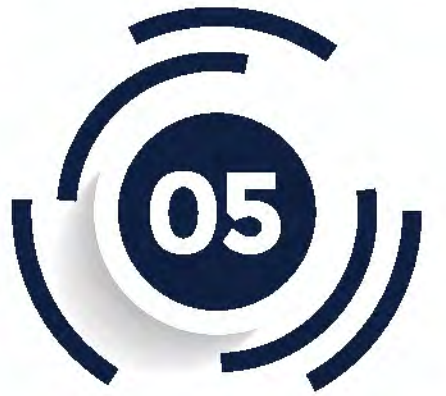
Tree/Vegetation Maintenance - Land Lighthouse

Bordering the Land Lighthouse property the Port Authority owns a small parcel of the bluff that is overgrown and will benefit from selective clearing. There are numerous trees that can be limbed up for views. Selecting one lead and removing the rest will help the health of the tree and views out. In addition, tall herbaceous plant material has been let go for years and has created an additional screen. These herbaceous materials can be selectively sprayed and brush hogged annually to maintain.

The issue along this stretch is aesthetic views to the bay and invasive species.

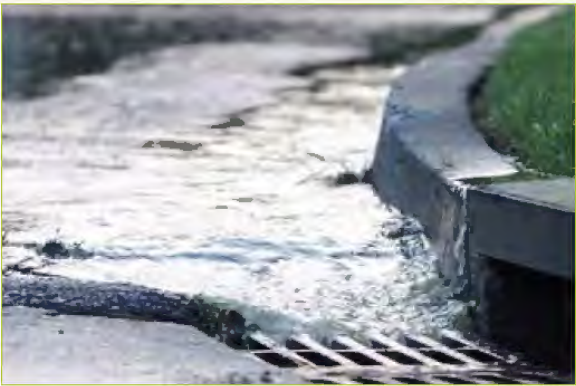
- **Curbed Roadway**

Areas where roads and walkways are at the top of slopes installing curbs will reduce the amount of water running off from the roadway over the slope.

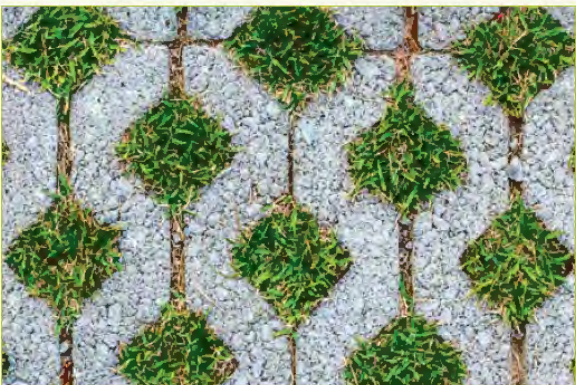
- **Porous Paving**

If a hard surface is needed, try using a porous material with proper drainage connections. Some examples include:

- Permeable pavers
 - Porous concrete/asphalt
 - Gravel
 - Reinforced grass pavers

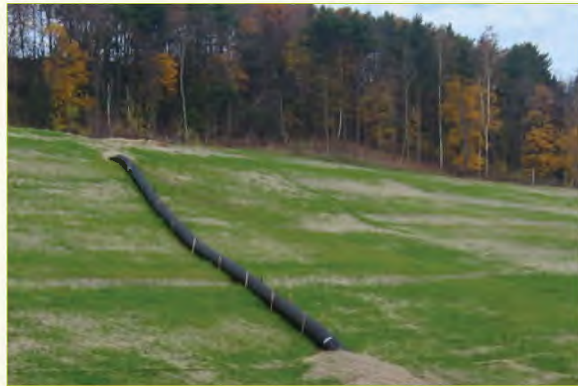
- **Direct Stormpipes to Bottom of Slope**
Capturing stormwater from roofs, yards, and other surfaces and directing that water through a pipe to the bottom of the slope will avoid causing erosion from letting the water discharge at the top or middle of the slope.

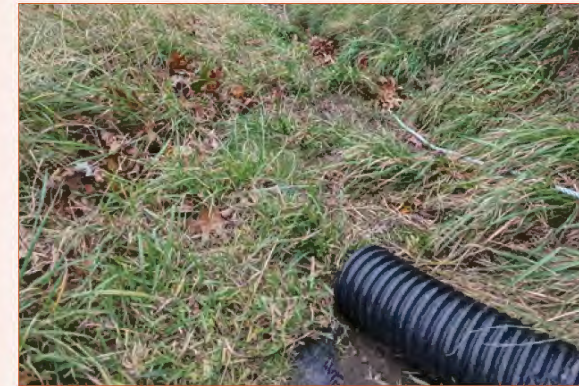
- **Direct Stormpipes to top & middle of Slope**
Directing stormwater through a pipe to the top or middle of the slope will create erosions from uncontrolled high velocity water wearing away at the slope face.

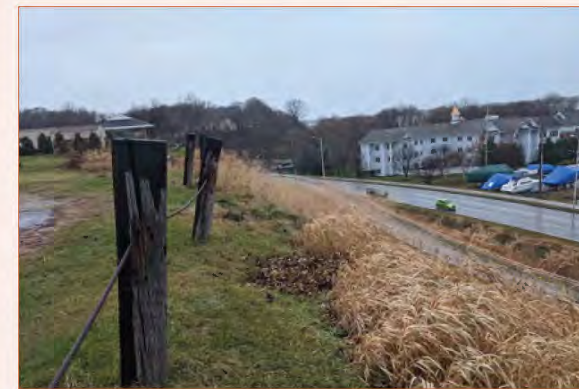
- **Excessive Runoff over Slope**
Allowing water to flow freely over the slope with no vegetation to buffer it will begin the process of erosion and continue to get worse over time.

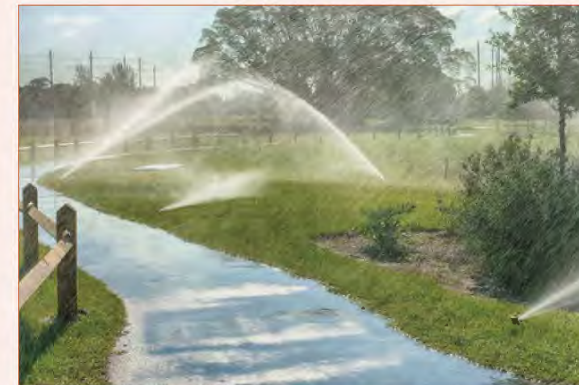
- **Using Spray Sprinklers**
Using excessive water through spray sprinklers at the top of the slope, use when ground is already saturated or leave them on for long periods of time thus adding more water to the surface and groundwater.

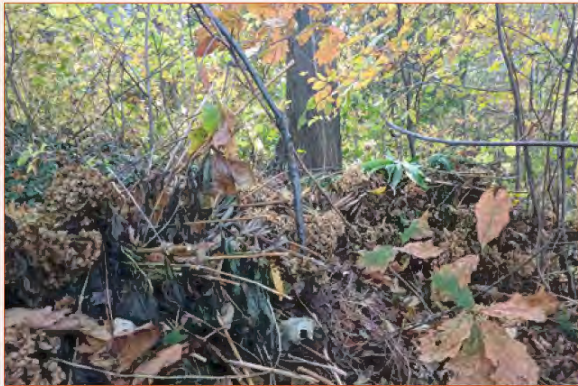
- **Dump Yard Waste over Slope**
Disposing of yard waste including leaves, clippings, branches, etc. in large heavy piles at the top of the slopes.

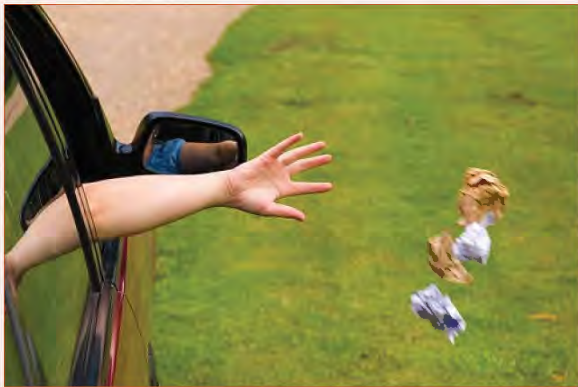
- **Dumping of Trash**
Dumping cans, bottles, and other inorganic trash over the slopes edge.

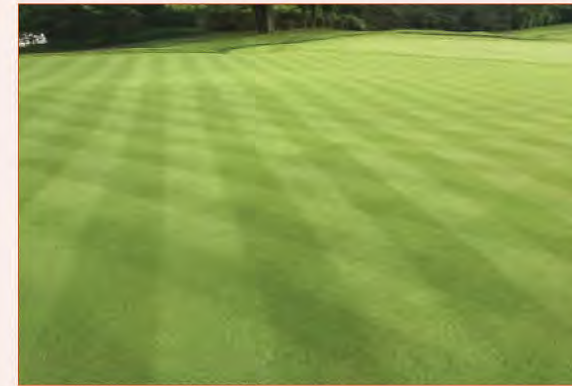
● Excessive & Low Mowing

- Lawn that is mowed often and low focuses all of it's energy to producing blades thus creating weak root systems.
- Requires more supplemental water as it tends to dry out faster

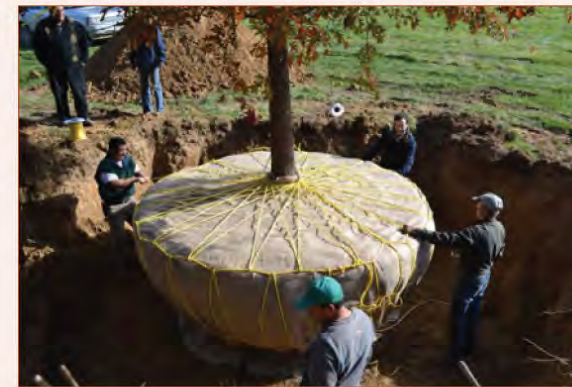
● Large Plants & Trees with Heavy Machines

- Large trees and shrubs require more soil disturbance and excess soil left behind and often require large machines to install all increasing the risk of soil movement

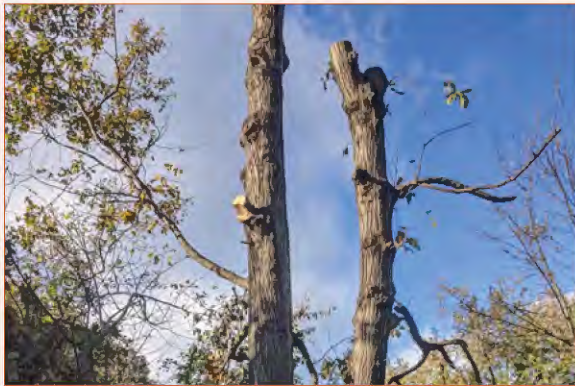
- **Clear Cutting & Topping**
 - Clear cutting and topping of trees for views or other reasons is never permitted.
 - Removal of key species (see list) is not permitted
 - Topping forces the tree to grow outward rather than upward creating a dense irregular branching pattern that does not allow sunlight to penetrate through to the ground.

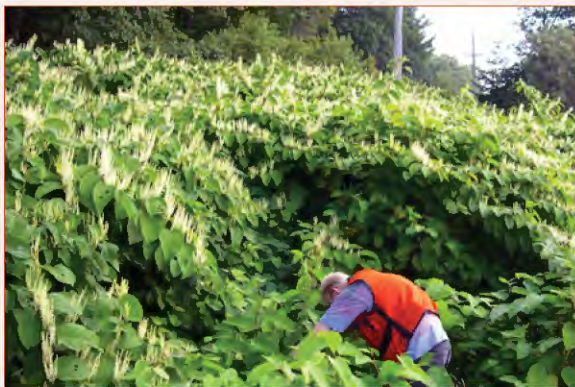
- **Letting Invasives Takeover**
 - Invasive species will out-compete the native vegetation and threaten the biodiversity of ecosystems

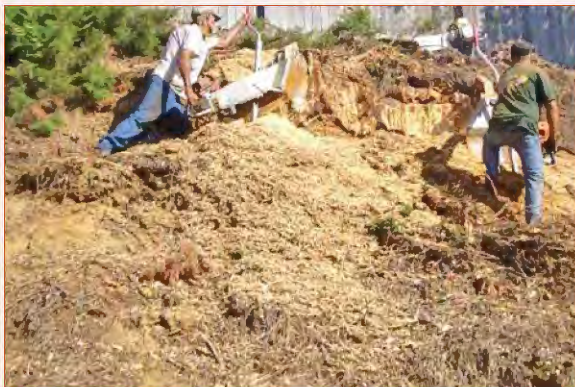
- **Excessive Soil Disturbance**
 - Removing stumps & roots causes a lot of soil disturbance as well as severely weakens the stability of the soil.

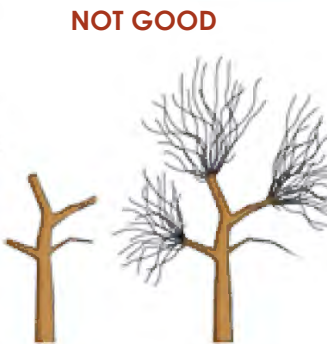
NOT GOOD

Topping produces clumps of uncontrolled growth

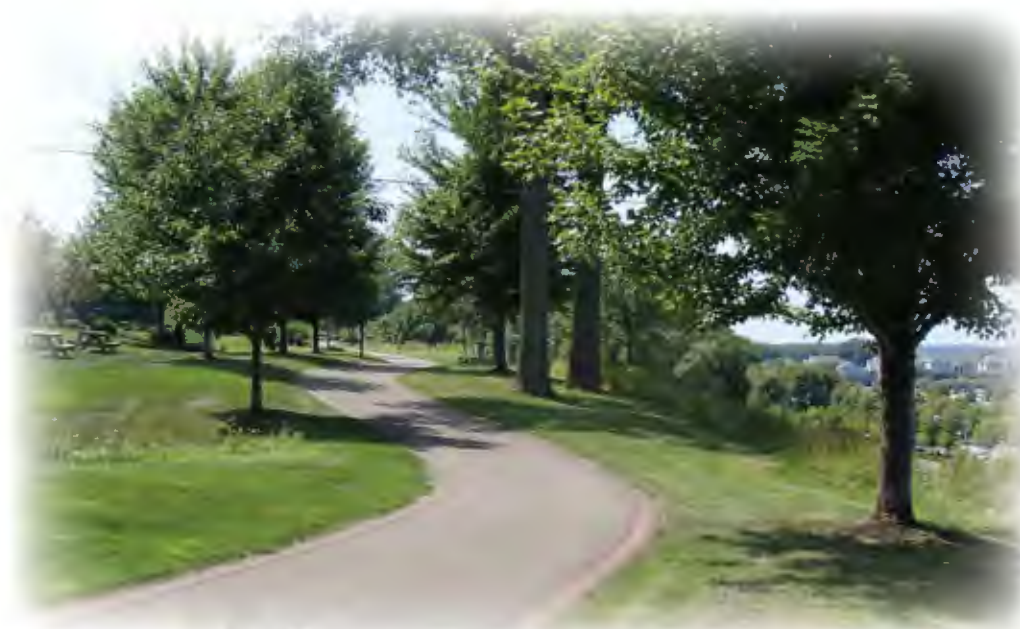
Extending the Bayfront Promenade where it ends at Poplar Street will carry pedestrians across Front Street extending the walking and biking trail.

This includes an estimated budget to remove the existing roadway and extend the existing promenade to Plum Street. This includes installing an overlook with benches and a binocular viewport as well as revitalizing the greenspace surrounding the promenade. Including in this cost are estimated design fees.

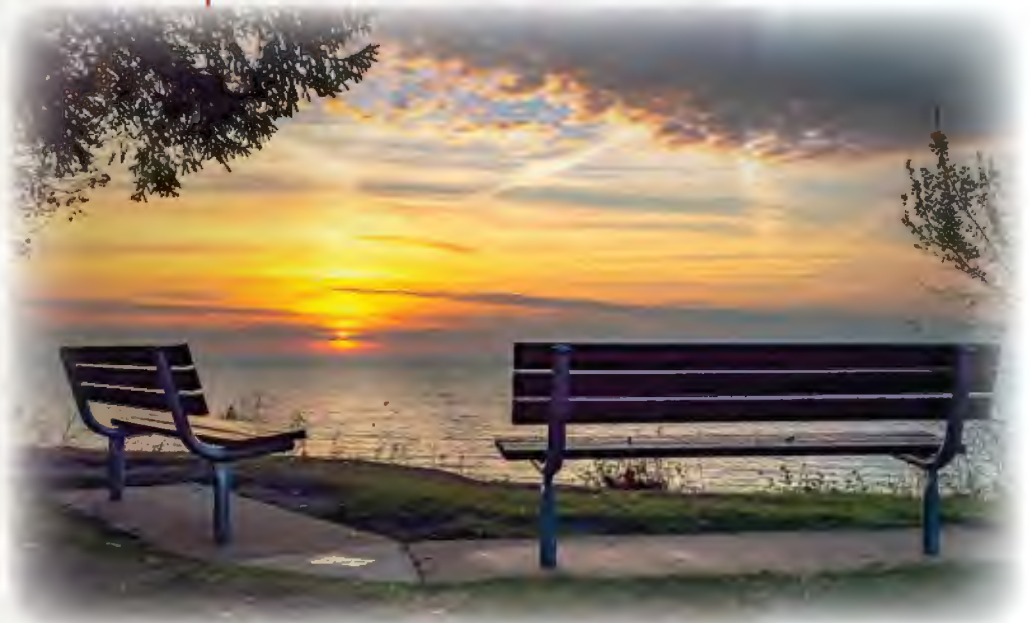
OVERLOOKS

Along the bayfront there are numerous opportunities for simple overlook locations. These overlooks can be as simple as benches with a foundation and can also include binocular pedestals to view the bay, wild life, various ships coming in (Niagara), and Presque Isle. The overlooks will also provide seating opportunities for walkers, runners, and bikers using the multi-use trail running along the top of the Bayfront Bluffs.

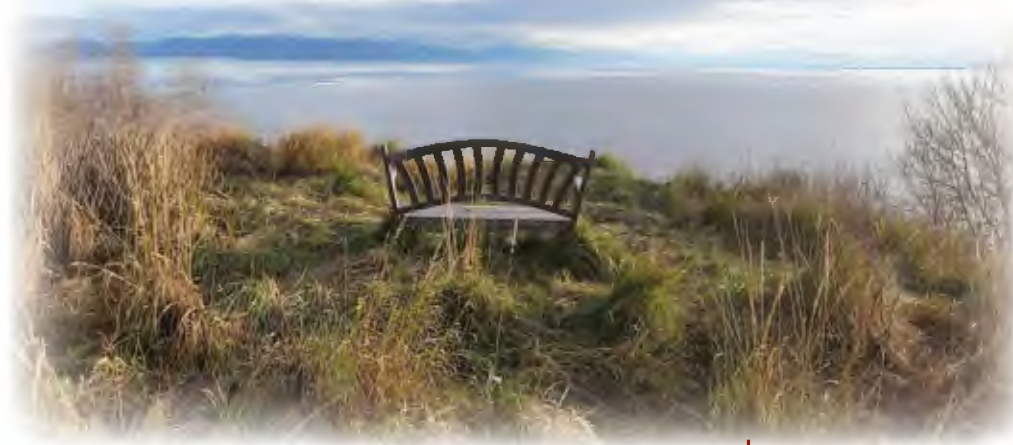
OVERLOOKS

Along the bayfront there are numerous opportunities for simple overlook locations. These overlooks can be as simple as benches with a foundation and can also include binocular pedestals to view the bay, wild life, various ships coming in (Niagara), and Presque Isle. The overlooks will also provide seating opportunities for walkers, runners, and bikers using the multi-use trail running along the top of the Bayfront Bluffs.

This includes furnishing and installing two pedestal binocular viewers (non-coin operated) with a concrete foundations.

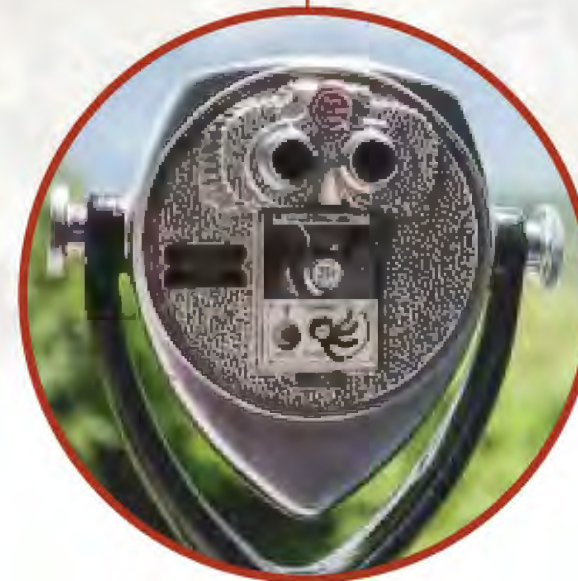
BINOCULAR
PEDESTAL

Binoculars will allow pedestrians to get a closer view out to the Bay during events like the Tall Ships Festival
