Erie, Pa

Bluff & Ravine Evaluation

February 26, 2020

Dahlkemper Landscape Architects & Contractors

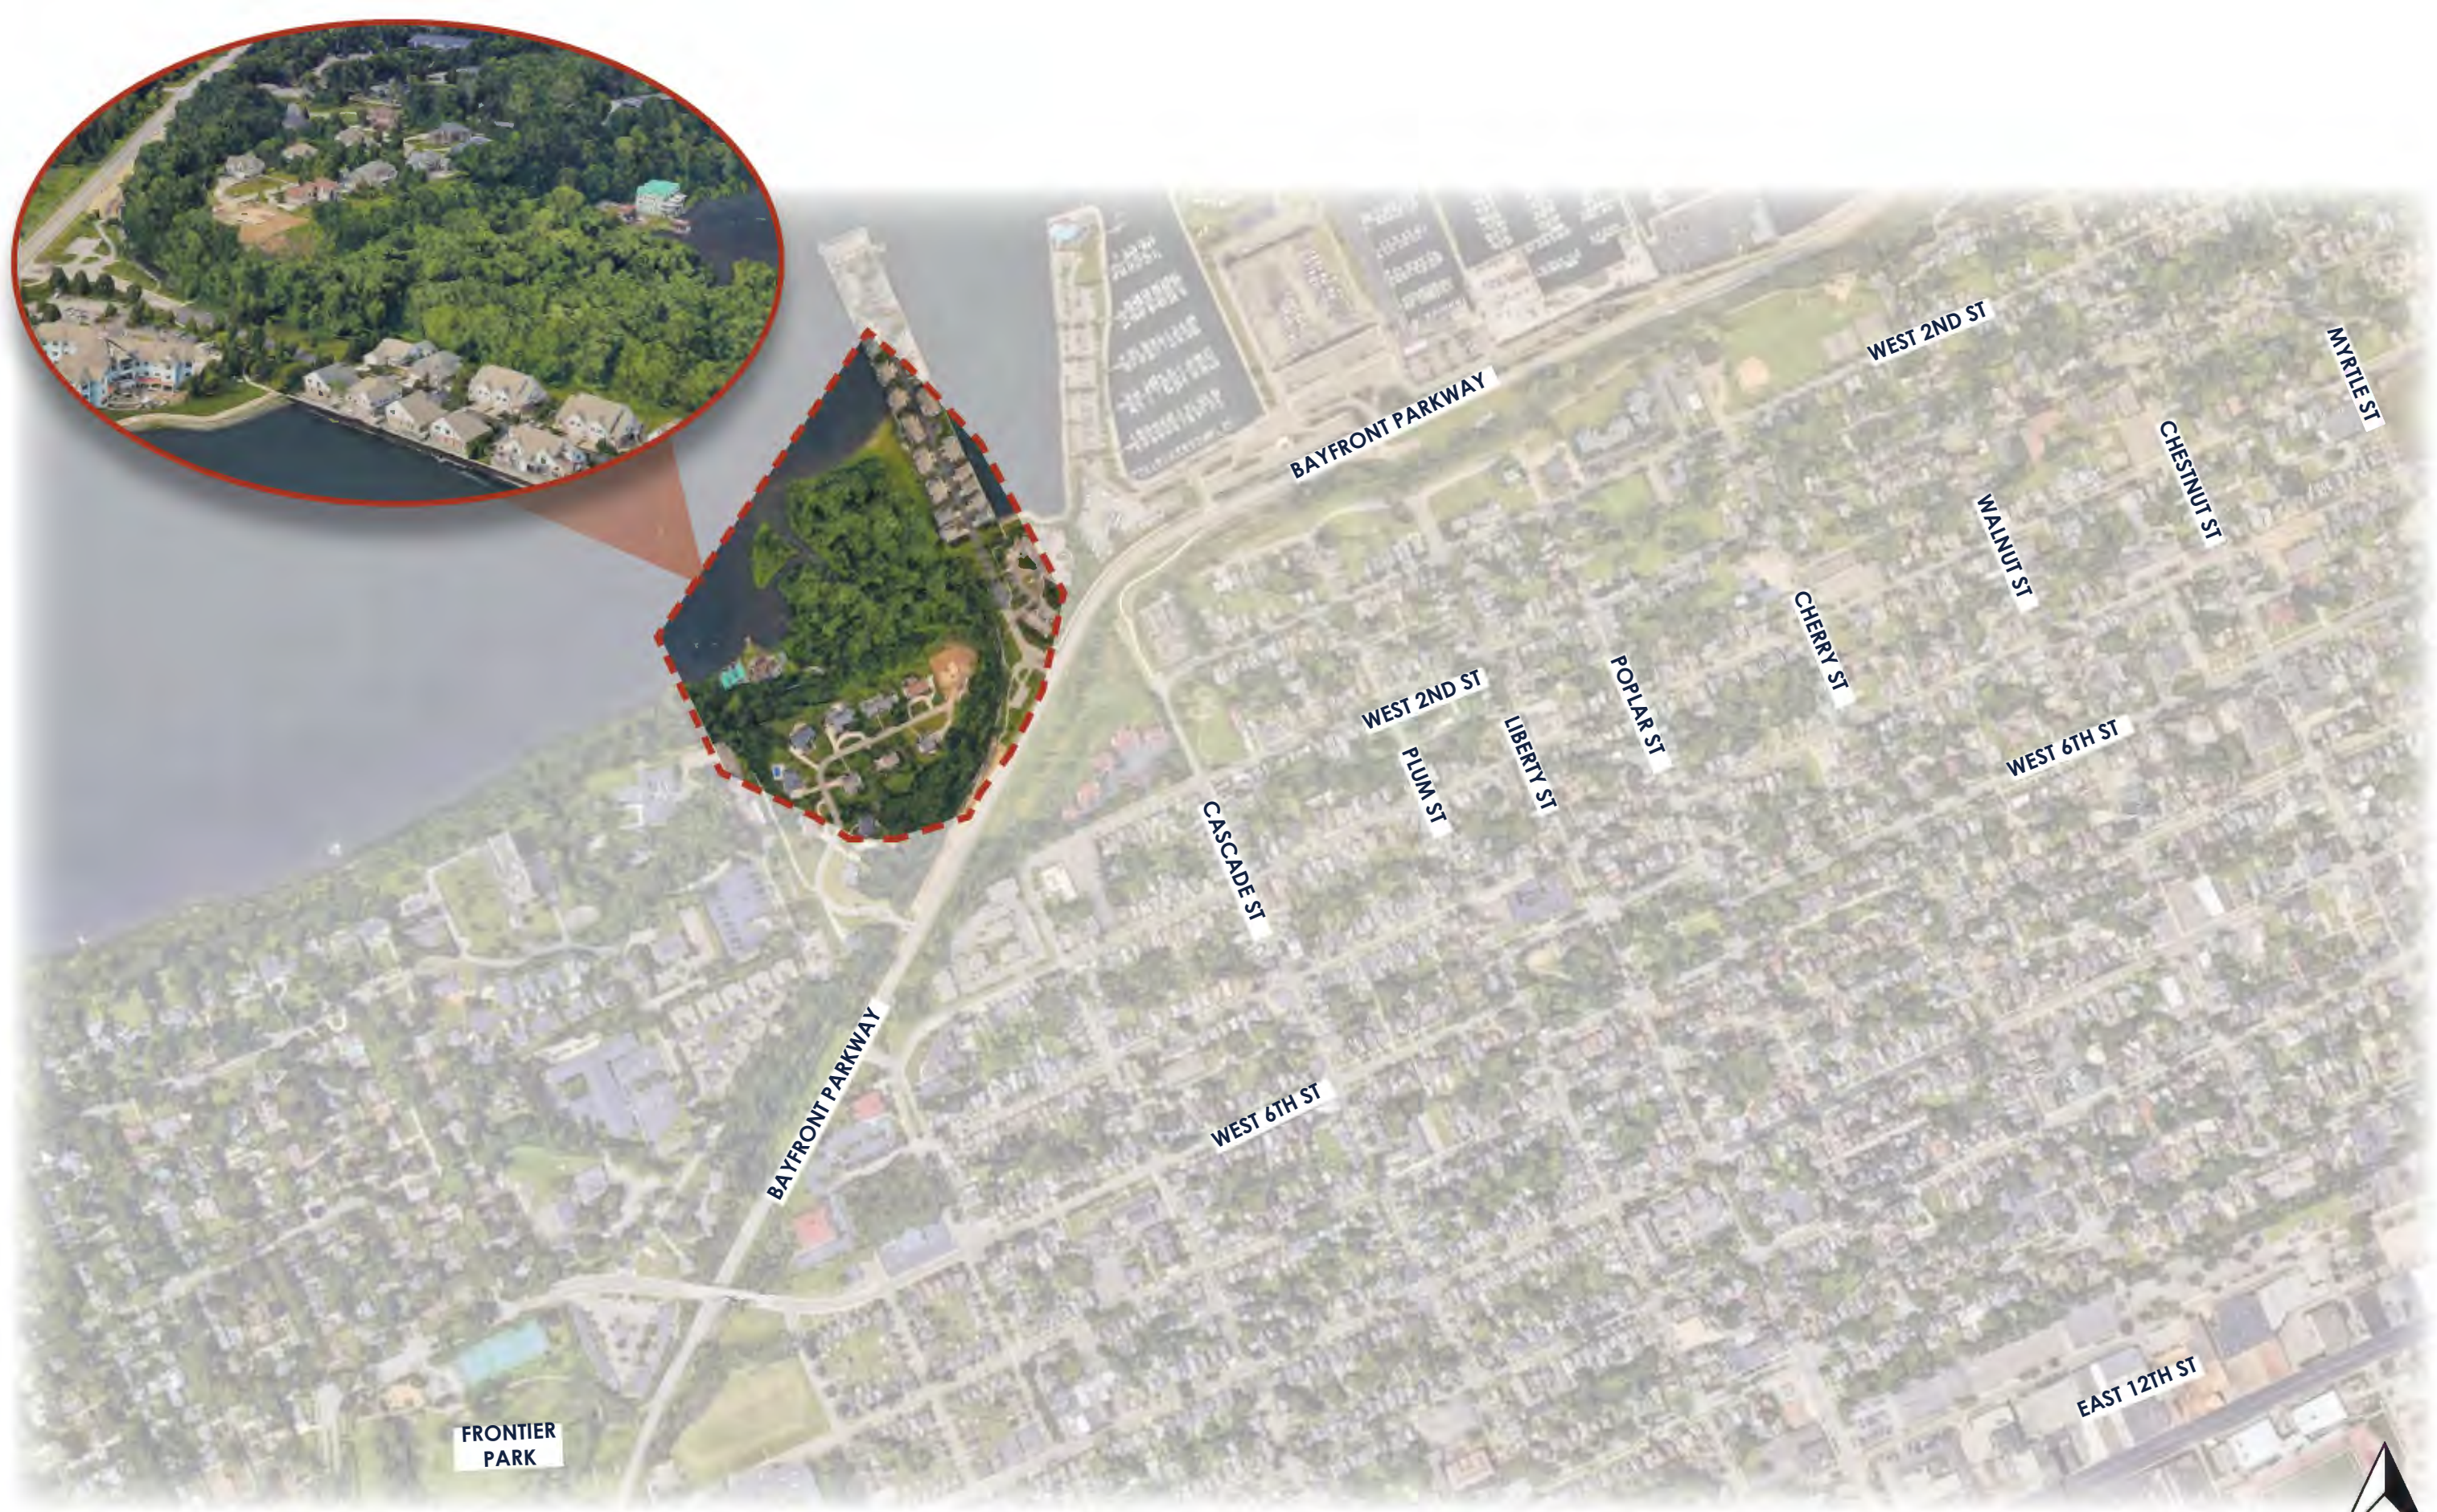
Raised boardwalk at Cascade Creek

This provides an estimated for a designed and installed 515 linear foot raised boardwalk system by Modular Trail Structures. This boardwalk system is minimal disturbance and easy installation.

This estimate includes the design of the boardwalk as well as the furnishing and installment of the boardwalk system on site. The price varies due to factors that can effect the price such as type of wood and width of the boardwalk.

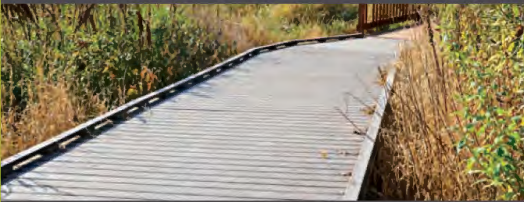
Poerio Park, Kenosha, WI
Hiking and Biking Trail

Length: 120 feet
Footing: Bearing Plate Design (w/ adjustable leg)
Frame: Pre-fabricated Pressure Treated Lumber
Decking: 2" x 6" Plastic Lumber

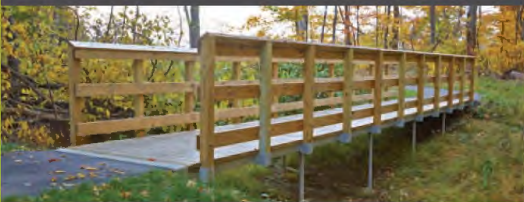
Liberty Park, Summit County, OH
Hiking and Biking Trail

Length: Two 36 foot Boardwalks
Footing: Bearing Plate Design (w/ adjustable leg)
Frame: Galvanized Steel
Decking: 2" x 6" Pressure Treated South Yellow Pine

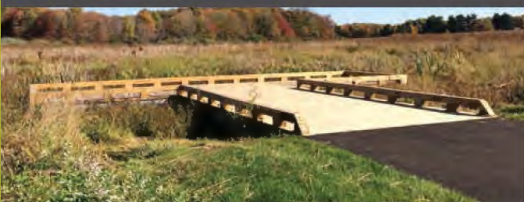
Frohring Meadows, Chardon, OH
Wildlife Viewing and Group Education Platform

Length: 40 feet
Footing: Bearing Plate Design (w/ adjustable leg)
Frame: Galvanized Steel
Decking: 2" x 6" Pressure Treated South Yellow Pine

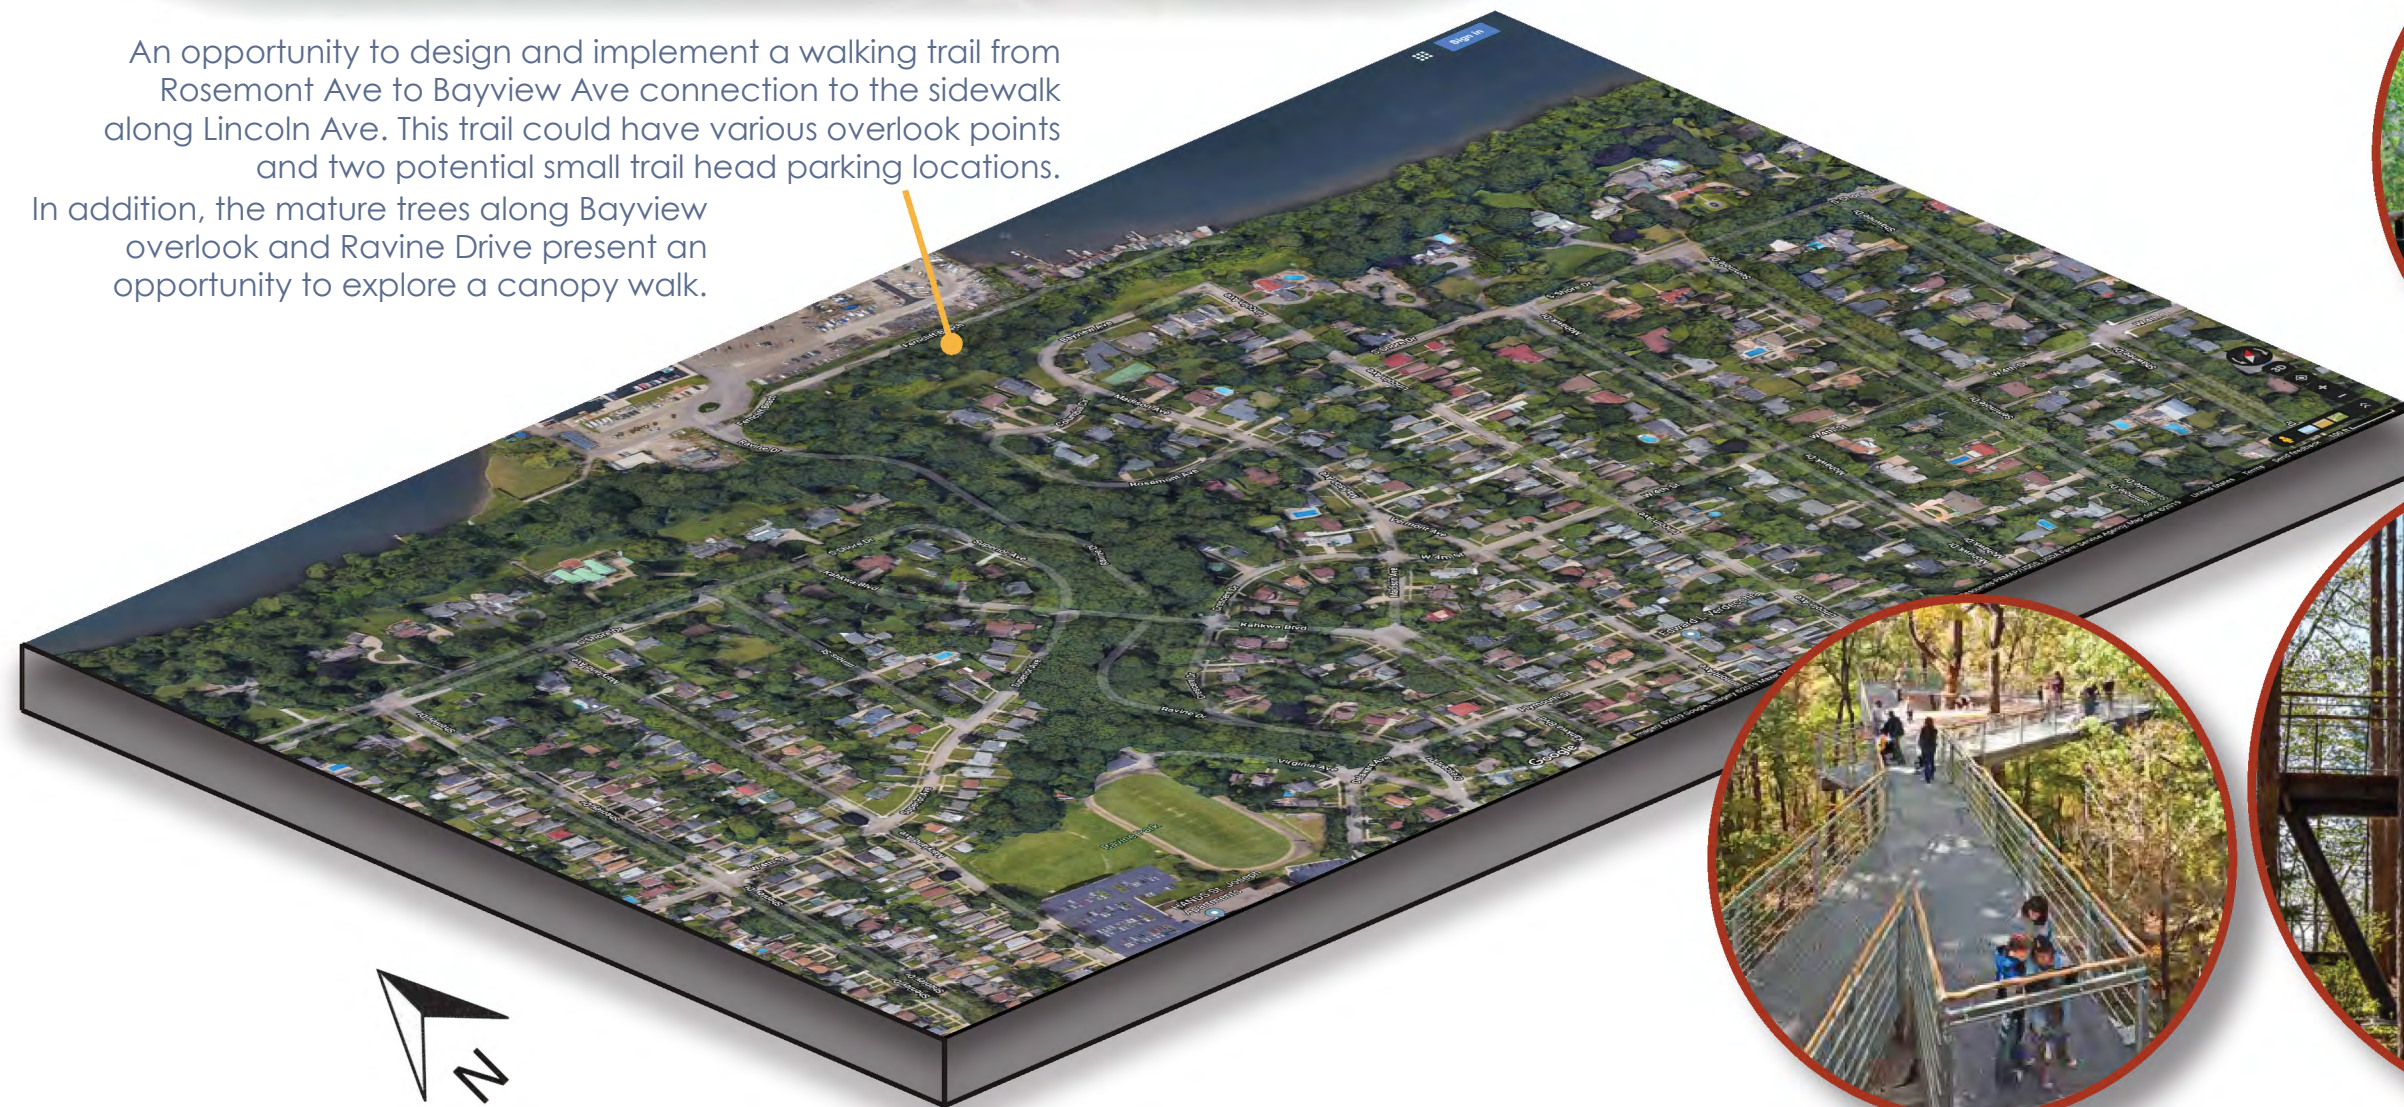
An opportunity to design and implement a walking trail from Rosemont Ave to Bayview Ave connection to the sidewalk along Lincoln Ave. This trail could have various overlook points and two potential small trail head parking locations. In addition, the mature trees along Bayview overlook and Ravine Drive present an opportunity to explore a canopy walk.

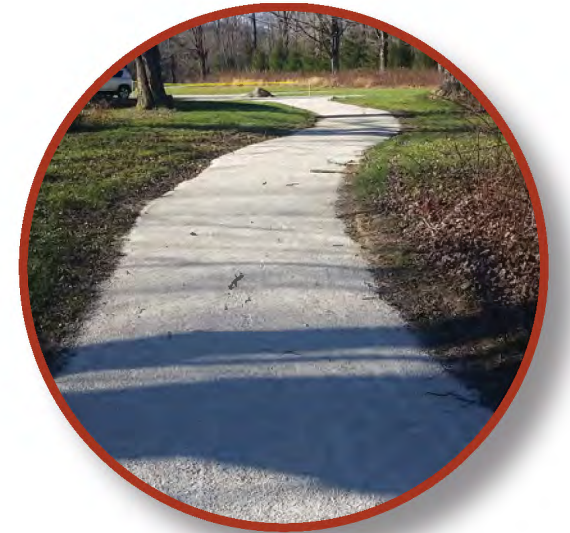
B ADA GRAVEL WALKING TRAIL WITH OVERLOOK LOCATIONS

This would include design, layout, and installation of an 8'-0" wide gravel ADA trail along the top of the ravine connecting Rosemont Ave to Bayview Ave.
